# **ADELAIDE IN-DEPTH ACCIDENT STUDY**

1975-1979

## **PART 7: ROAD AND TRAFFIC FACTORS**

**A.J. McLean  
W.J. Offler  
B.L. Sandow**

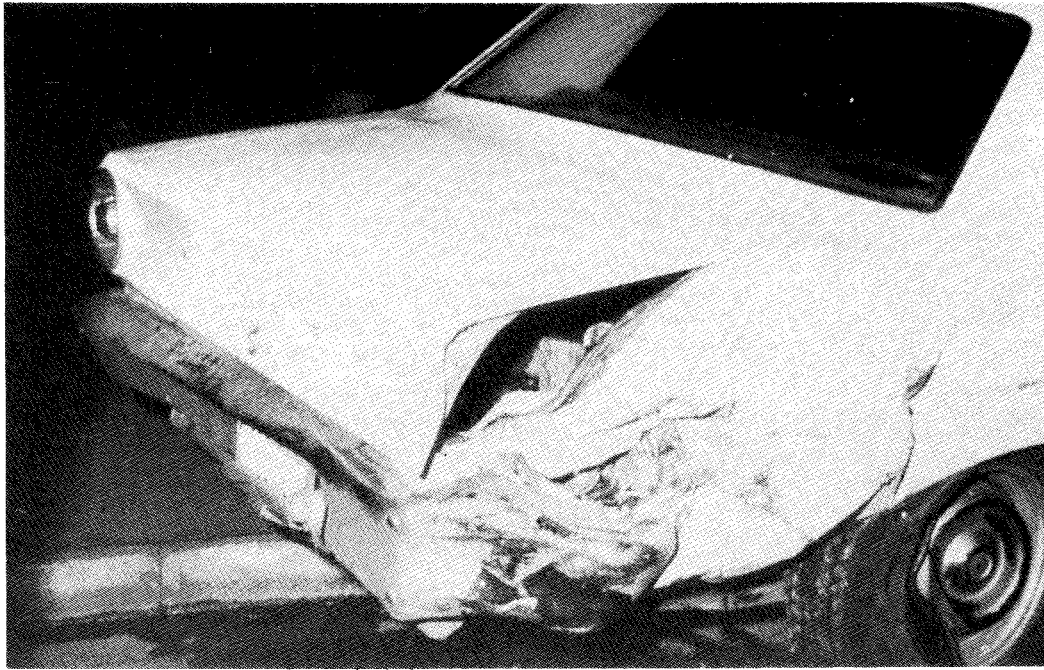
FIGURE 3.2: Accident 071.

One other of these alcohol-involved accidents occurred on an arterial road. In this accident (071, Figure 3.2) the mercury vapour lamps provided a non-uniform level of illumination. The driver of the car had a blood alcohol level of 0.21 and the very poor static visual acuity of 3:36 in both eyes, was not corrected by wearing glasses. His car hit the right rear corner of a parked car (Figure 3.3) and then yawed anti-clockwise and rolled onto the back of a second parked car (Figure 3.4). He reported that he had been talking with his passenger when he hit the first car, which he had not seen, and that he thought that alcohol had only contributed to a small degree, if at all, to his being involved in this crash. This case is listed in Table 3.1 under "Veered to the left" but the car may well have been proceeding straight ahead.

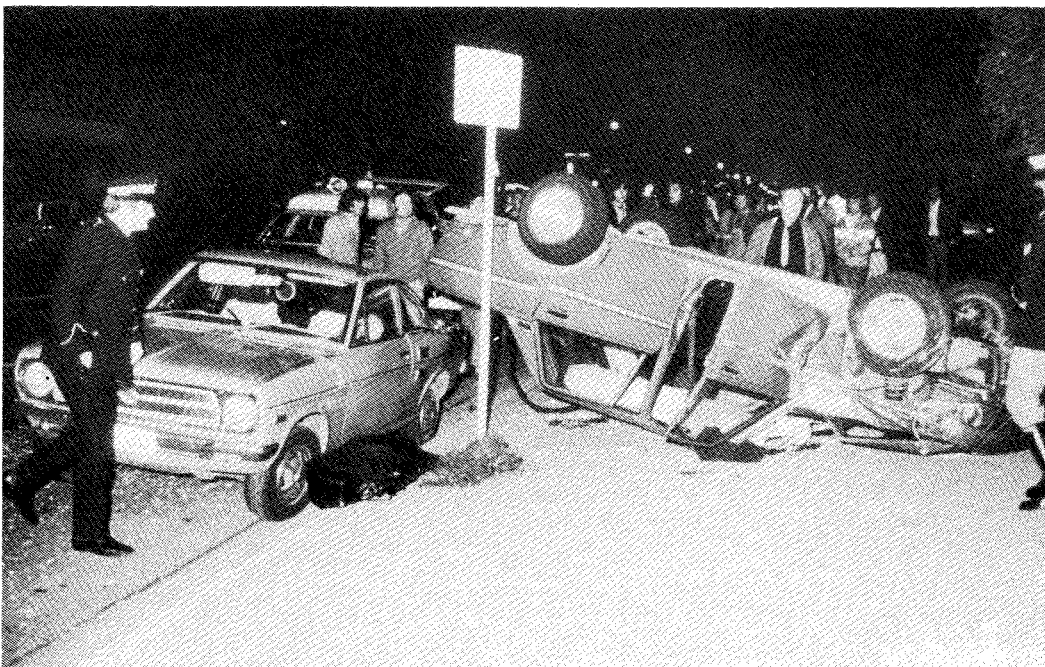
FIGURE 3.3: Damage to parked car : Accident 071.

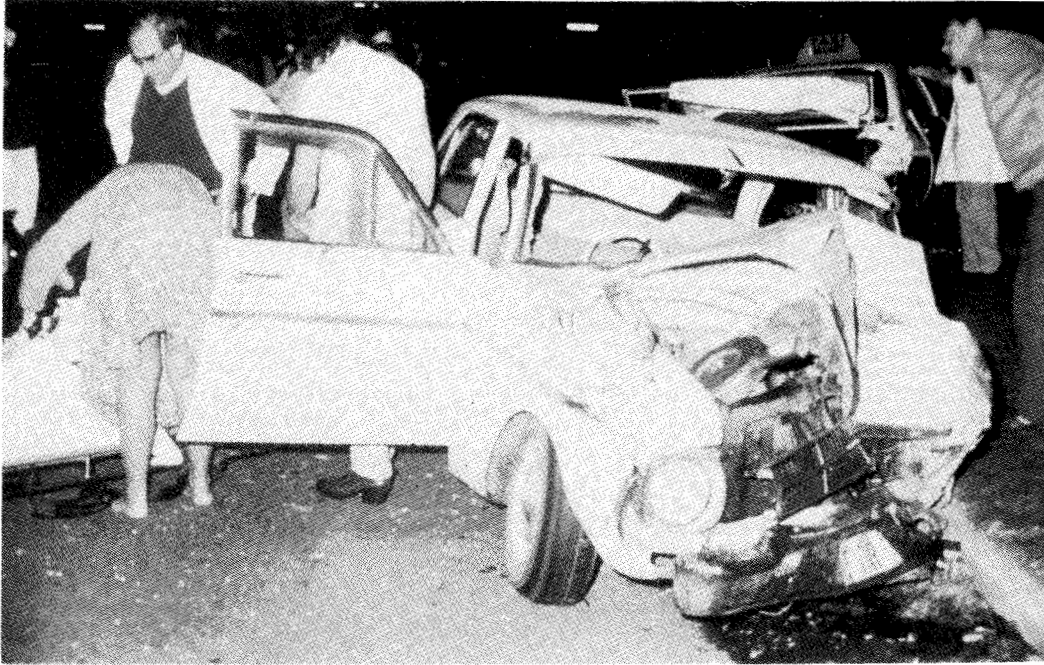
In Accident 138 the car which was hit was a taxi which was stationary at the kerb with its parking lights on and also the interior light. The driver of the striking car had a blood alcohol level of 0.26 and was talking with his passengers. There was a suggestion that he may have "dozed off" just before he hit the taxi but we could not confirm this. His car did not appear to have veered to the left before the collision but rather had been travelling straight ahead. The resulting damage to the vehicles was severe (Figures 3.5 and 3.6).

FIGURE 3.5: Damage resulting from collision with parked taxi (shown in background and in Figure 3.6) : Accident 138.

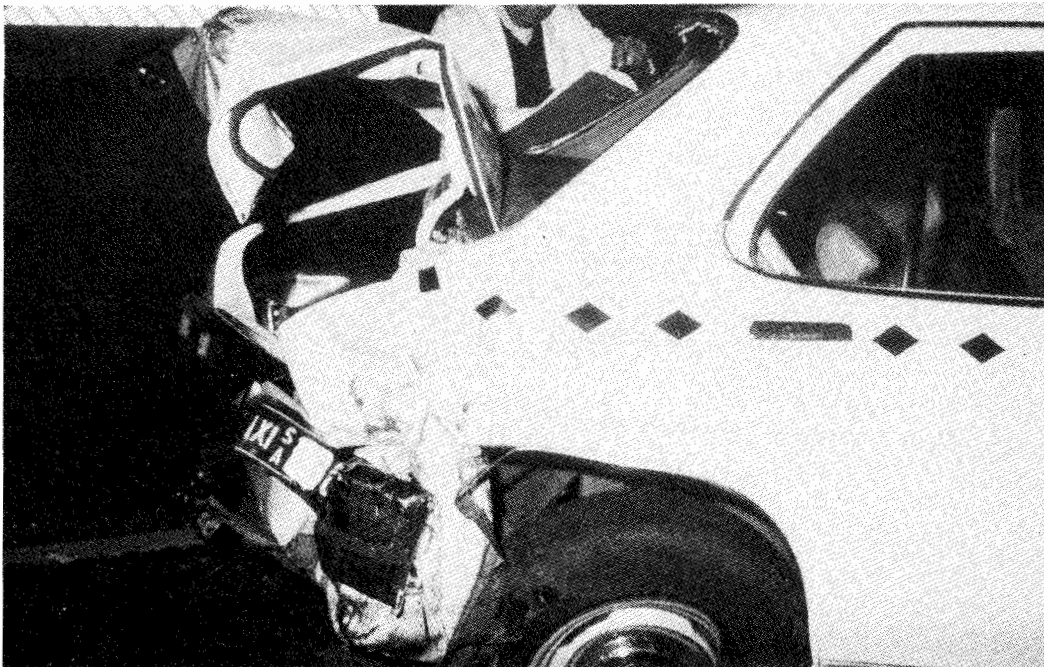
FIGURE 3.6: Damage to parked taxi (see Figure 3.5).

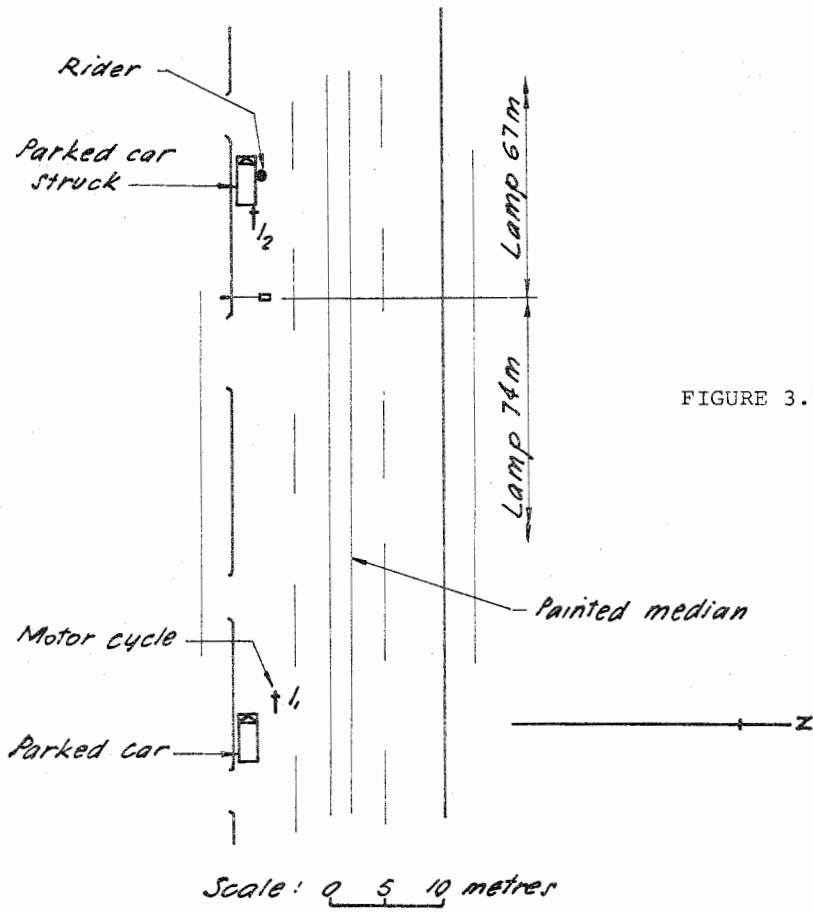
FIGURE 3.7: Accident 131.

The motorcyclist who had a learner's permit (for only two days) crashed into the back of a parked car (Accident 131). He was riding in the left of two lanes along a road which was unevenly illuminated by sodium vapour lamps (Figure 3.7) and recalled thinking that he could not see very well (partly because he was looking through a tinted visor). Hearing a rattle

The car struck by the motorcycle in Accident 022 was dark red and was parked in a relatively dark area. In Accident 131, however, the car was directly illuminated by a sodium vapour light (Figure 3.7). This car had dark green paintwork and a white vinyl top. The rider did not see it from a distance (before he looked down at his motorcycle to locate the source of a rattle). As noted earlier, he was viewing the roadway through a dark tinted visor.

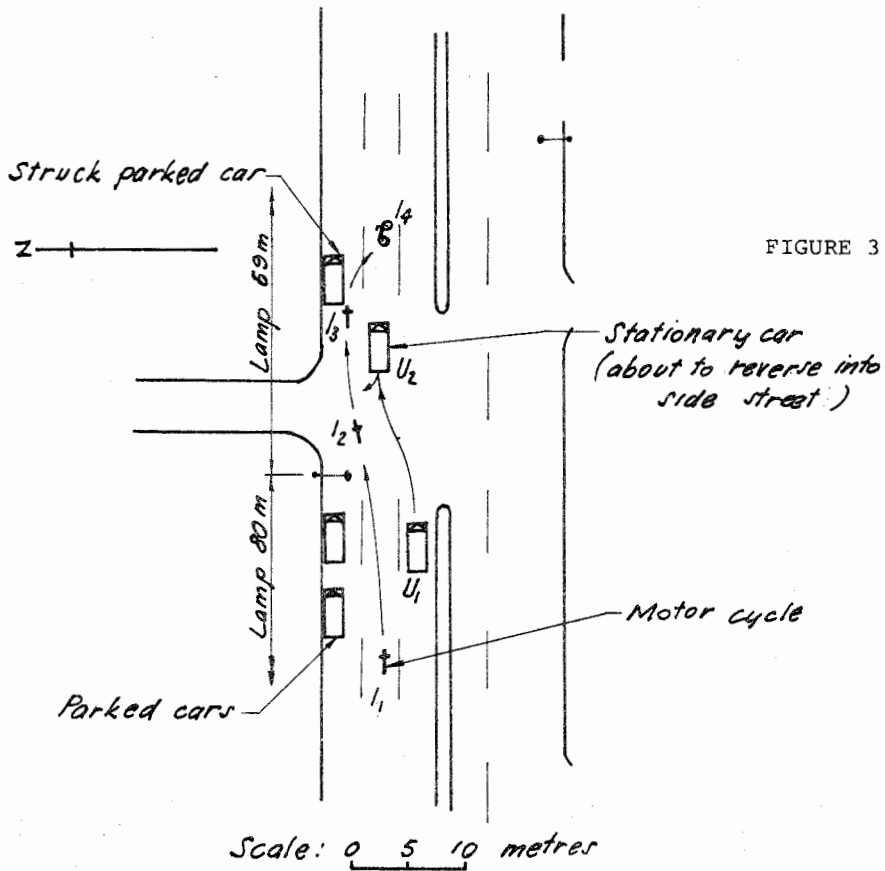
FIGURE 3.9: Accident 035

Accident 035, shown in Figure 3.9, involved a motorcyclist who was forced to swerve to his left when, he claimed, a car ahead indicated a right hand turn and then suddenly swerved to the left possibly intending to enter a side street. An independent witness confirmed that this car was present but was uncertain of its movements immediately before the accident. The driver of the car left the scene of the accident without identifying himself. The rider tried to stop by braking with the back brake only. The wheel locked and the machine started to slide sideways so he released the brake and passed the car on its left, only to find that his way was blocked by a parked car, which he hit. The motorcycle skidded 16 metres when braking and would have slowed down by about 40 km/h by doing so. The collision with the parked car seems to have been at a speed considerably greater than 15 km/h and so it is probable that the initial speed of the motorcycle was greater than the speed limit of 60 km/h.

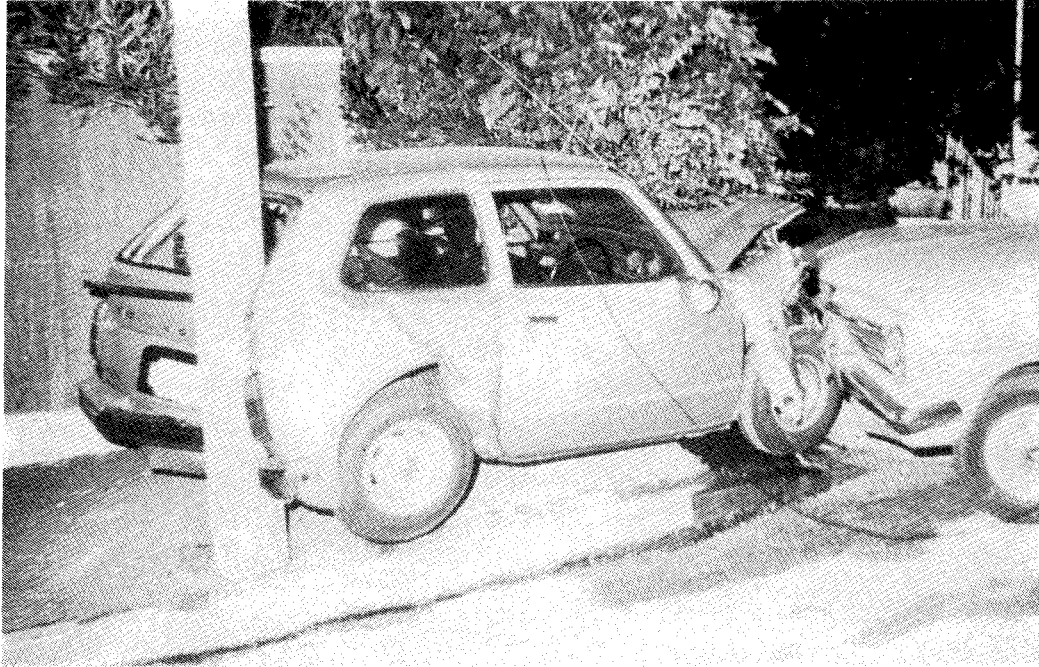
FIGURE 3.11: Parked car crushed between car out of control and a timber utility pole : Accident 007.

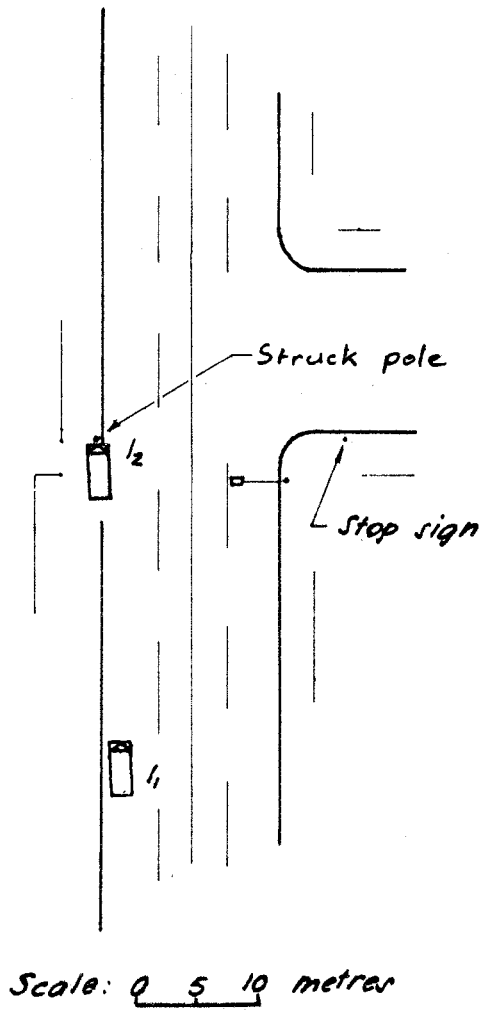
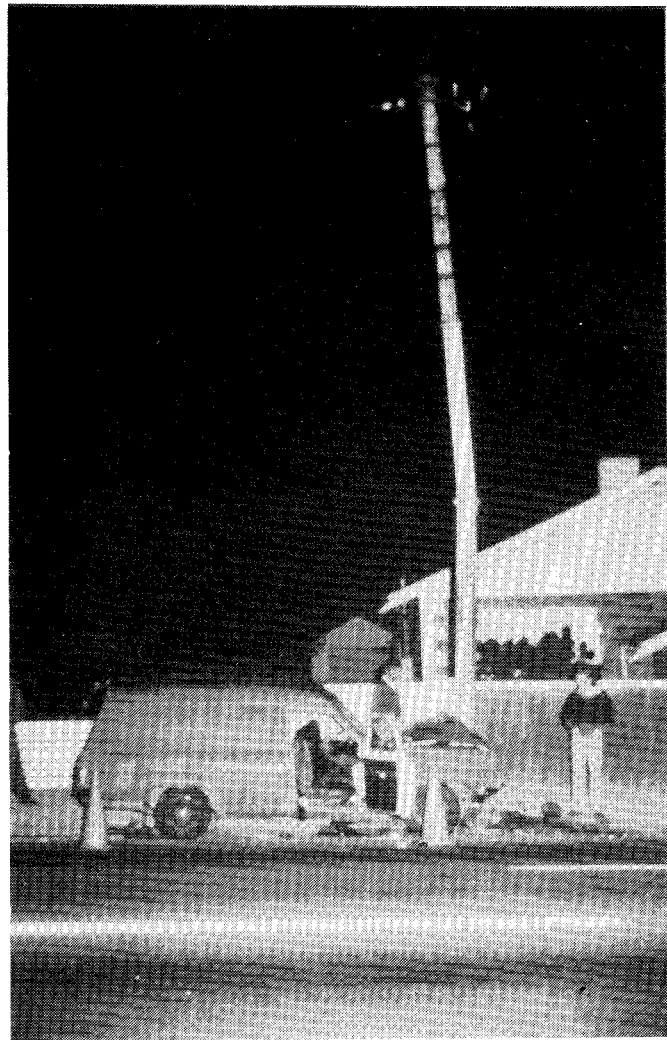
FIGURE 3.13: Accident 051.

We believe that two of the intoxicated drivers may have fallen asleep. In Accident 051, a witness who was travelling in the other direction said that he saw an oncoming car pull over to the side of the road and then its lights went out. He assumed that it had parked but when he got closer he saw that it had crashed into a pole (Figures 3.12 to 3.15). The pole itself was not badly damaged (Figure 3.14) but this was not true for the car (Figure 3.15). The occupants, neither of whom were restrained, would not have survived had emergency care not been available within minutes of the crash. The driver had a broken neck and chest injuries which made breathing very difficult. The passenger also had severe chest injuries and facial and brain injuries.

FIGURE 3.14: Damage to utility pole : Accident 051.

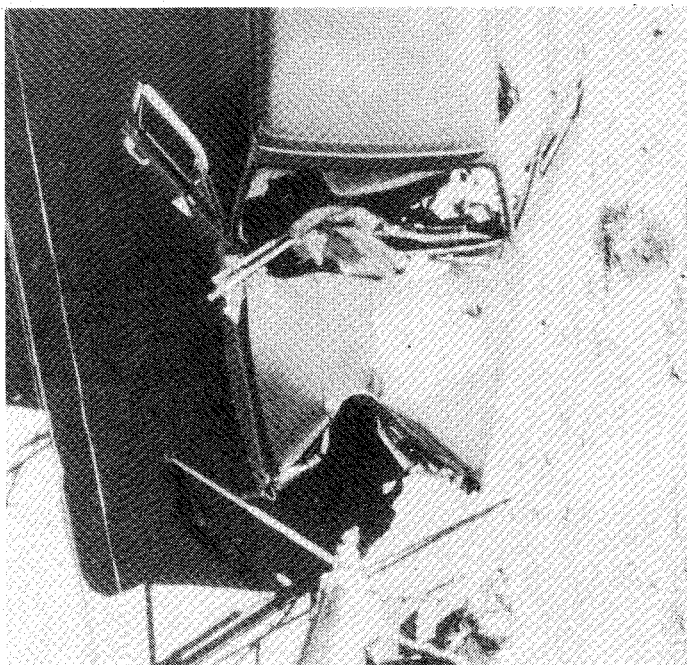
FIGURE 3.15: Damage to car in Accident 051.

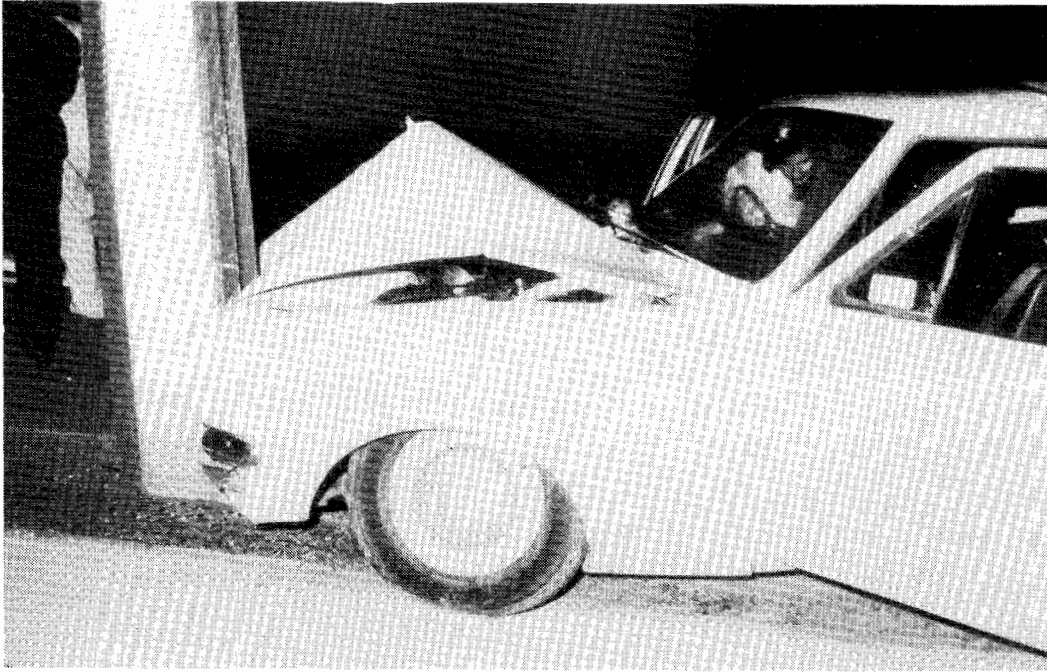
FIGURE 3.16: Damage to car after collision with utility pole :  
Accident 096.

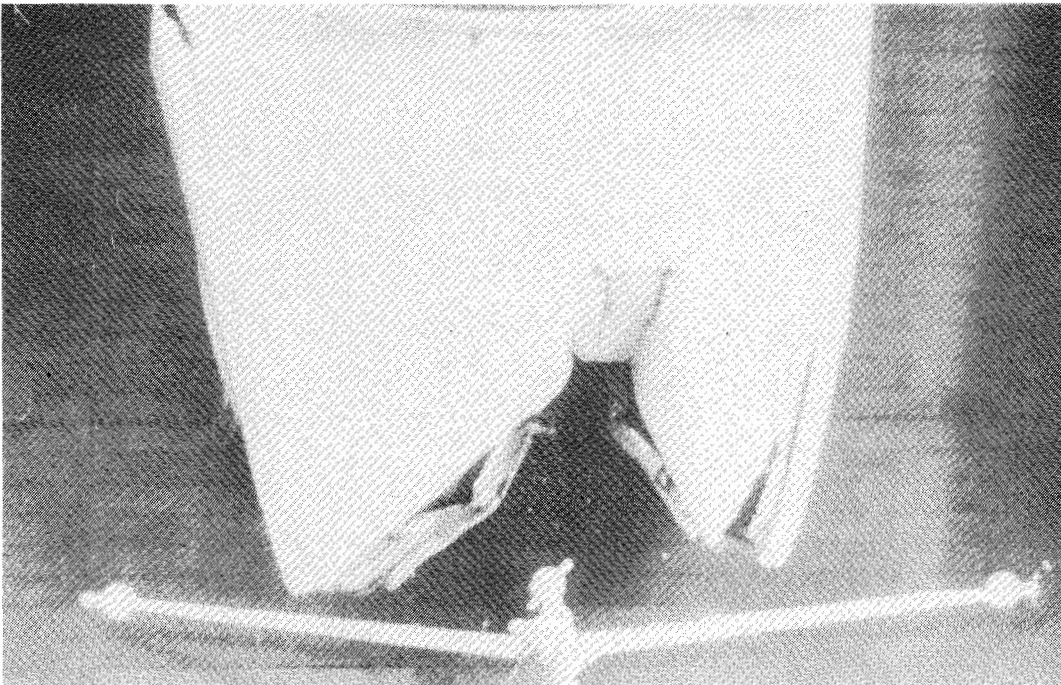
FIGURE 3.17: See Figure 3.16.

The damage to the car was severe (Figure 3.17) but, unlike the car in Accident 051, the windscreen was not

broken. This was a trivial consequence of the fact that the occupants were wearing seat belts. The driver sustained fractures of the left wrist and right collar bone in addition to his head injury. He was able to stand alongside the car, unaided, moments after the impact.

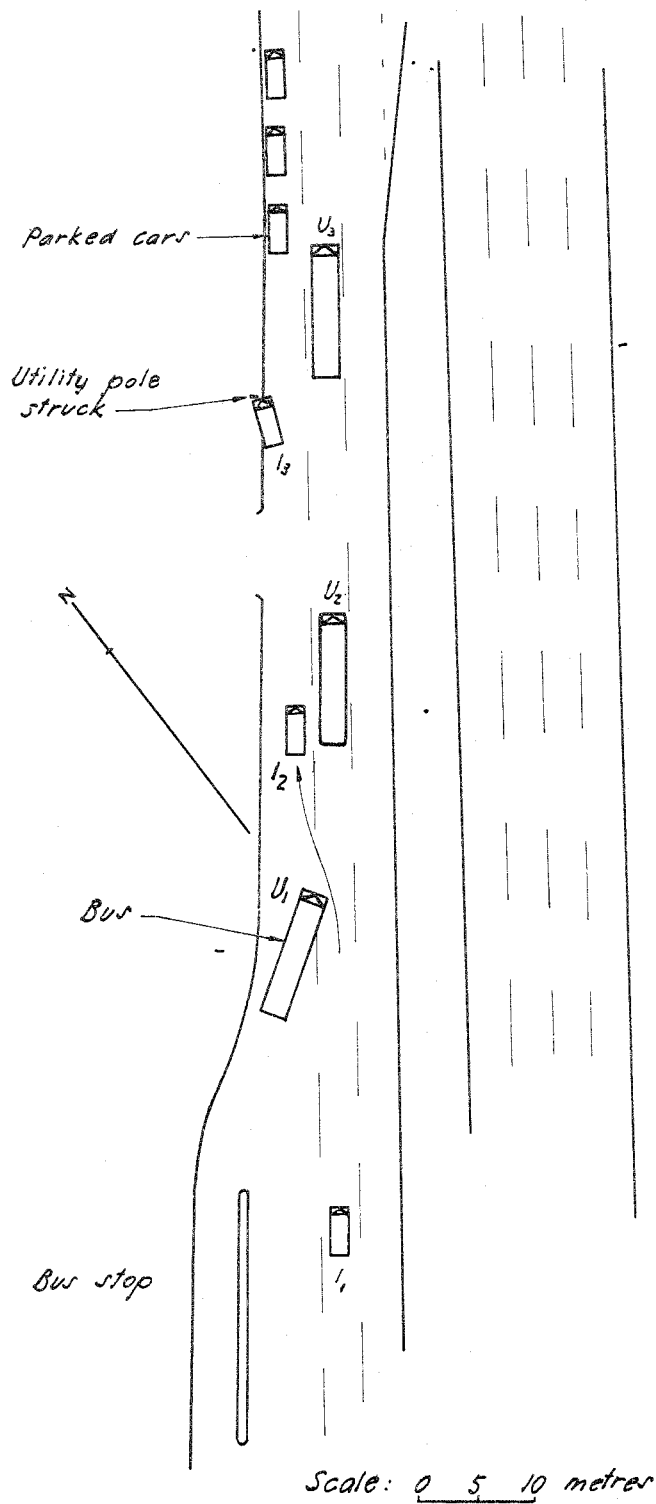
FIGURE 3.20: Accident 100.

One of the three accidents in this category was very similar to the accidents in which a car veered off a straight road. An intoxicated driver (BAC 0.25) was talking with his passenger and failed to notice that he had entered a right hand curve. His car went straight ahead and collided with a reinforced concrete lamp standard. This accident (094) resulted in about the same severity of damage to the car as occurred in Accidents 096 and 051 which were reviewed at the start of this Section on collisions with poles. The driver and passenger were both wearing seat belts. The driver had his belt loosely adjusted and he sustained facial lacerations and contusions from hitting the steering wheel. The load taken by the seat belt was sufficient to fracture his collarbone, as happened with the driver in Accident 096, but this is a very much less severe injury

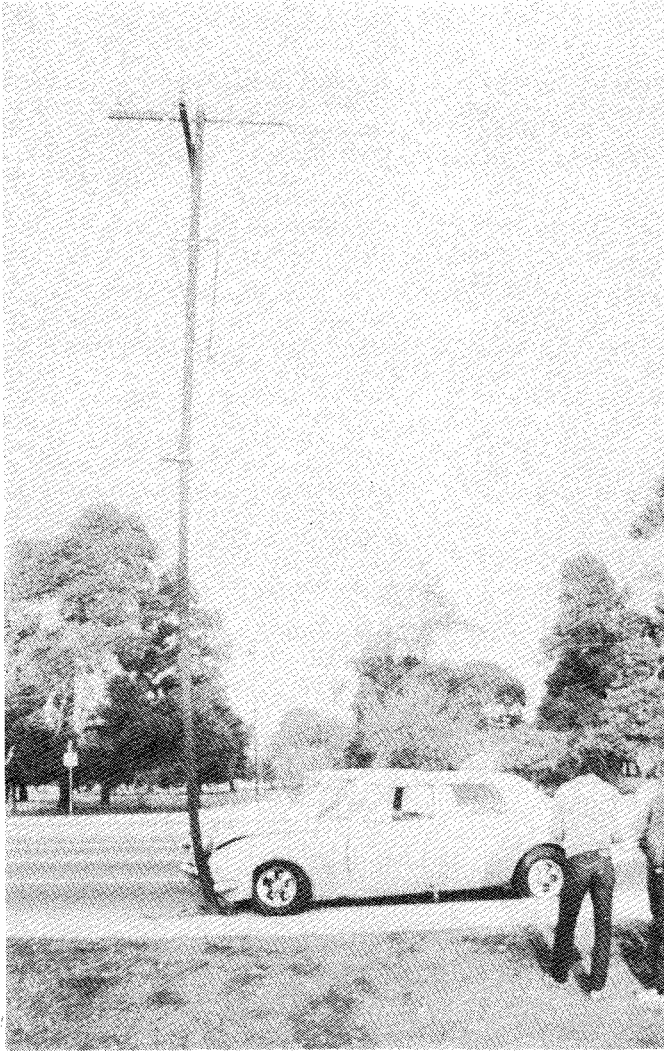
FIGURE 3.21: Damage to pole, Accident 100. (see Figure 3.20)

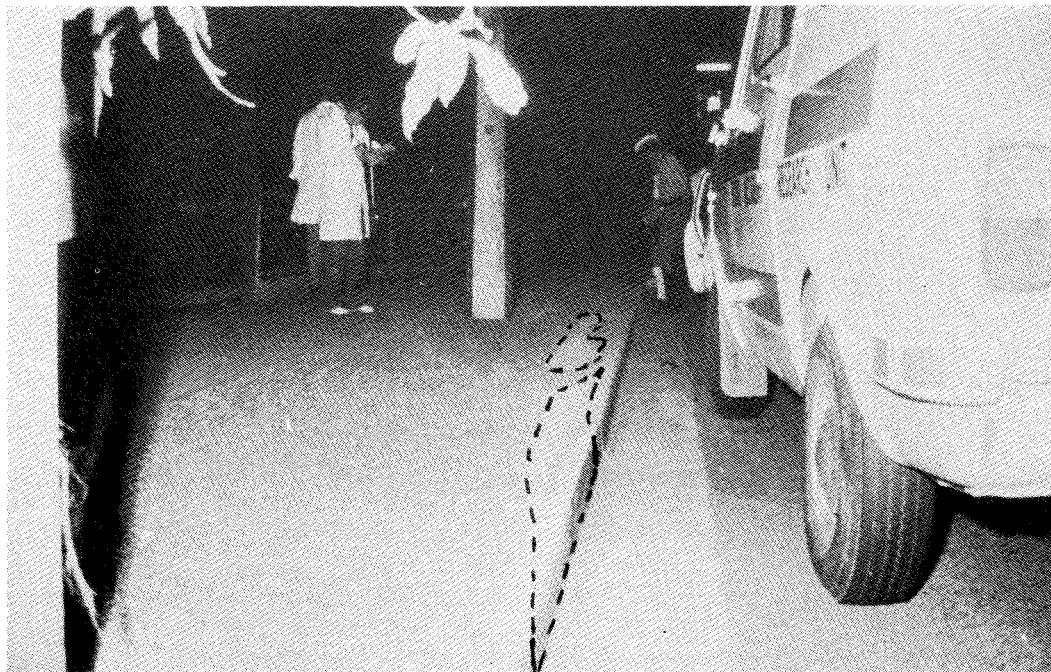
FIGURE 3.22: Tyre marks on kerb and footpath on the approach to pole struck by motorcycle rider and pillion passenger : Accident 289.

The third accident of this type involved a motorcycle which ran up onto the footpath some distance after exiting from a right-hand right angle bend (Accident 289, Figures 3.22 and 3.24). The 16 year old rider and his pillion passenger both hit their heads on a Stobie pole which was narrowly missed by the motorcycle. Despite the fact that they were both wearing crash helmets they were both killed. The rider had a blood alcohol level of 0.14, and had been licensed for six months.

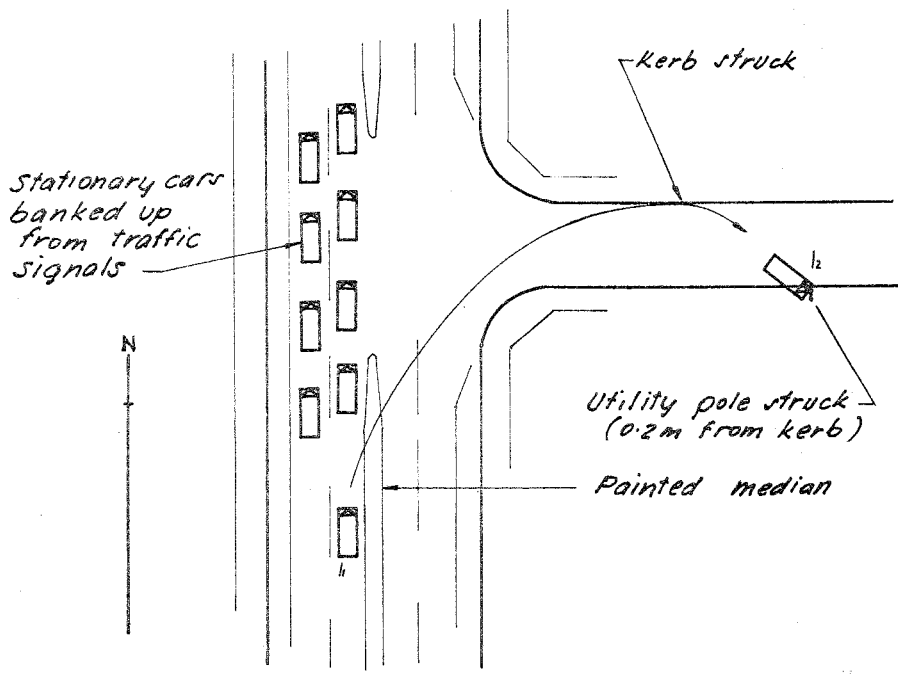
FIGURE 3.23:  
Accident 108.

A driver following a friend home from a football match turned into a side street by cutting across a painted median because the traffic ahead of him was banked up from a set of traffic signals (Accident 108, Figure 3.23). This driver was not familiar with the area and found that he was travelling too fast to negotiate the turn. His car hit the kerb on the outside of the turn and failed to straighten up, instead continuing on the same curve path back across the side street and crashing into a pole.

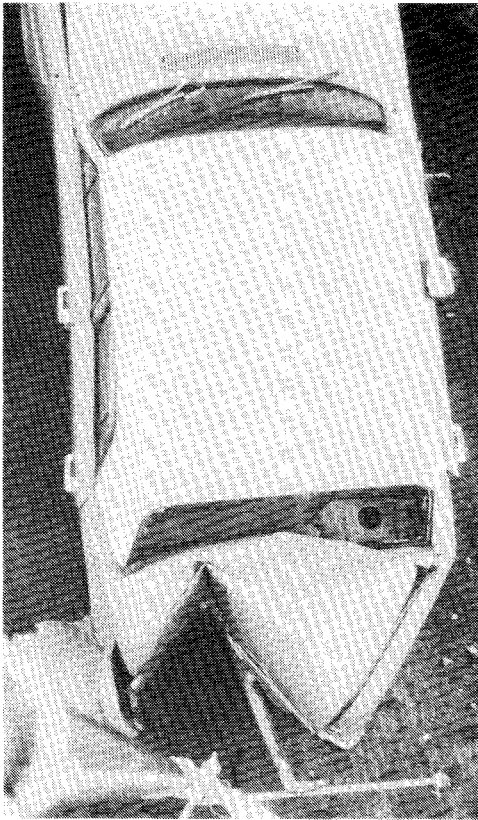
FIGURE 3.25: Damage from collision with pole. (see Figure 3.26)

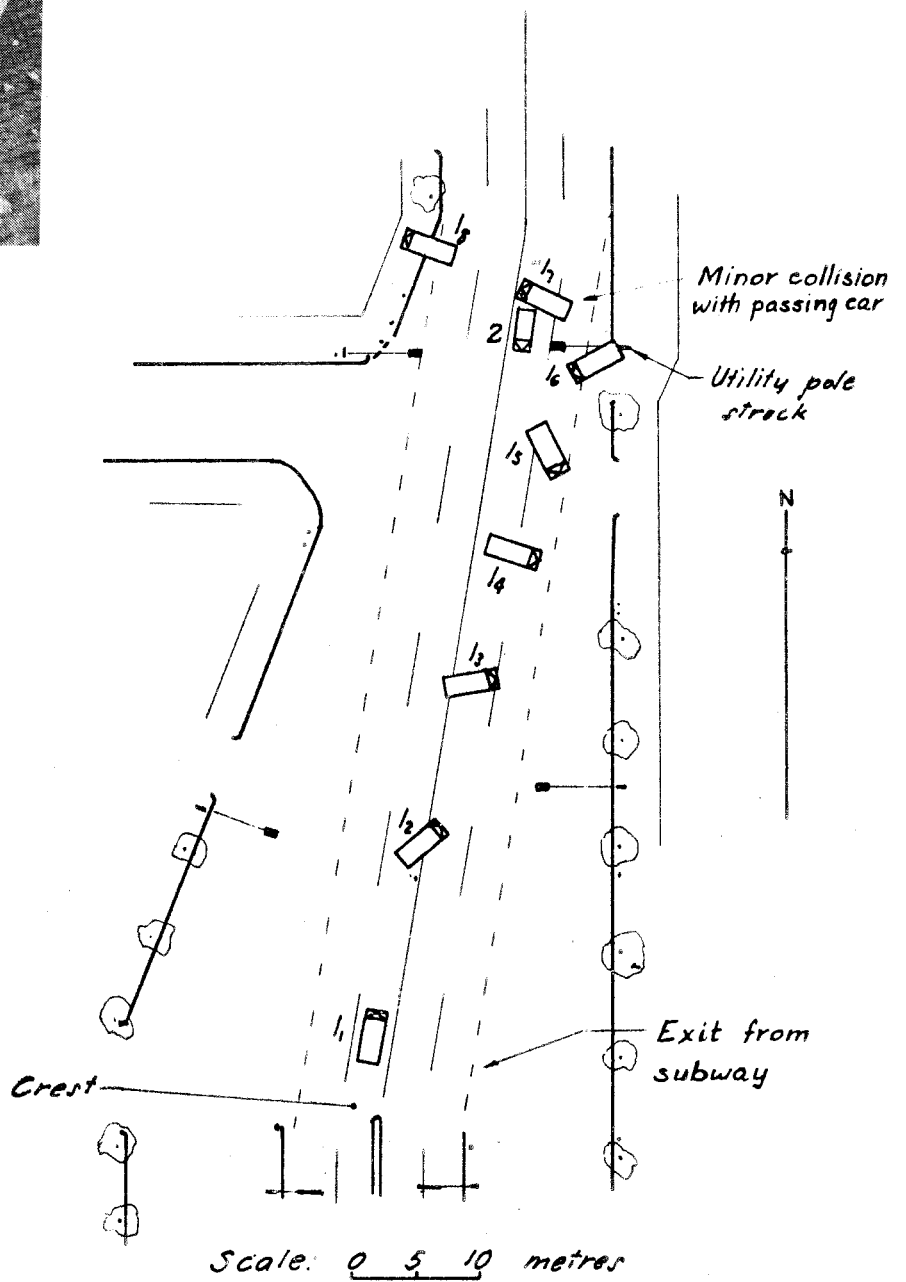
FIGURE 3.26:  
Accident 062.

This accident (062) was very similar to Accident 132 which resulted in a collision with parked vehicles. A 16 year old driver who had been licensed for two months lost control of his car when it started to slide in a gradual s-bend. It was raining at the time. The car crashed backwards into a pole on the far side of the road and then continued on back across the road. It was involved in a minor collision with another moving car before coming to rest on the footpath up against a fence (Figures 3.25 and 3.26). The condition of the tyres fitted to this car increased the risk of it skidding on a wet road, as was the case in Accident 132.

If the pole had been set back from the kerb line it is possible that some of the eight or nine drivers noted above may have been alerted by the impact with the kerb in time to have regained control of their car. A further seven or eight of the 19 collisions may also have been avoided had the pole been set back. However at some locations it may be impractical to move the pole towards the property boundary because of the presence of underground services or for other reasons. An alternative way of achieving the desired separation between the kerb and the pole would be to move the kerb line (thereby reducing the width of the carriageway). This could be done in conjunction with the provision of parking bays on many streets and roads. On arterial roads it may mean that the traffic flow capacity of the road is reduced and this in itself would be a direct cost to the community but, as noted above and by Fox, Good and Joubert, the existing situation is not without its costs.

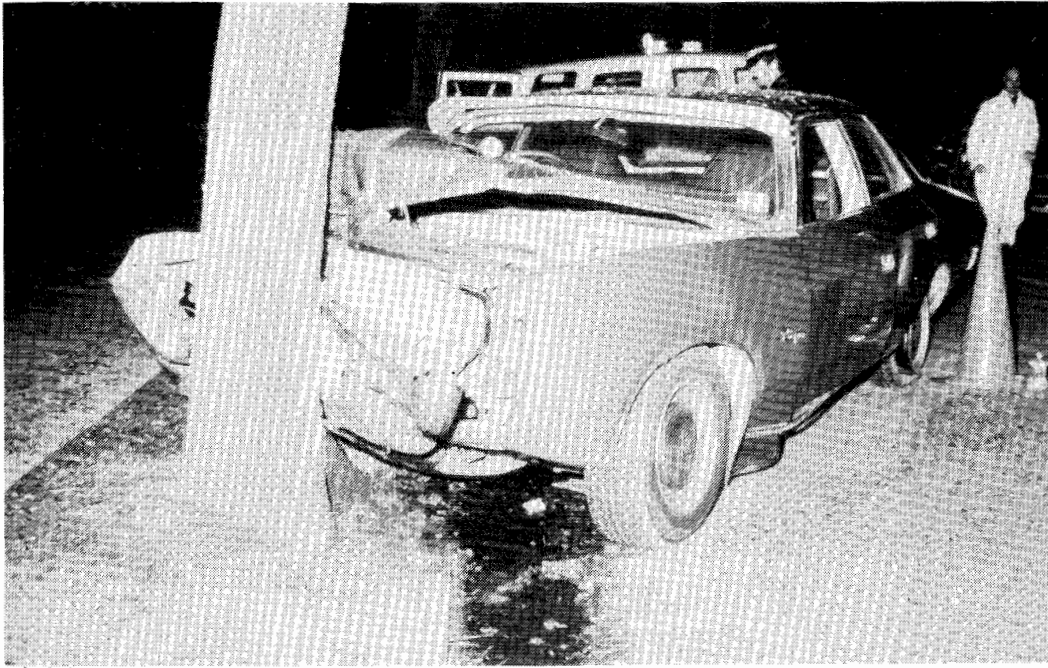
FIGURE 3.31: Damage resulting from collision with tree :  
Accident 057 (See also Figures 3.30 and 3.32).

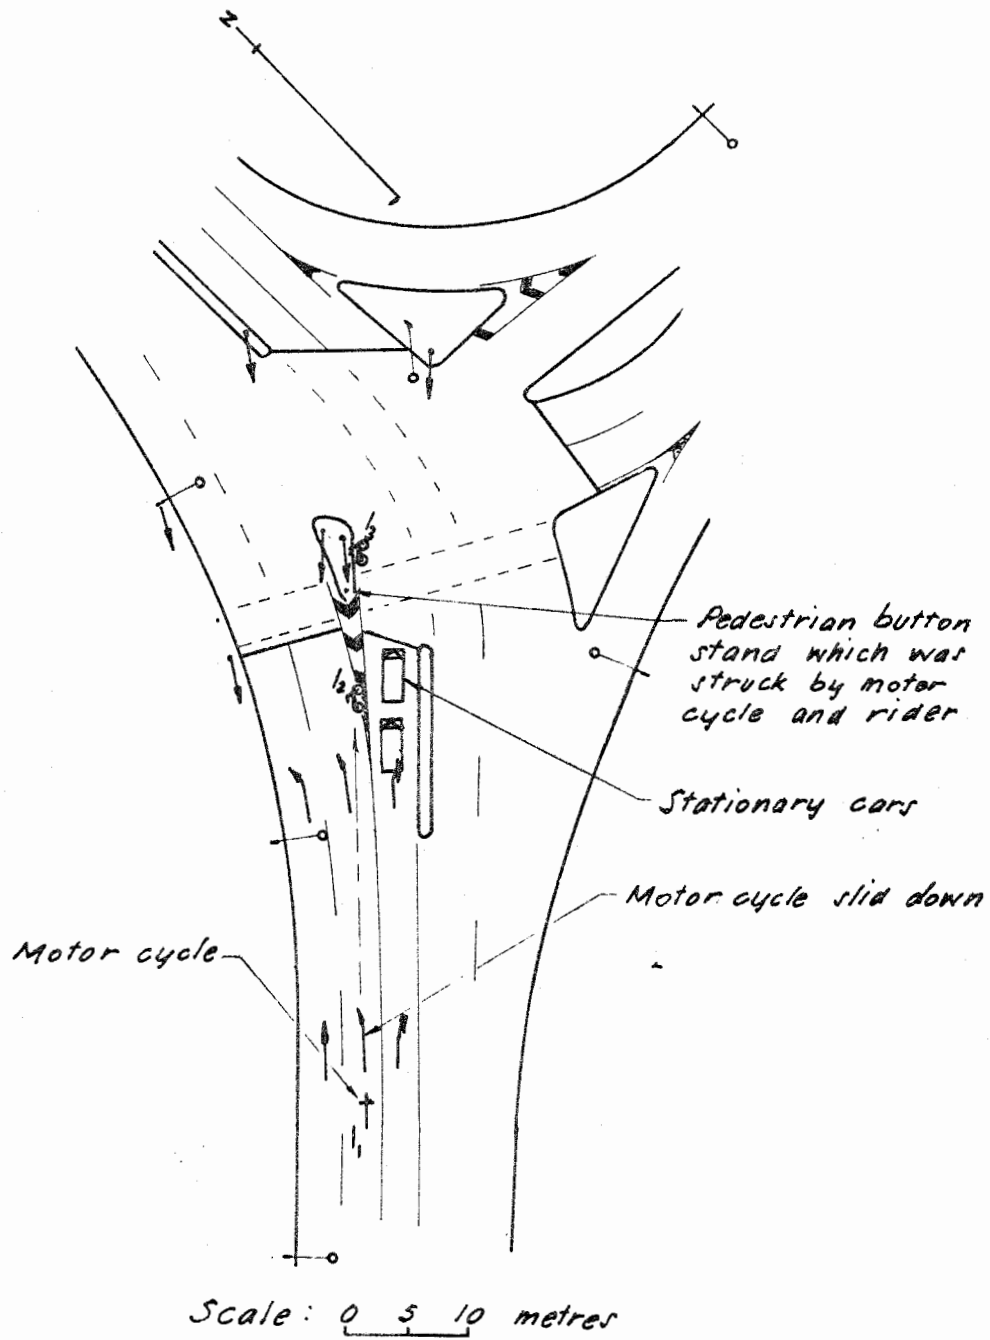
FIGURE 3.39: Accident 010.

In an accident which appears to have been similar in many respects to Accident 085 (reviewed in the Section dealing with collisions with kerbs) a motorcyclist fell from his machine on the approach to a signalised Y-junction (Accident 010, Figure 3.39). The motorcycle began to

slide down when on a painted arrow. It continued on, sliding on its side together with the rider, until they hit a pole carrying an actuating button for the pedestrian crossing at the intersection. The rider was seriously injured in this impact, sustaining concussion and multiple fractures. Because of his head injury he was not able to remember the events leading up to the accident, beyond knowing that he was returning from a trip to a take-away food shop. He said that he would have been intending to follow the road around to the left and not turning right. He was intoxicated (BAC 0.15) and this may have caused him to brake unduly sharply. The surface of painted road markings is known to be slippery, compared to the pavement surface, even when dry, as it was at the time of this accident, but we cannot say that this was the cause of the rider losing control or even a contributing factor. It is possible that the motorcycle may have hit, or been hit by, another vehicle although there was no clear evidence of such an event on the damaged machine. A driver of one of the cars which was stationary in the right turn lane heard a bang immediately before the motorcycle and rider slid past and hit the pole but this could have been the sound of the motorcycle hitting the road.

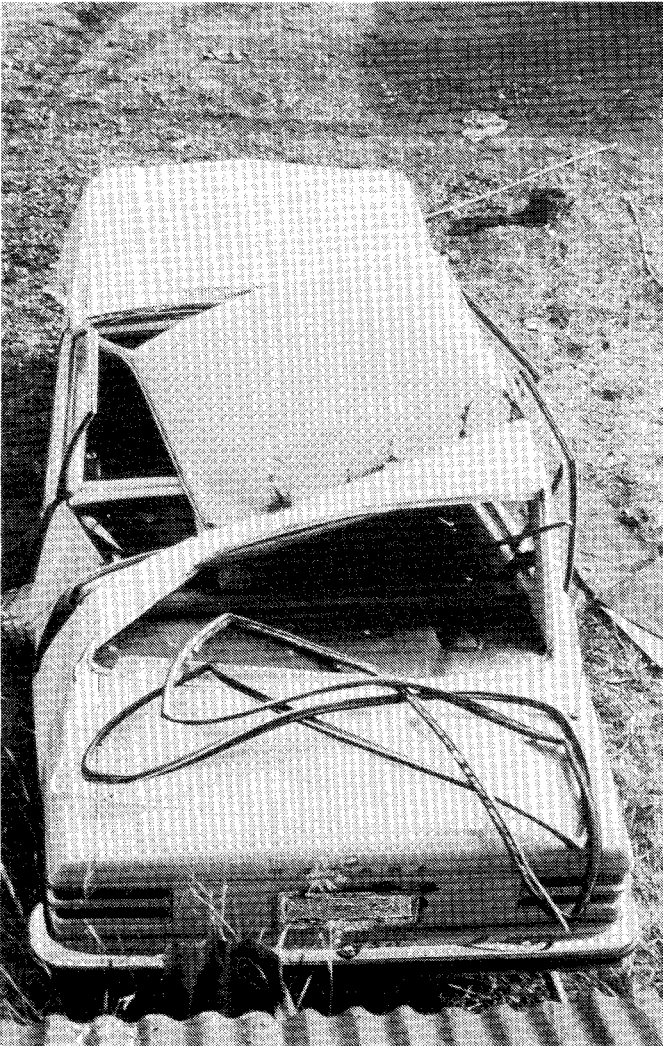
FIGURE 5.9: Damage to car (shown in Figure 5.8) due to secondary collision with a utility pole.

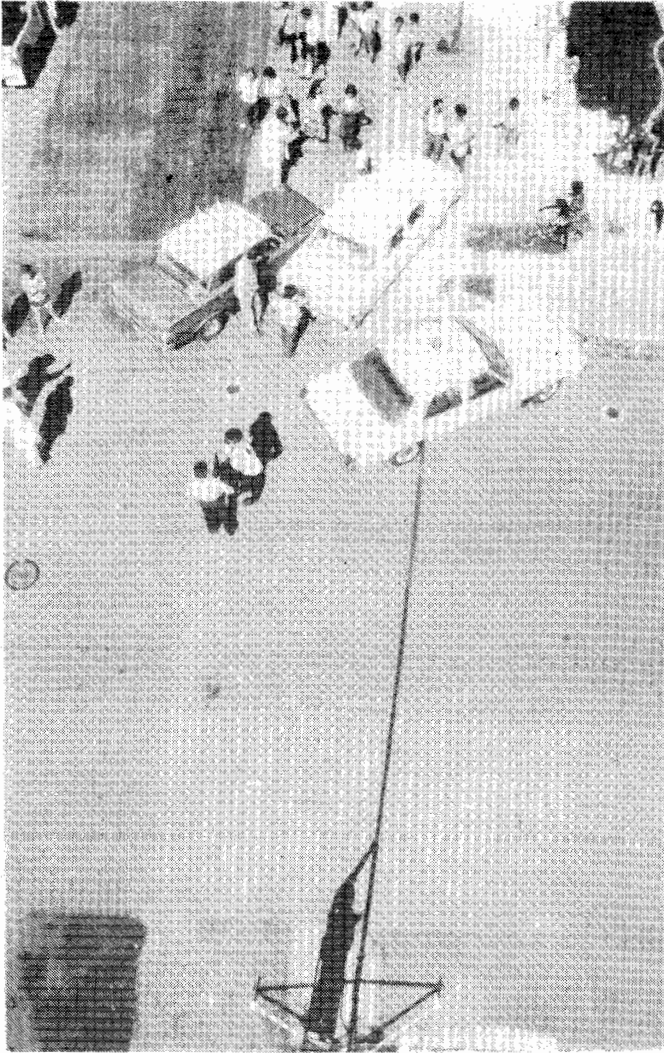
FIGURE 5.10: Final positions of cars following collision at an uncontrolled intersection. Marks painted on road are from a previous collision. Accident 266.

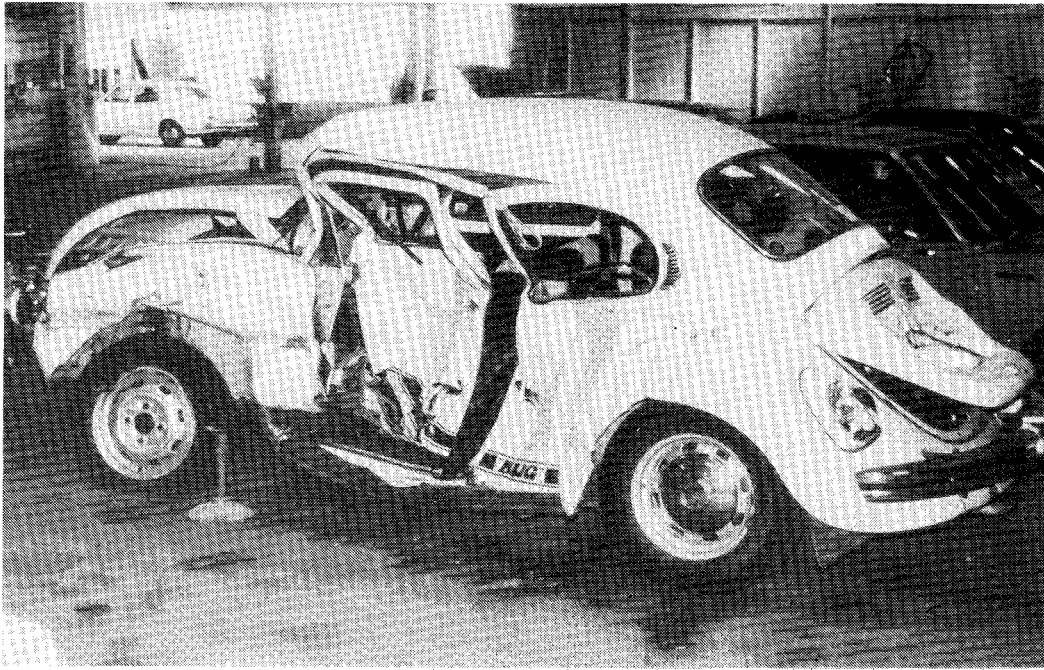
FIGURE 5.12: Damage to car involved in a two car collision at an uncontrolled intersection: Accident 286 (see Figure 5.13).

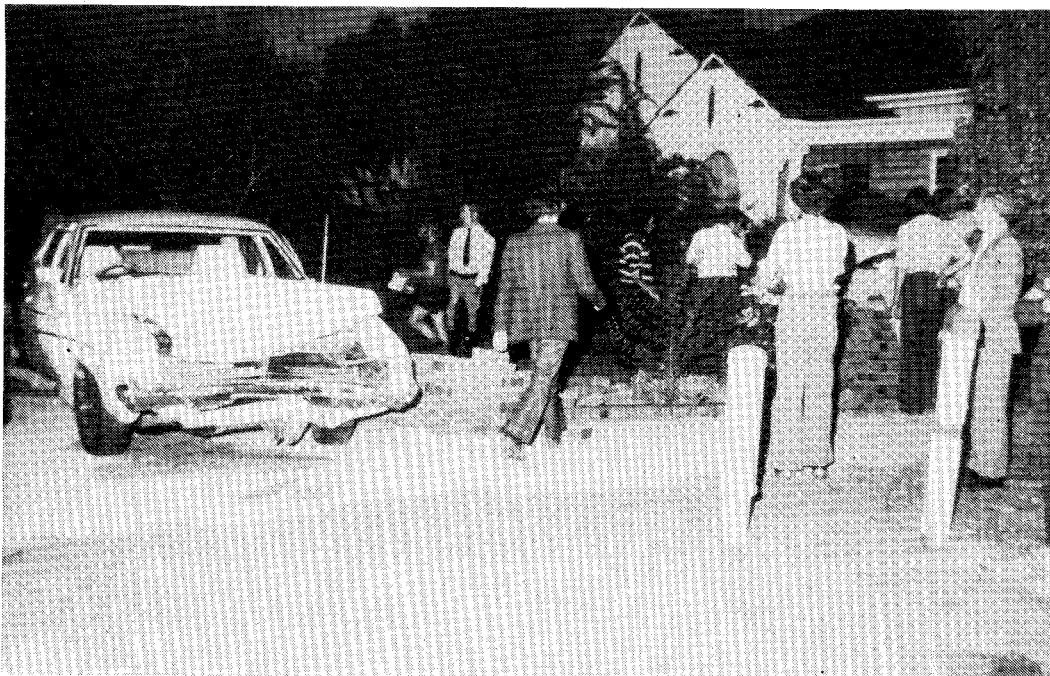
FIGURE 5.13: Striking car in Accident 286. The roof of the struck car is just visible on the right (see Figure 5.12).

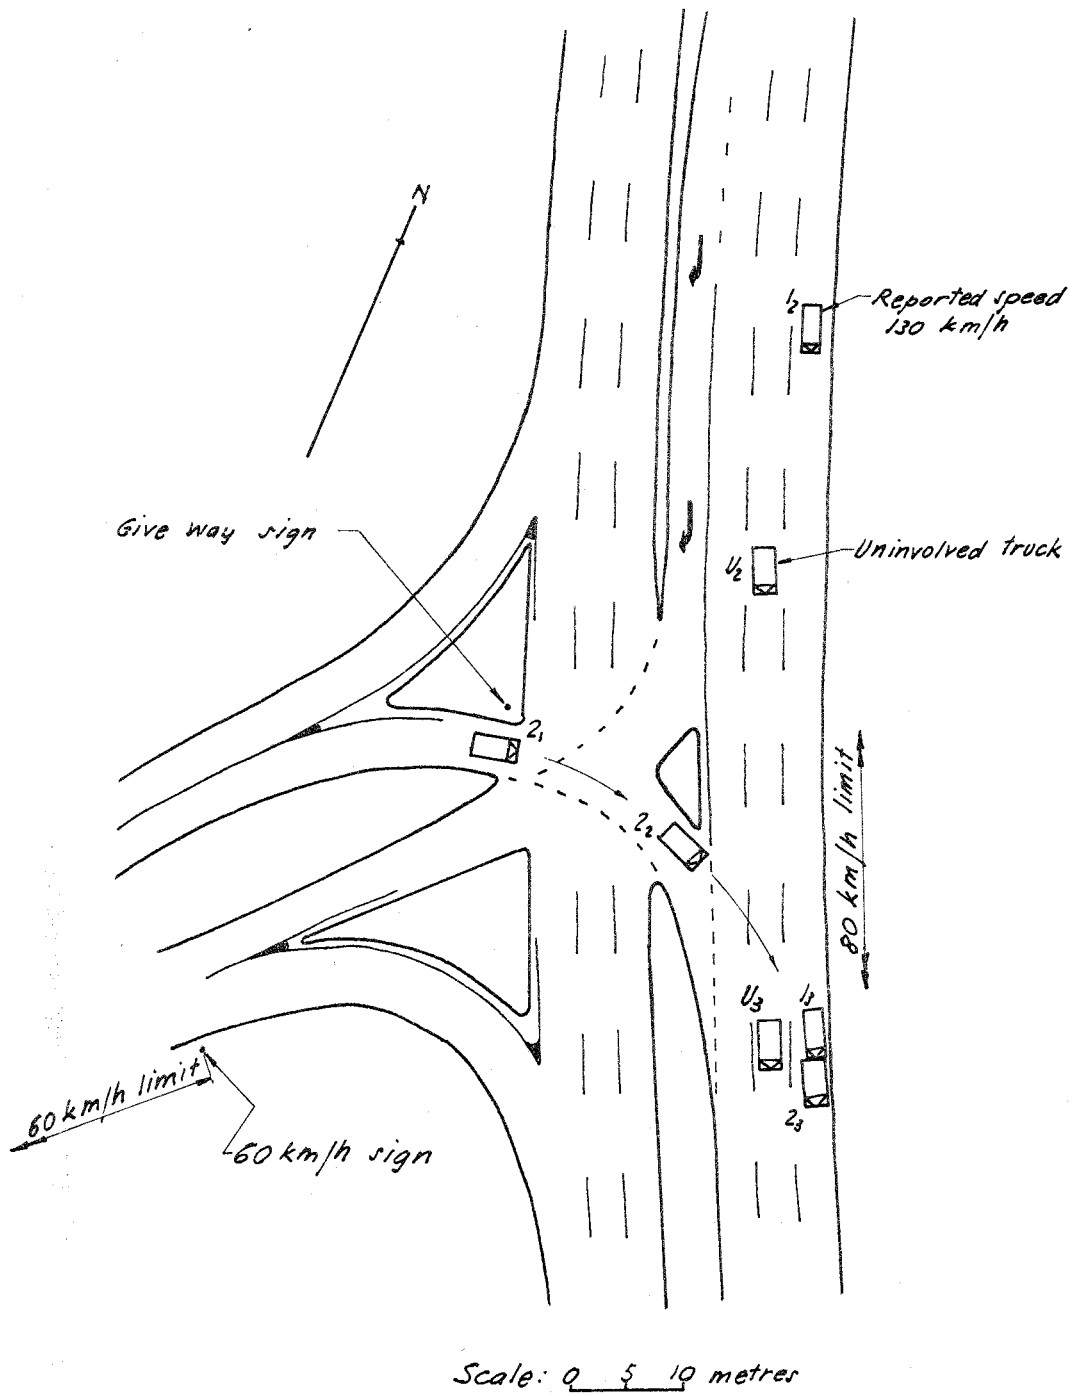
FIGURE 6.7: Accident 025.

The other accident was considerably more complex, with both parties making significant errors (Accident 025, Figure 6.7). A heavily laden van turned right from a GIVE WAY sign onto a six lane divided road. The driver of the van saw a truck approaching on his left and in the centre lane. He decided that he could cross ahead of this truck, and so he did so, moving across into the left lane because he intended to turn left into a private entrance a little further down the road. However a car was travelling in this left lane and rapidly overtaking the truck. When the car driver saw the van pull into the left lane he was unable to slow down in time to avoid a rear end collision. He told us that he had been travelling at about 130 km/h (the speed limit on the road is 80 km/h). The driver of the van, who did not see the car before the impact, said later that he should have waited at the median crossover and allowed the truck to pass before continuing on across the road.
