# **ADELAIDE IN-DEPTH ACCIDENT STUDY**

1975-1979

## **PART 7: ROAD AND TRAFFIC FACTORS**

**A.J. McLean  
W.J. Offler  
B.L. Sandow**

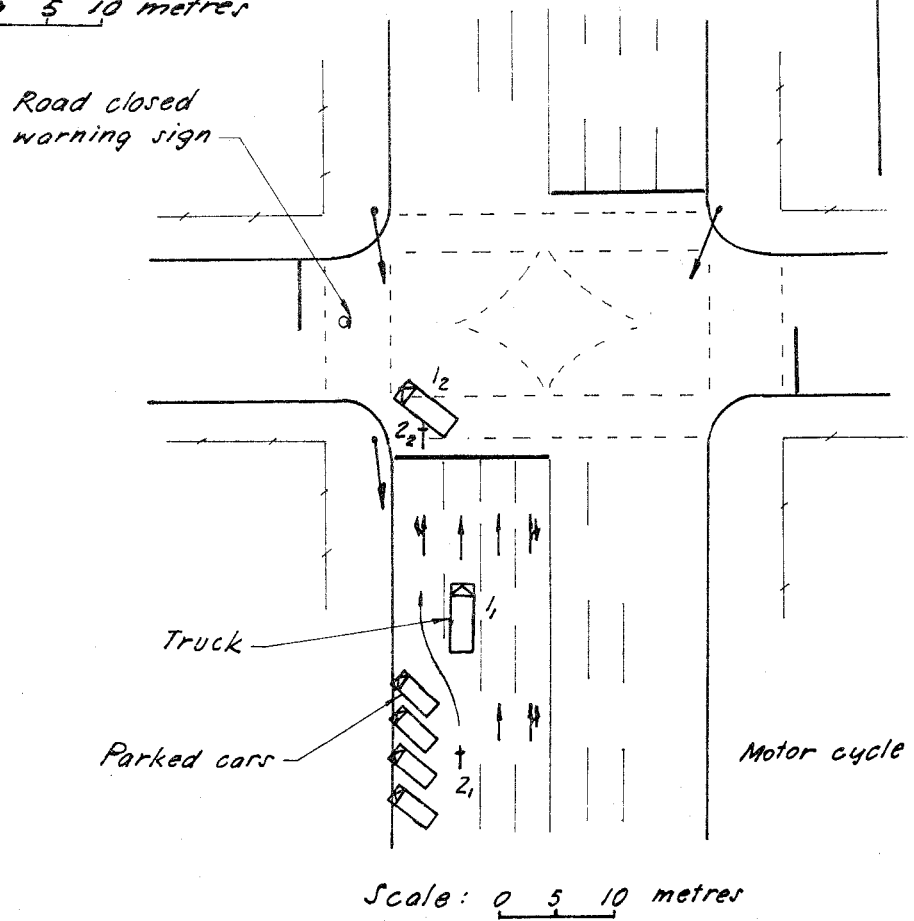
FIGURE 7.3:  
Accident 014.

In Accident 014 a truck turned left from the second lane from the kerb at a signalised intersection and collided with a motorcycle which was attempting to pass it

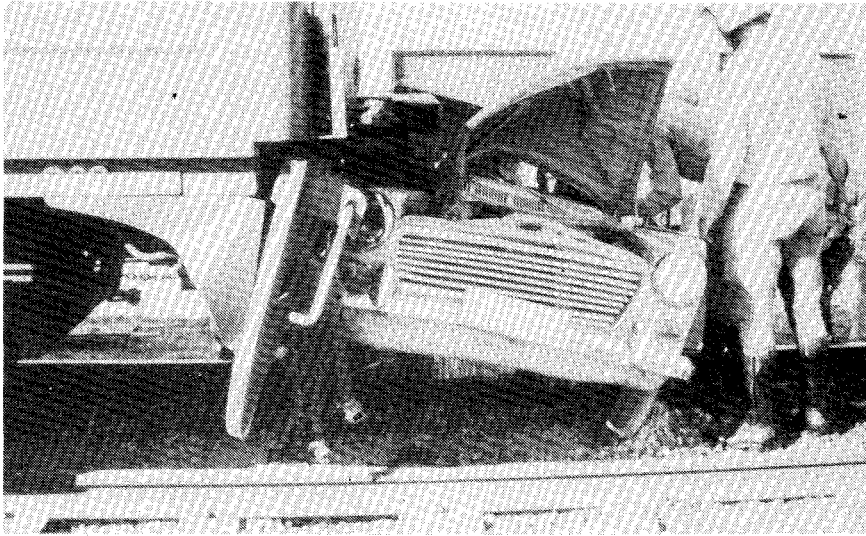
The young male driver of a small car was killed, and his passenger injured, in a collision with a diesel-powered commuter train (Accident 264). He had stopped at a level crossing where both a STOP sign and flashing lights and bells were installed. The lights were operating, and continued to operate after the train had passed through because a second commuter train was approaching from the other direction. Although the bells were still ringing the driver drove into the path of this second train, which was approaching from his right, on the track nearest to him. The car was struck broadside-on and pushed

FIGURE 7.7: Final positions of car and train, Accident 264.

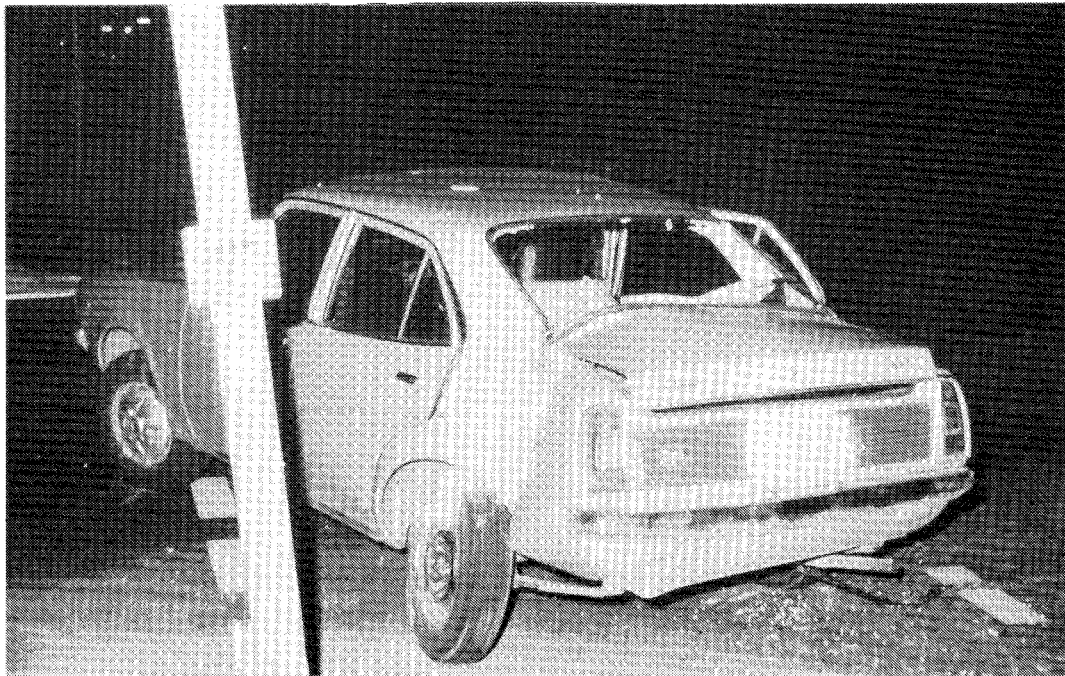
FIGURE 7.11: Damage to car from secondary collision with signal pole (Accident 173).
