**PRELIMINARY STUDY OF FATIGUE BEHAVIOUR
OF TIMBER MOMENT RESISTING JOINT**

Thesis presented for the degree of
Master of Engineering Science
at the University of Adelaide
Australia

-August 1995-

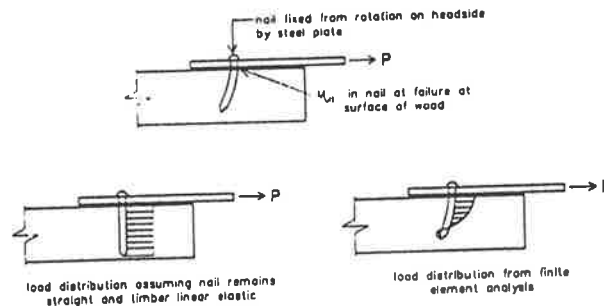
where the point of contraflexure in the nail was on the headside (21) as shown in Figure 2.3.

Figure 2.3 Headside of nail fixed from rotation

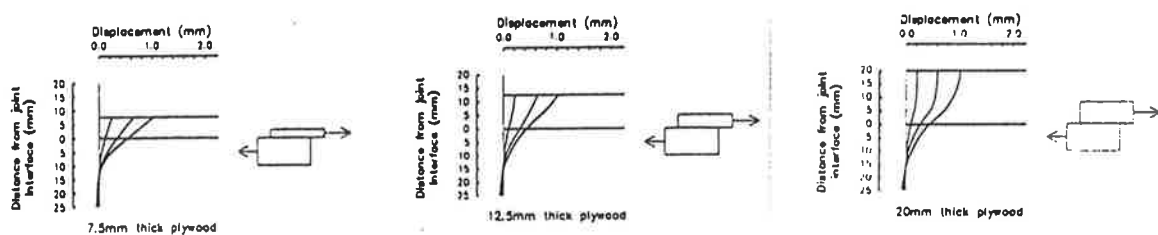
Effects of the thickness of both plates are significant. Polensek (46) found that 3/8in.(9.5mm) thick plywood absorbed more energy than 5/8in.(15.9mm) plywood and that the thicker plywood had a higher slip modulus when there was joint friction. In addition, residual slip was greater in the case of the 3/8in.(9.5mm) thick plywood. Hunt & Bryant (21) performed tests to investigate the nail penetration and headside thickness effects. For pointside penetration of $6d$ to $22d$ (where d is the diameter of the nail), there were small differences in loads at 0.4mm joint displacement, but the ultimate load increased with penetration of the nails. For a penetration of $4d$, there was compression of nail-to-wood bearing down one side of the whole length of the nail and there was insufficient penetration to ensure yielding of the nail at the joint interface. When studying the effect of thickness of headside plate, there were noticeable nail head rotations at small displacements when the plywood thickness was 7.5mm and that, even at large displacements, head rotation was small when the plywood thickness was 20mm or more. In this test, with plywood thickness of 19mm, minimal nail head rotation was expected. The thickness of the side plate would influence the shape of the deformed nail and thus the location of the point of contraflexure. Stiffness at lower loads as well as ultimate strength increased with the plywood thickness up to a certain limit (in the experiment the limit was 18mm) as shown in Figure 2.5.

Figure 2.5 Deformed nail shapes for various headside plywood thickness

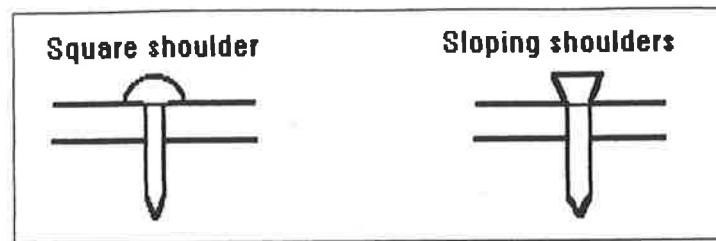
Nail head shape is also a factor to be considered, especially when thin steel side plates are used. Nails with square shoulders as shown in Figure 2.7 give stiffer and stronger joints than those with sloping shoulders because head restraint effects are present at all loads.

Figure 2.7 Two types of nail head shape

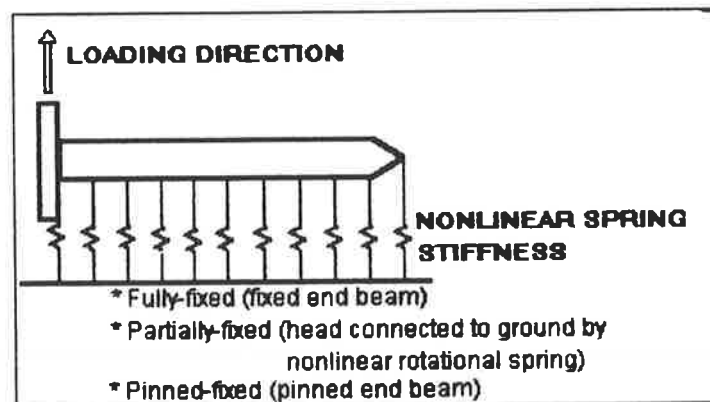
Nicholls (39) modelled the degree of nail head restraint in his investigations in which fully-fixed, partially-fixed and pinned nail head fixity conditions were considered as shown in Figure 2.8. As in the Hunt & Bryant research (21), Nicholls took the fully restrained case as nails were driven through thick metal side plates (c.f. Lheude (29) also assumed high strength nails were fully-fixed when using gun-driven nails in steel side plates). For the partially-fixed condition, a 2mm plate with no preformed holes was utilised. Finally, Nicholls simulated the pinned head fixity using a 2mm plate with oversize preformed holes. He then used a finite element model with non linear material properties to model the nail in each of the conditions:

Figure 2.8 Modelling of a nail with nonlinear material properties

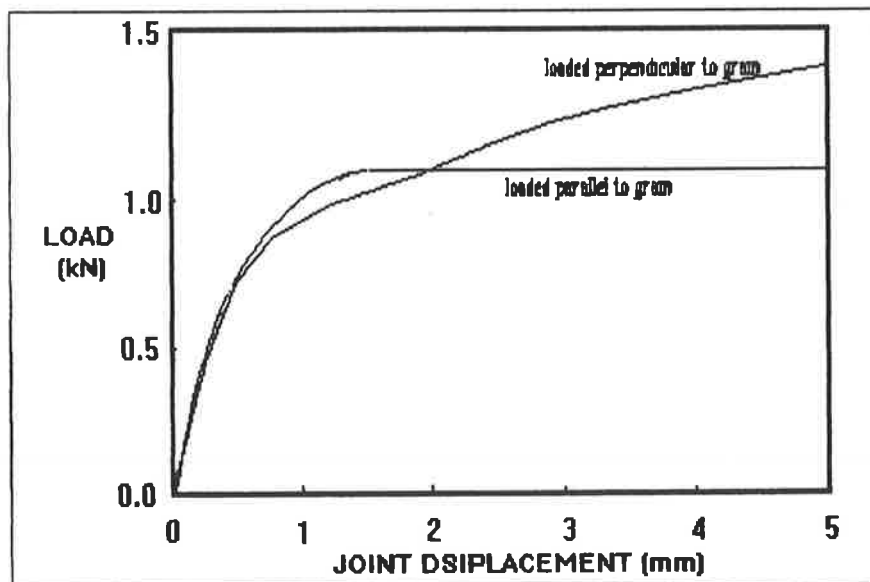
Figure 2.9 Typical load displacement behaviour for nail loaded parallel and perpendicular to wood grain

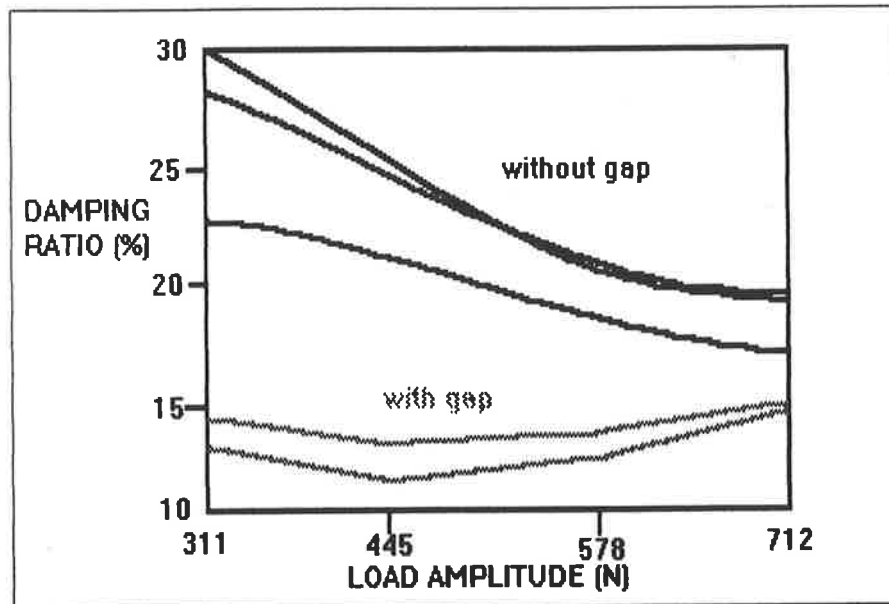
Figure 2.10 Effect of load magnitude and assembly condition on viscous damping

Figure 2.10 shows that damping decreased when the load was increased in tight (without gap) joints. This was due to partial gaps forming in the contact interlayer because the increasing shear load loosened and pulled the nails out. The reduction of joint tightness lessens interlayer friction and damping. On the other hand, joints with gaps have relatively constant damping for most of the loading range and a small increase at high loads as the gap partially disappears thereby increasing the interlayer friction. This explanation was applied to the behaviour of the various test specimens under certain loading conditions (see Chapter 5).

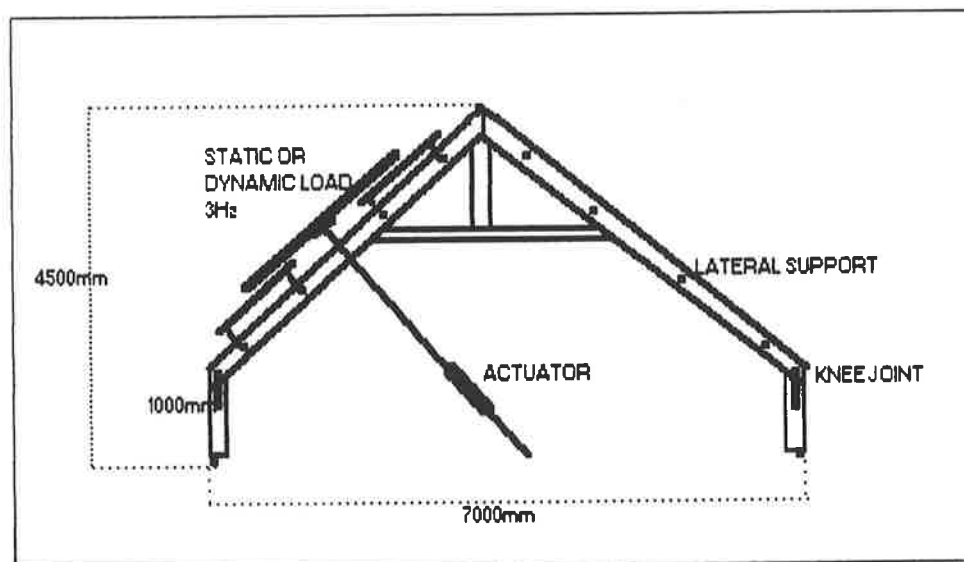
Figure 2.13 Test set-up in the full-scale testing of prefabricated timber frame

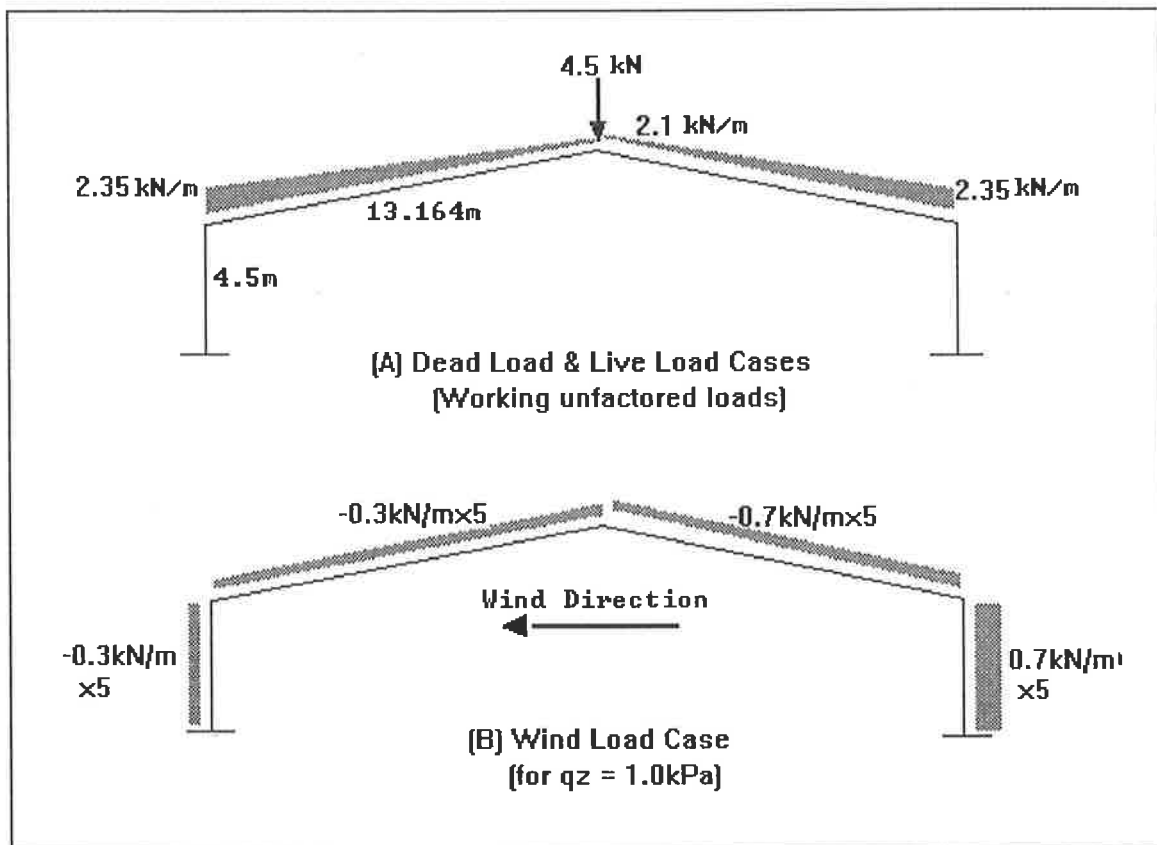
The two main loading cases are shown in Figure 3.2. These loadings represented the loads on one portal frame are working (unfactored) loads as given by AS 1170.2. The LVL rafter and column properties used for analysis were those specified in section 2.2.1. The computer program calculated the moment and shear at all the nodal points. The point of contraflexure (point of zero moment) was located from the dead loading case and was found to be 6.1m from the eaves along the rafter section. Apart from analysing the original timber portal frame, the dimensions of the frame were altered to investigate the sensitivity of the moment-shear ratio of the joint to changes in frame dimensions. The column height was shortened and lengthened by 1m and the span changed by 5m. The results are tabulated in Table 3.1.

Figure 3.2 Different load cases on the timber portal frame

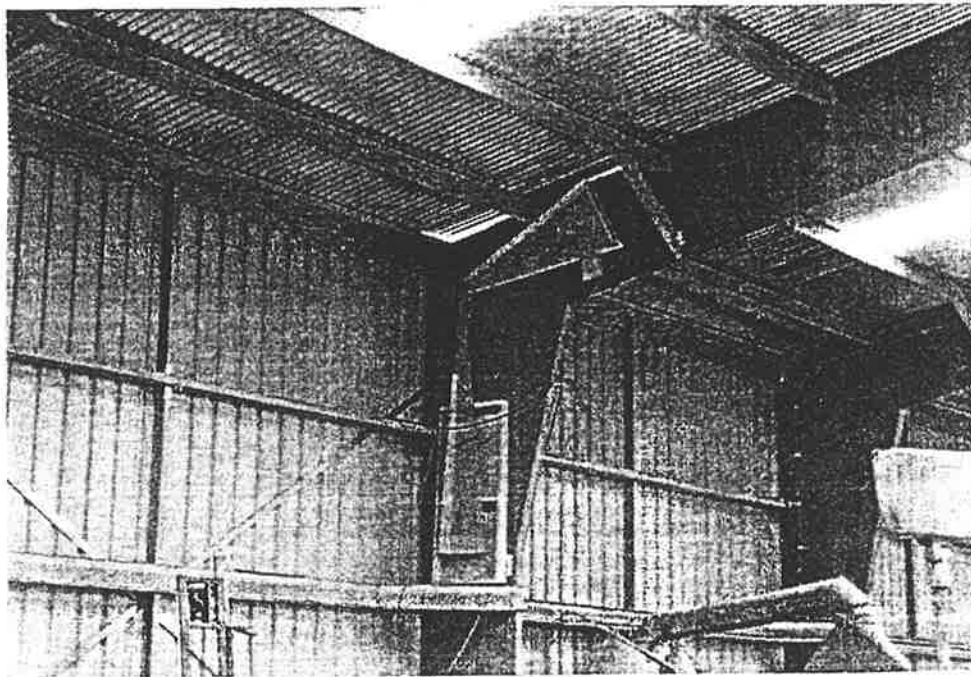
Figure 3.3 The actual joint in the timber portal frame & the test specimen

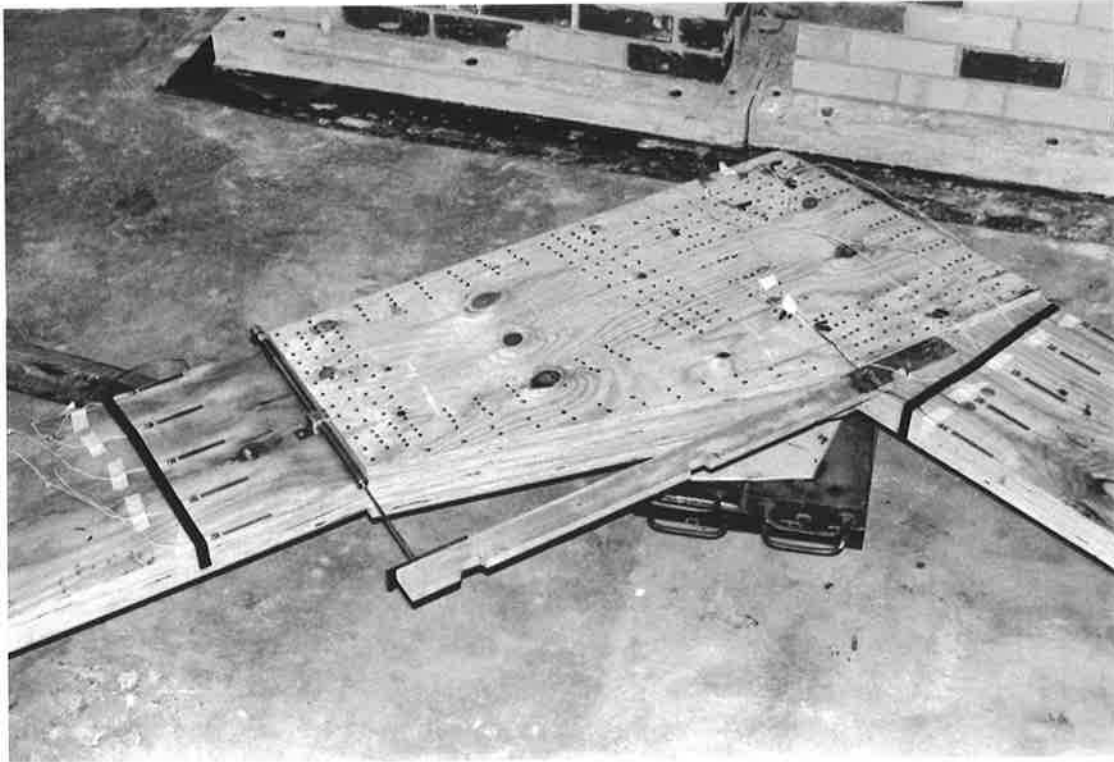
It should be noted that the timber leg representing the rafter in the test specimen (Figure 3.4) was untapered with a length corresponding to the distance to the point of contraflexure in the Wingfield building (see Figure 3.2, section 3.3). Tapering was used in the actual rafter in the timber portal frame (Figure 3.3). The width of this LVL member was reduced from the joint end to the apex in order to minimise the cost of material and reduce the self weight of the structure since maximum moment is usually found near the eaves. However, for laboratory testing, self weight was not important and pure joint failure was desirable. Consequently, a constant width LVL of 400mm was used for the test specimens.

Figure 3.4 Layout of the whole specimen

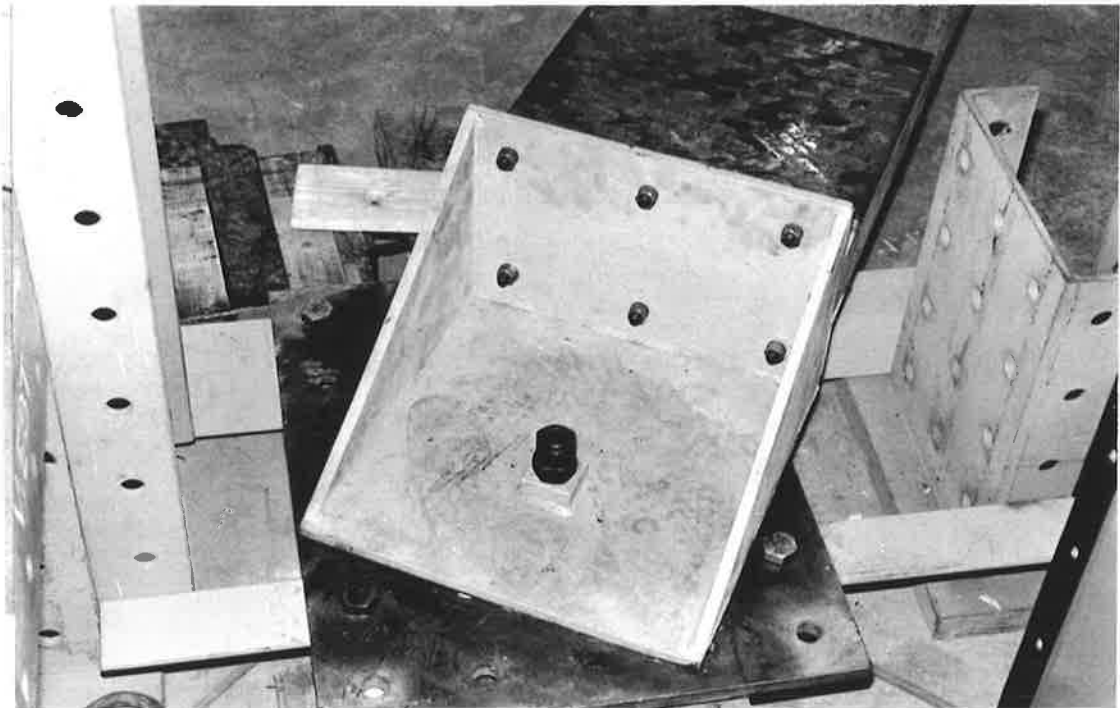
building. It was not only used for tension and compression loads transfer but to provide shear resistance. In the experimental set-up, the connections served the same purposes, but they were fixed to the ram and pivot joint instead of to the ground. Careful consideration was also given when selecting the location for testing since a plan area of 5m x 2m was necessary. Existing floor studs at 1200mm intervals were used to form the anchorage for supporting the hydraulic ram and the pivot end (see Figure 4.5). The arrangement is shown below in Figure 4.6.

Figure 4.6 LVL base connection

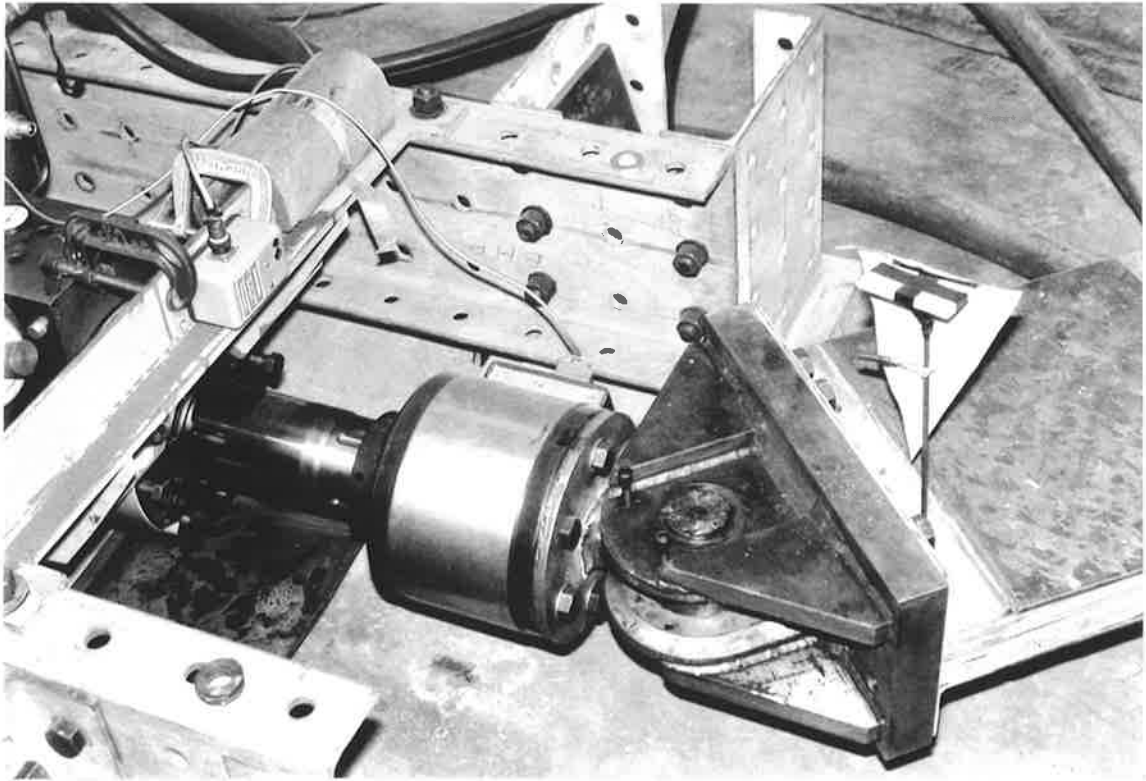
In order to ensure a moment-free connection at the base of the column member, the column base connection was joined to a knuckle joint which in turn was bolted to the loading ram through a steel tube (see Figure 4.8). This provided unidirectional loading to the timber joint. The 60mm diameter pin in the knuckle joint ensured that no moment was applied to the end of the test specimen.

Figure 4.8 Connection at the column end

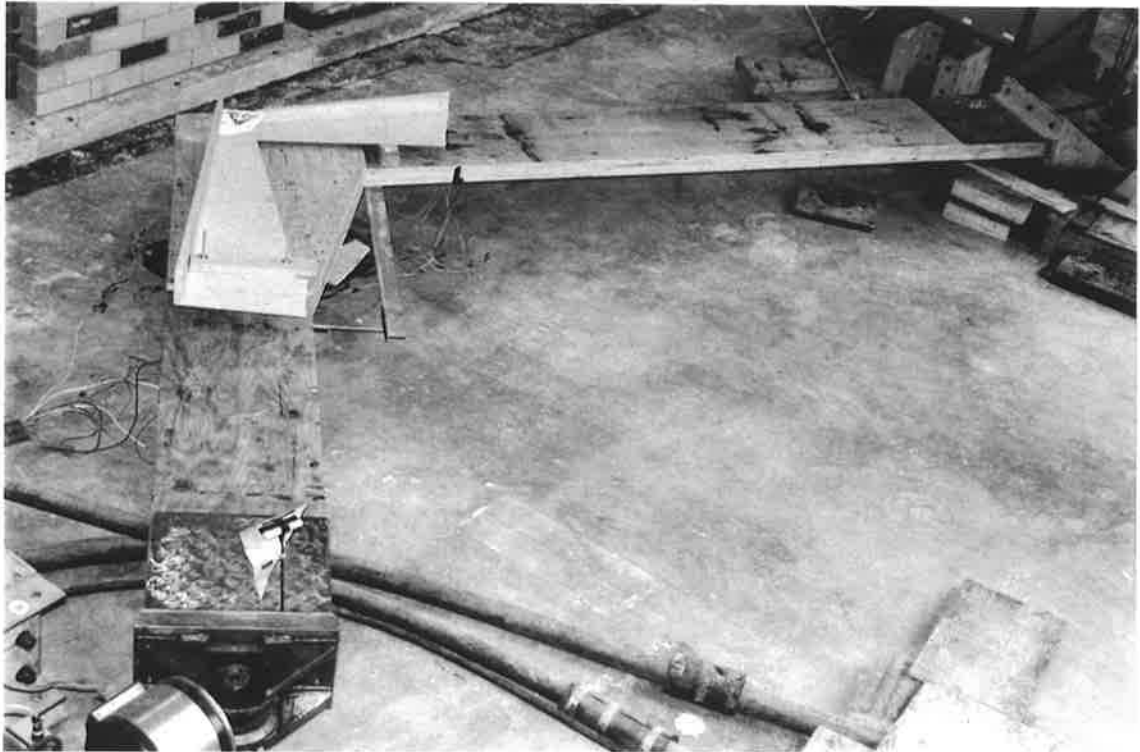
This pivot system provided the reaction forces for the rafter end and **eliminated any** moment transfer. Therefore, this zero moment support simulated the point of **contraflexure** along the rafter where only shear and axial forces would occur. The base angles of the rafter limb were bolted to the pivoting joint. This connection was designed to transfer any load from the LVL member through high tensile 24 mm bolts to a steel plate which was fixed to the ground studs by a steel truss system similar to the one used for the hydraulic jack. All the above connections were designed to withstand the ultimate load with a sufficient factor of safety to prevent fatigue failure of the steel connections.

Figure 4.11 Top view of the set up of the specimen

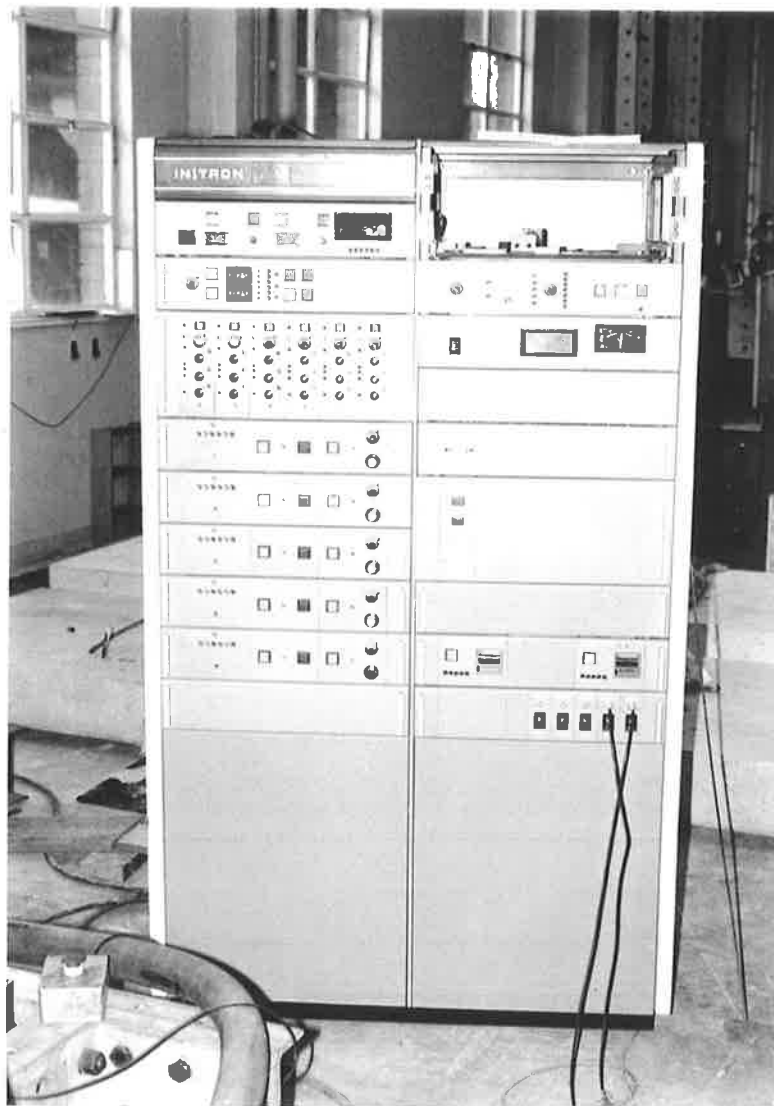
Figure 4.12 Control unit of the Instron machine

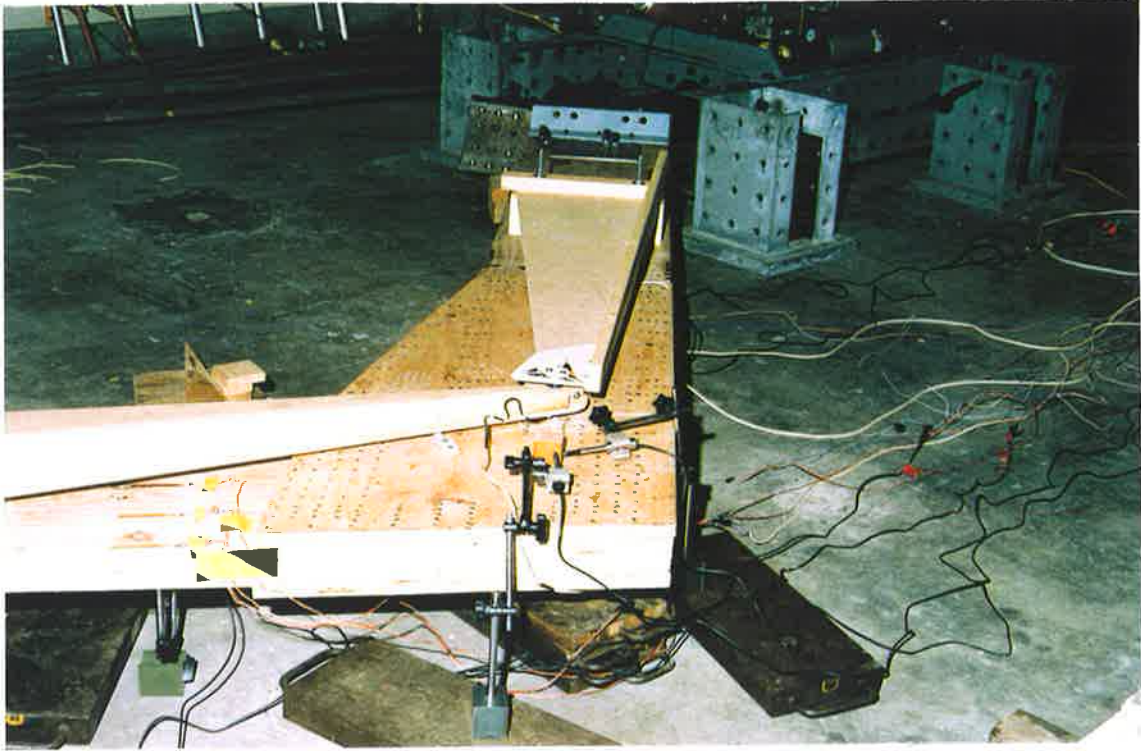
LVDT method: This method was based on the simple geometry of the joint which visualized the timber joint as two simple members hinged at their junction. An imaginary triangle is formed by joining the point of intersection, to a point along the centreline of the rafter and another point along the centreline of the column as shown in Figure 4.14. Then, by measuring the X-Y displacement of those three points and hence determining the changes in the length of the sides of the imaginary triangle, it was possible to employ the cosine rule to compute the rotation of the joint. These displacement were measured by LVDT's (linear variable differential transformer).

Figure 4.14 LVDT method by forming an imaginary triangle

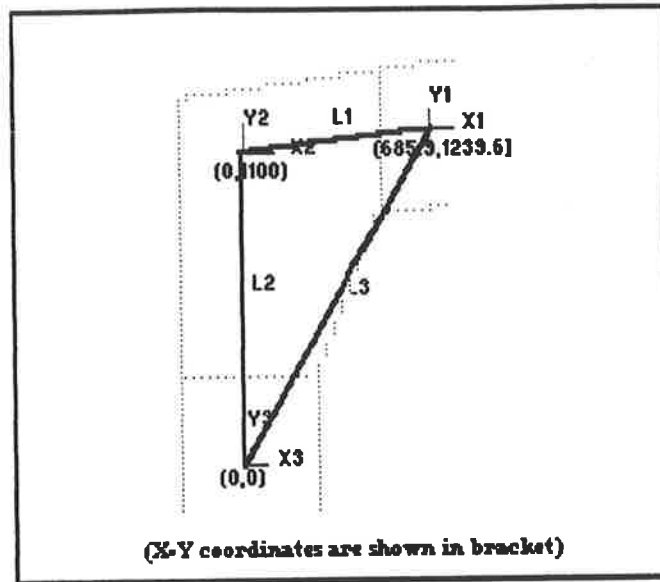
For this method to work satisfactorily, the centre of rotation must be at the intersection of the member centrelines. Due to the complicated action between the LVL and the plywood gusset plate, there was no theoretical tool nor any indication from previous tests as to where the actual centre of rotation was located. Its position was assumed to be the meeting point of the centreline of the LVL legs. The other two points were chosen at convenient locations along the centrelines just off the gusset plates.

Figure 4.15 LVDT method

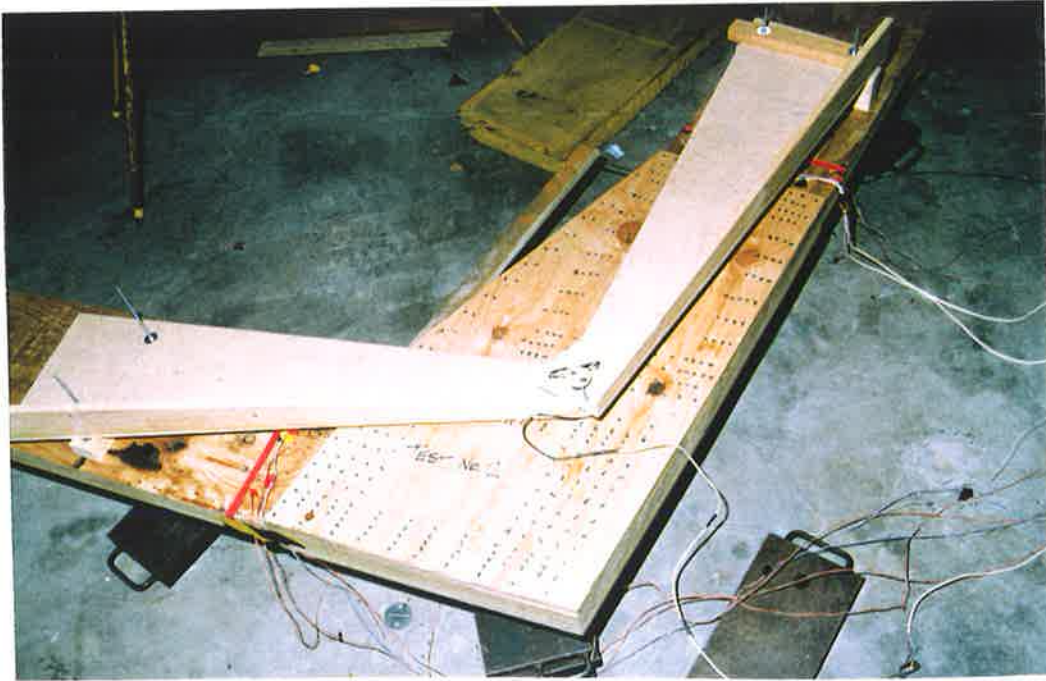
RVDT Method: This method provided a direct measurement of the relative rotation of the rafter and column using a Rotary Variable Differential Transformer (RVDT). This device produces a voltage whose magnitude varies linearly with the angular rotation of its shaft. It works on a potentiometer principle similar to LVDT except there is a ferromagnetic rotor instead of a straight cylindrical core (see Figure 4.16).

Figure 4.16 Rotary Variable Differential Transformer

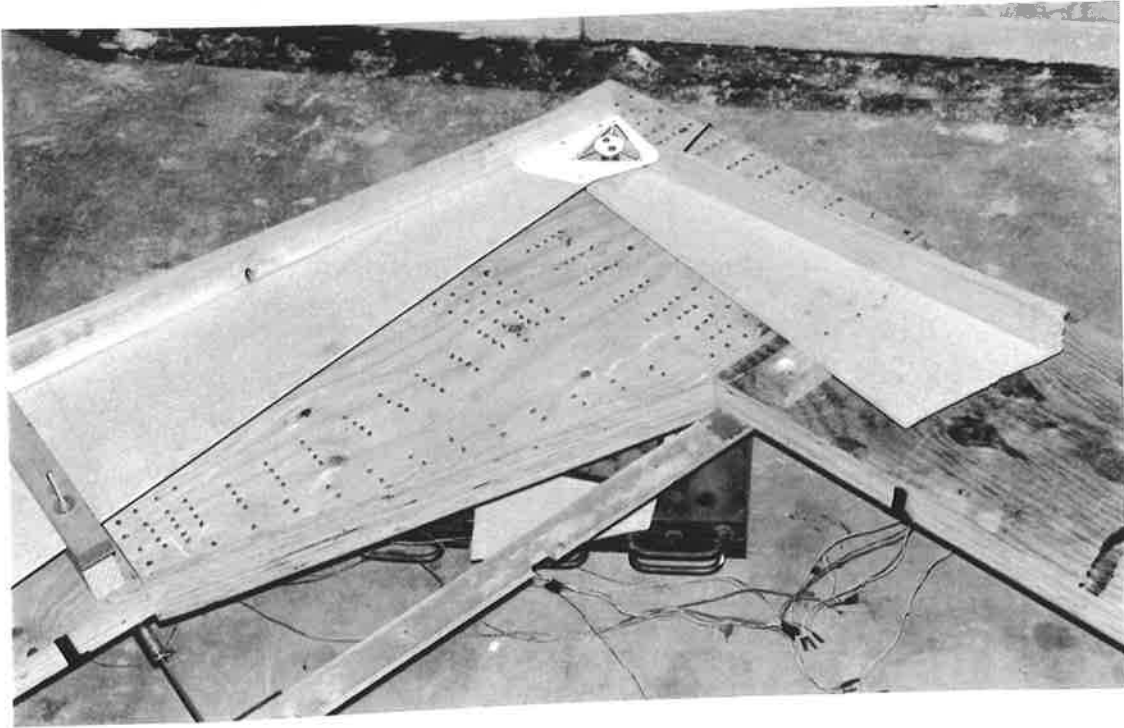
4.17). The mounting board on the column side held the shaft of the RVDT, such that the RVDT could rotate about a point on the column centreline.

Figure 4.17 Mounting boards for the RVDT

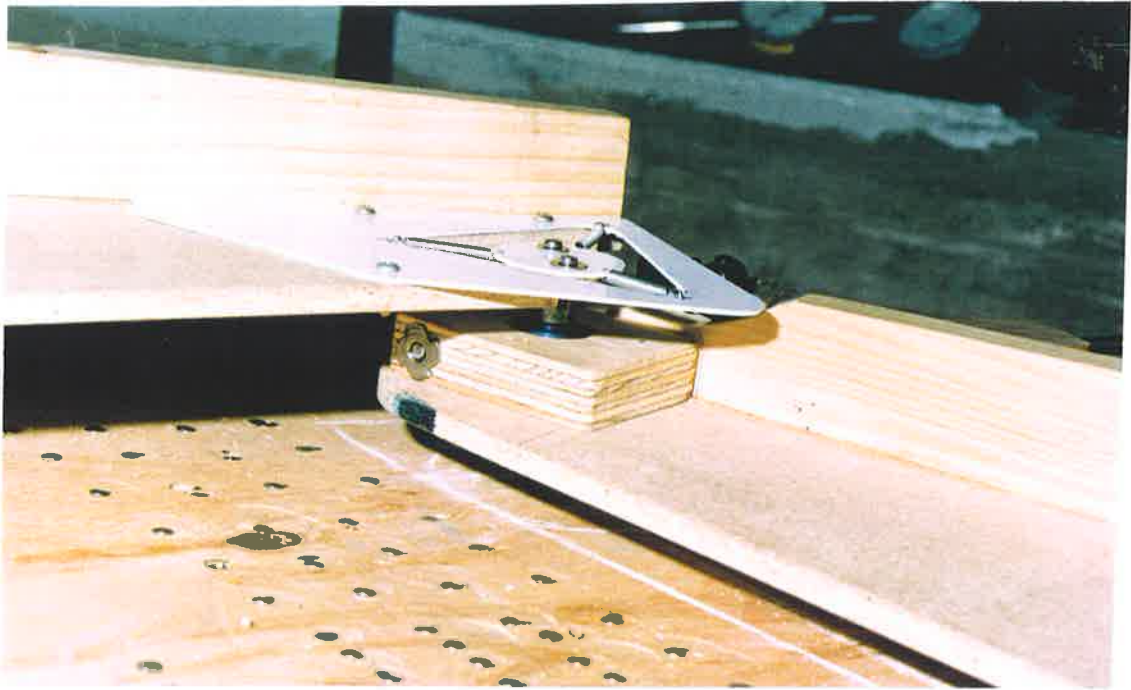
These boards projected over the plywood gusset and allowed mounting of the RVDT at the assumed centre of rotation. They were fixed to the LVL members by screws and their triangular shape gave a stiff, securely fixed and yet light weight design. Being light weight timber boards, they had little inertia during cyclic loading and their fixing just beyond the gusset prevented them from taking up any bending displacement from the LVL member. However, to avoid any damage due to load transfer between the shaft and casing of the RVDT (Max. load = 3.63kg), a special connection was arranged for the RVDT. A pre-tensioned spring system was put between the mounting board tip and the shaft (see Figure 4.18). This in effect allowed the shaft of the RVDT to 'float'.

Figure 4.18 RVDT and the mounting system

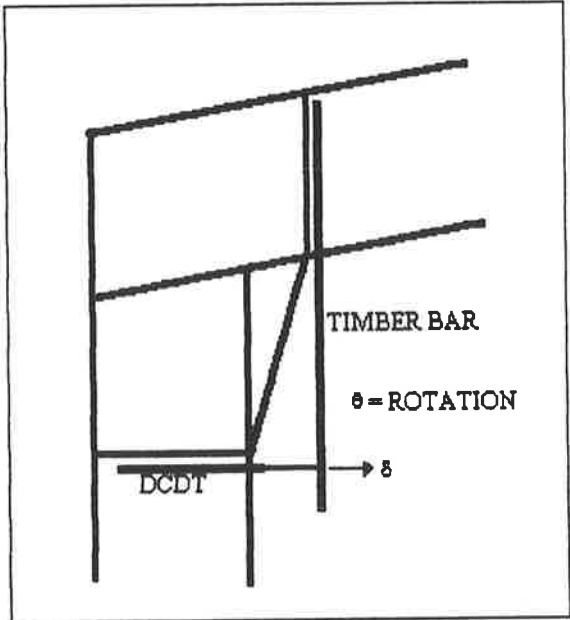
Figure 4.21 Geometry of the DCDT method

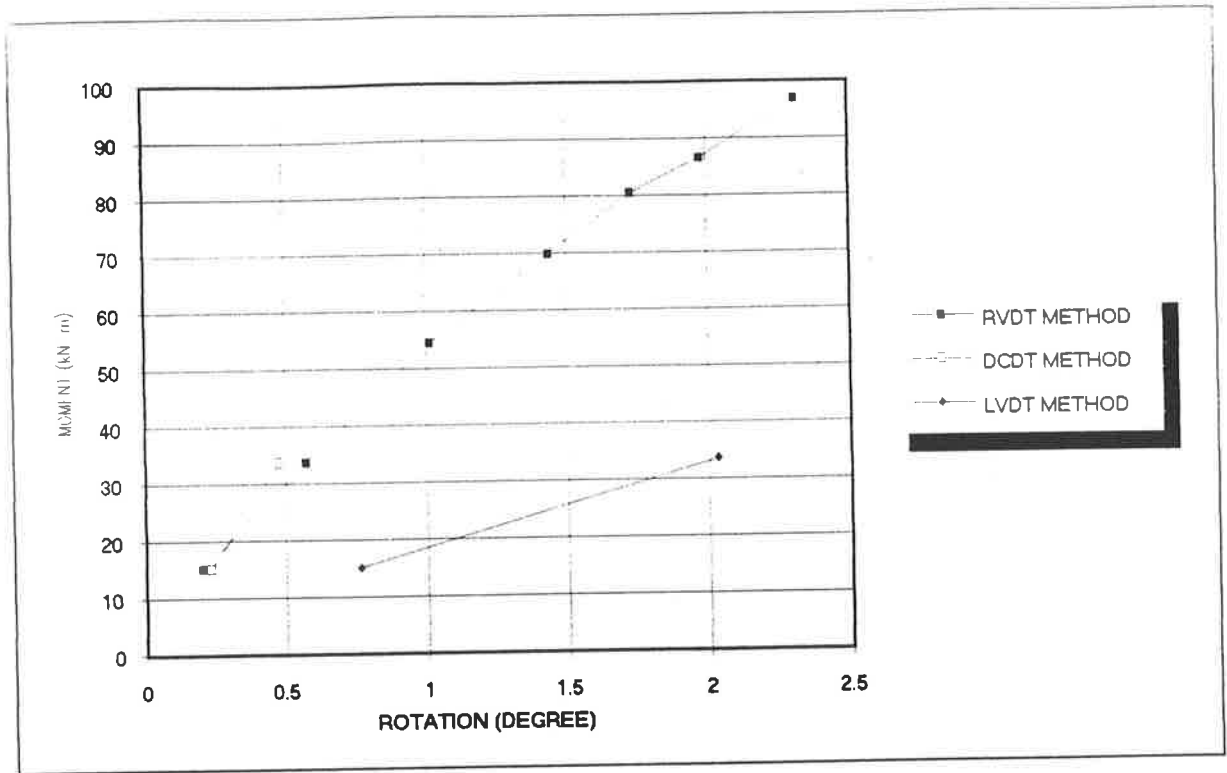
Figure 4.22 Moment vs rotation for specimen 1

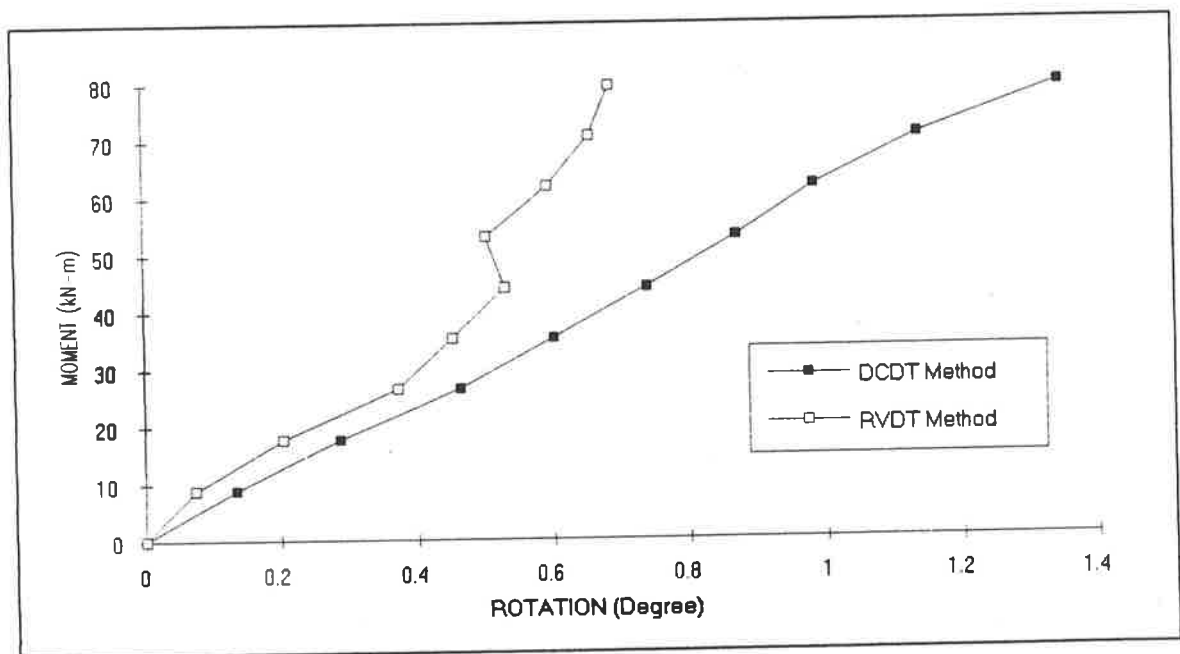
The second specimen was tested using the RVDT and DCDT methods. Both sets of readings seemed to agree with each other for rotation less than 0.014 radian (0.8°). For larger rotations, the RVDT seemed to respond strangely to the rotation by recording almost constant joint rotation with increasing load. Thus, the RVDT method was considered to be less accurate with the unknown location of the centre of rotation. On the other hand, the plot of moment vs rotation (see Figure 4.23) showed that the DCDT method indicated a consistent pattern.

Figure 4.23 Moment vs rotation during the failure loading for specimen 2

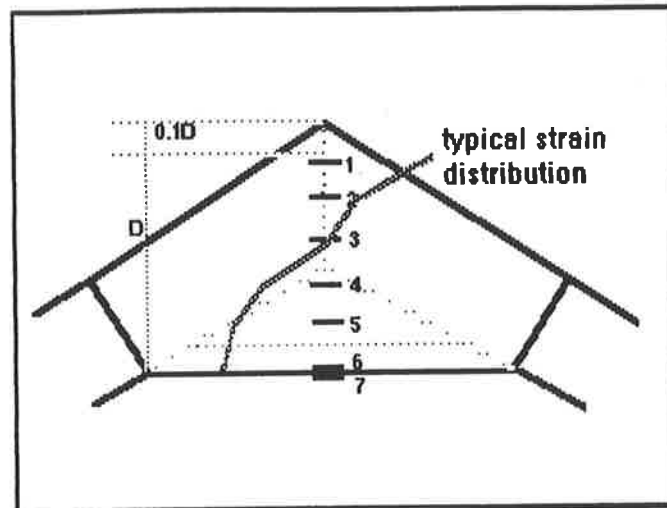
The ram displacements imposed at the column base by the Instron hydraulic jack caused joint rotation. It also induced strains in all locations of the test specimen. Due to the complex interaction between the plywood gussets plates, nail groups and the LVL members, complex non-linear strain was expected on the surface of the plywood plates. Batchelar and Cavanagh (8) have previously put strain gauges along a line from the apex to the strut (see Figure 4.24).

Figure 4.24 Gauge positions in the Batchelar and Cavanagh experiment

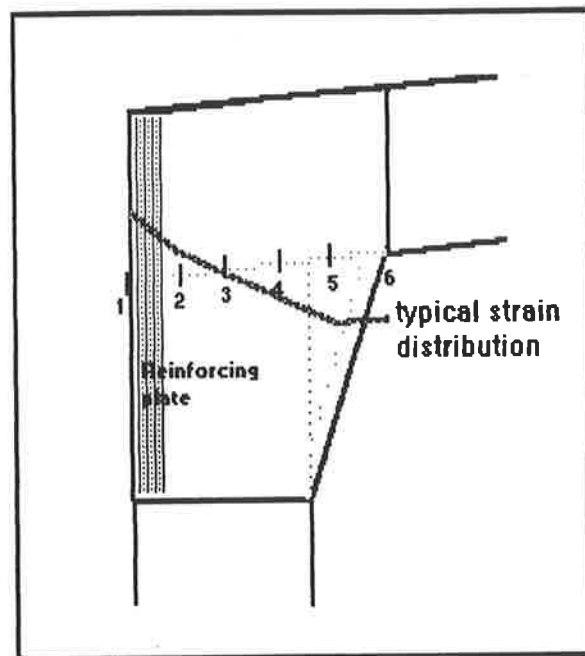
Figure 4.25 Gauge positions in the Batchelar and Hunt experiment

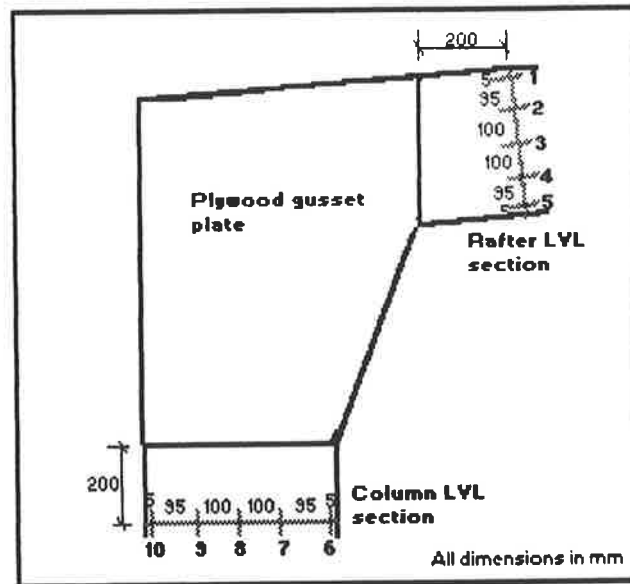
for suitable bonding. Then gauge location layout lines were drawn to locate the strain gauge before bonding the strain gauges (see Figure 4.26). For comparison, Batchelar utilized 60mm strain gauges mounted directly onto the plywood surface.

Figure 4.26 Locations of the strain gauges across the LVL members

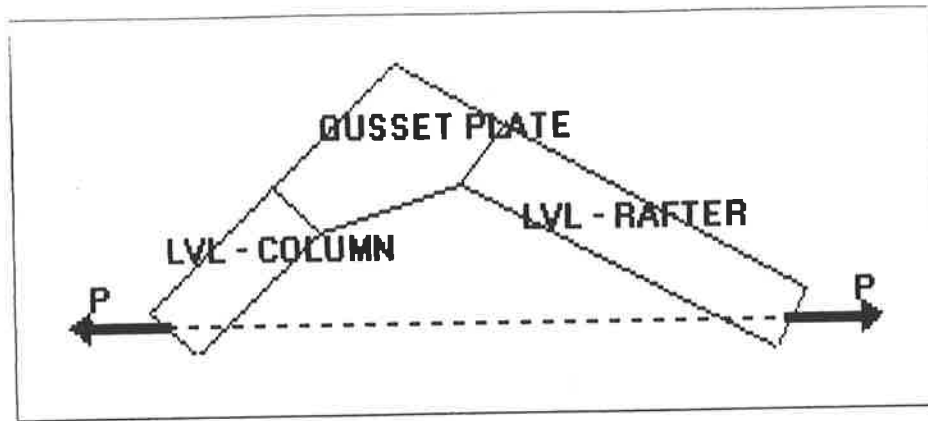
The testing involved first applying a standard loading calculated from AS1720 as 23kN (41kN-m) (25kN or 44kN-m was chosen for convenience - see section 3.4.2) for a working load moment which represented the dead load case. The cyclic loading superimposed on the static loading was chosen from the wind load code AS1170.2 as $\pm 9\text{kN}$ or $\pm 16\text{kN-m}$. Therefore, instead of having wind loading acting on the whole portal frame, a pair of loads acting opposite to each other was applied at the base of the specimen legs (see Figure 4.29).

Figure 4.29 Load vector diagram for the specimen

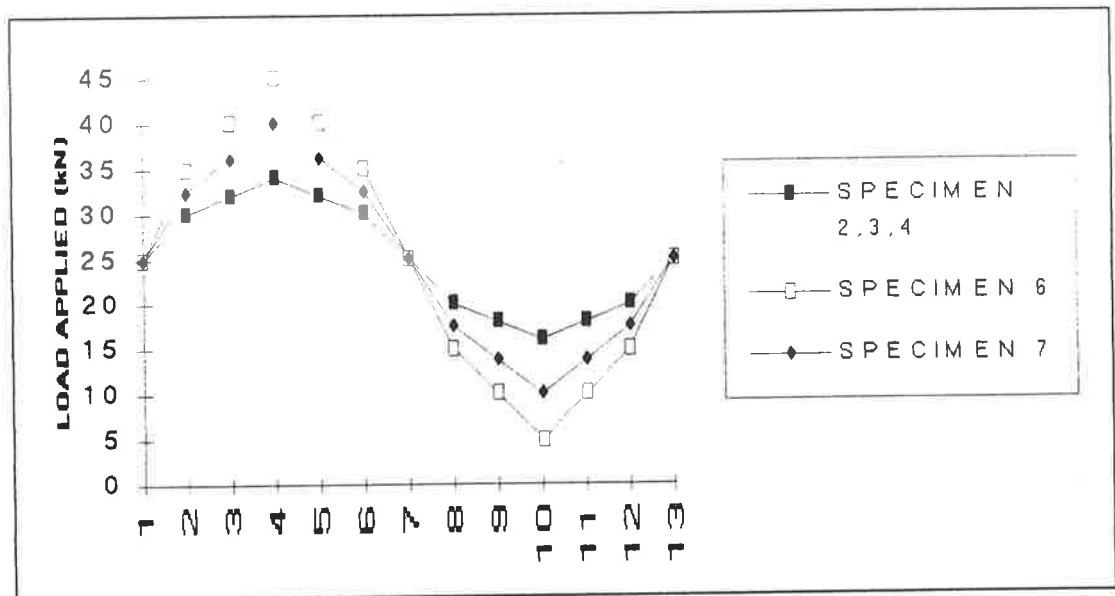
For data logging, the loading rate was slowed down during the cyclic loading phase. The method used to take all the readings at different parts of one loading cycle was to halt the automatic cyclic loading and adjust the load level at different points of the loading cycle manually. For each load point, a whole set of readings was obtained. In order to produce a smooth loading cycle, thirteen load levels were chosen (see Figure 4.30).

Figure 4.30 Points chosen for data logging within a complete load cycle

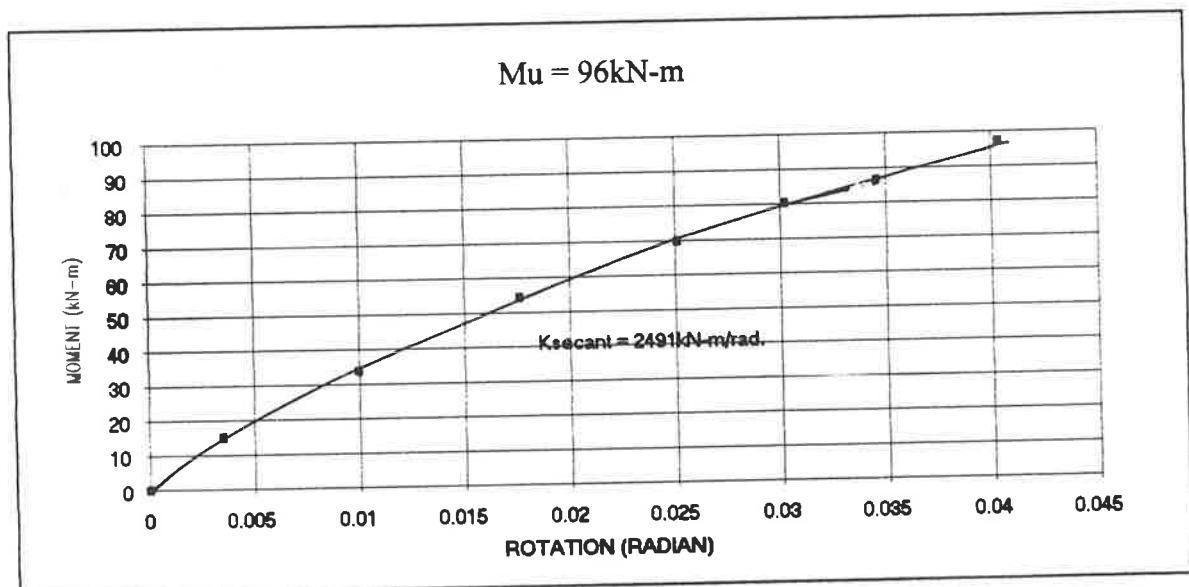
The first specimen was subjected to a simple static test to failure. The aim was to determine the static ultimate strength. This would not only provide a basis for comparison with the calculated strength from AS1720(2), but also formed a benchmark for comparison with the residual ultimate strengths obtained in subsequent tests where each specimen was first subjected to various amounts of fatigue loading. Moreover, this was an opportunity for testing the accuracy and reliability of the instrumentation.

Figure 5.1 Moment vs rotation for specimen 1

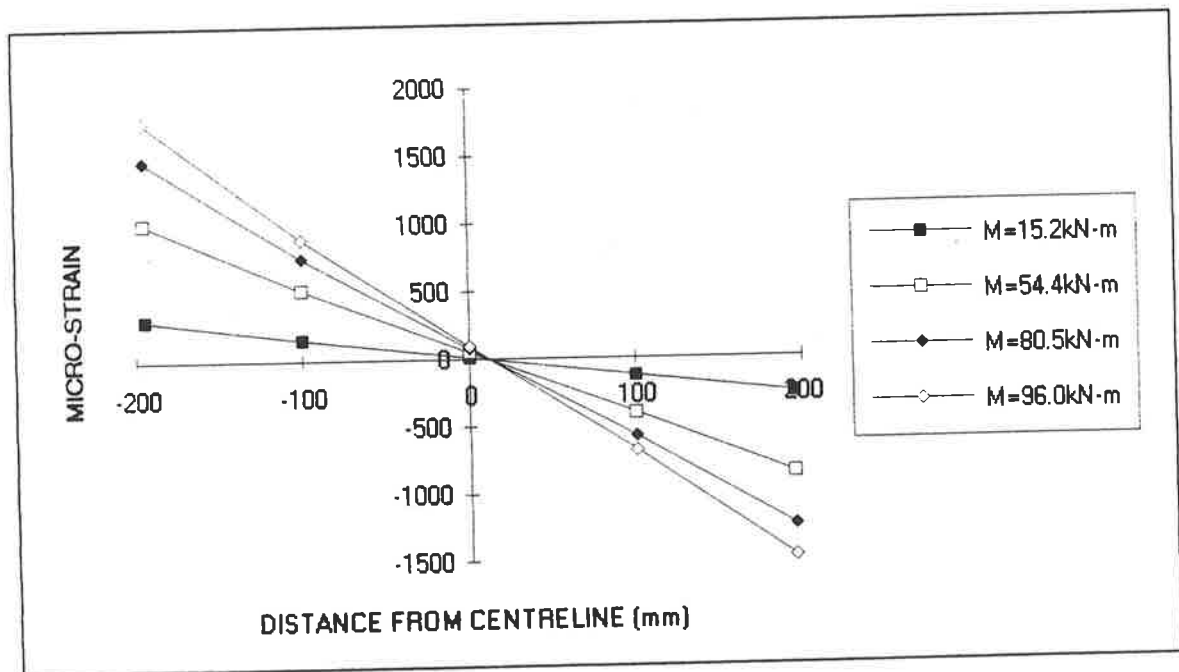
The strain profile across the LVL column section is shown in Figure 5.2 and was seen to be nearly linear with the neutral axis situated near the centreline of the member (12.5 mm from the centreline to the compression side). This implied that bending contributed the largest portion of stress. In all the strain plots, tension is positive and compression is negative.

Figure 5.2 Strain across column for specimen 1

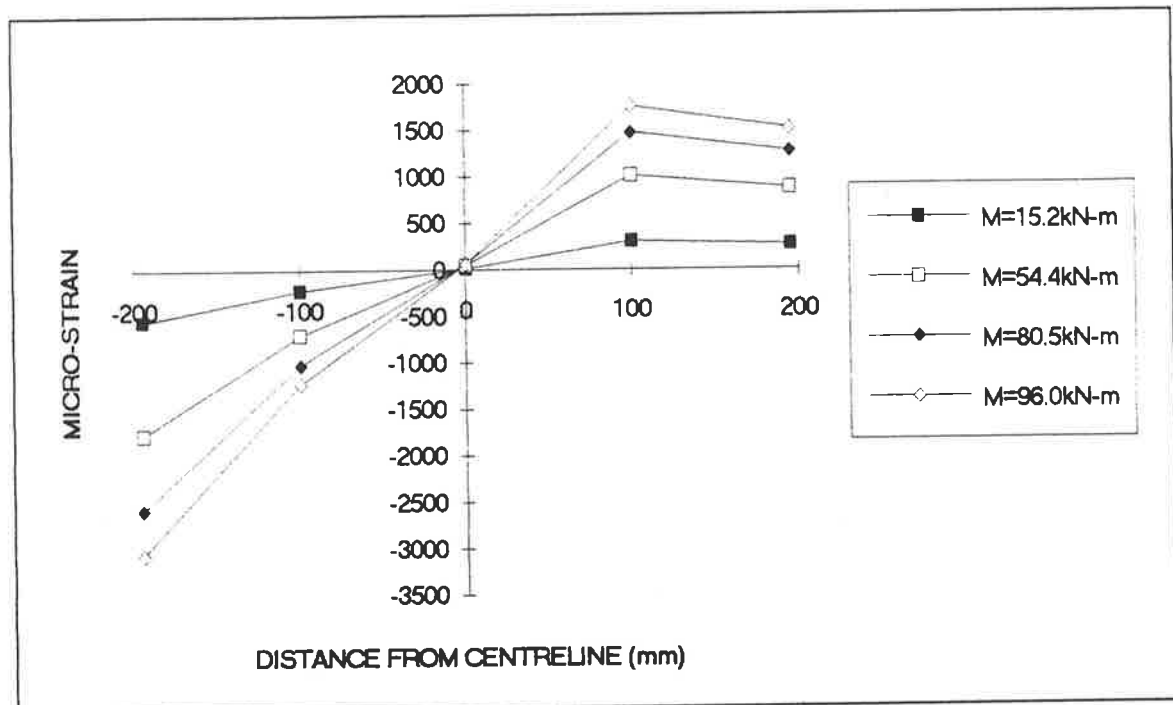
non-linear and in close agreement with the strain profile reported by Batchelar(7). P_{strain} and M_{strain} were calculated as 41.6kN (90% of P_{static}) and 58.2kN-m (73% of M_{static}) respectively in contrast to P_{static} and M_{static} of 46.3kN and 79.2kN-m. The close correlation confirmed the reliability of the non-linear strain profile. This non-linearity could be due to initial stress which existed in the test specimen or deep beam bending action.

Figure 5.3 Strain across rafter for specimen 1
