**PRELIMINARY STUDY OF FATIGUE BEHAVIOUR
OF TIMBER MOMENT RESISTING JOINT**

Thesis presented for the degree of
Master of Engineering Science
at the University of Adelaide
Australia

-August 1995-

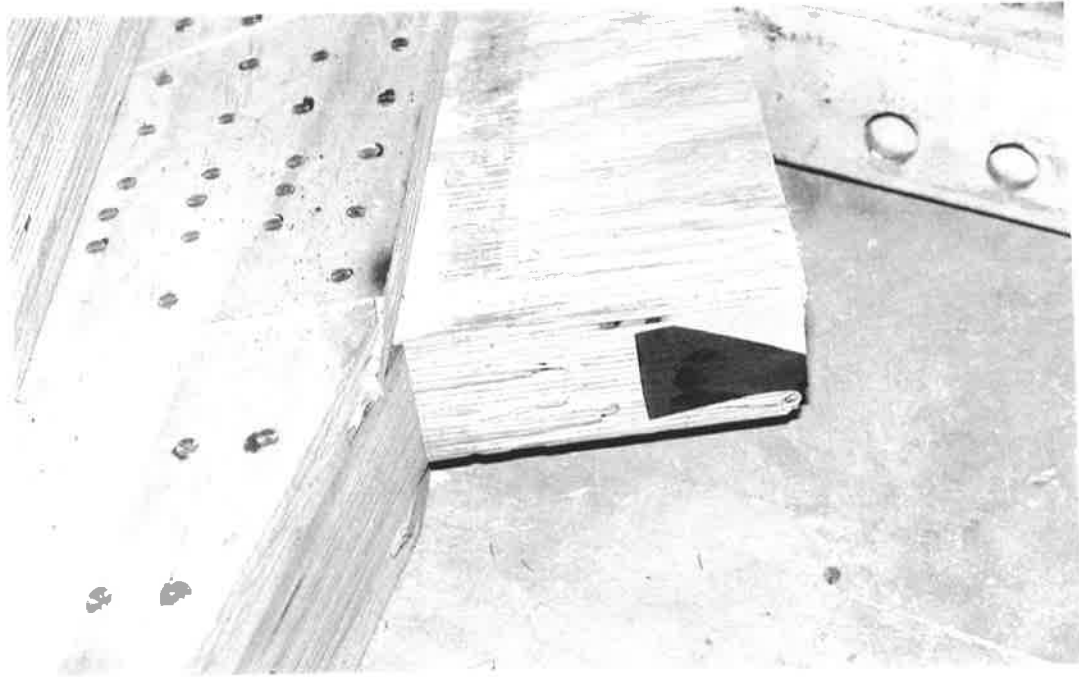
The static test concluded with the failure of the joint by a bending/tension failure of the LVL rafter member adjacent to the gusset plate. The failed specimen is shown below in Figure 5.4

Figure 5.4 Failure mode of specimen 1

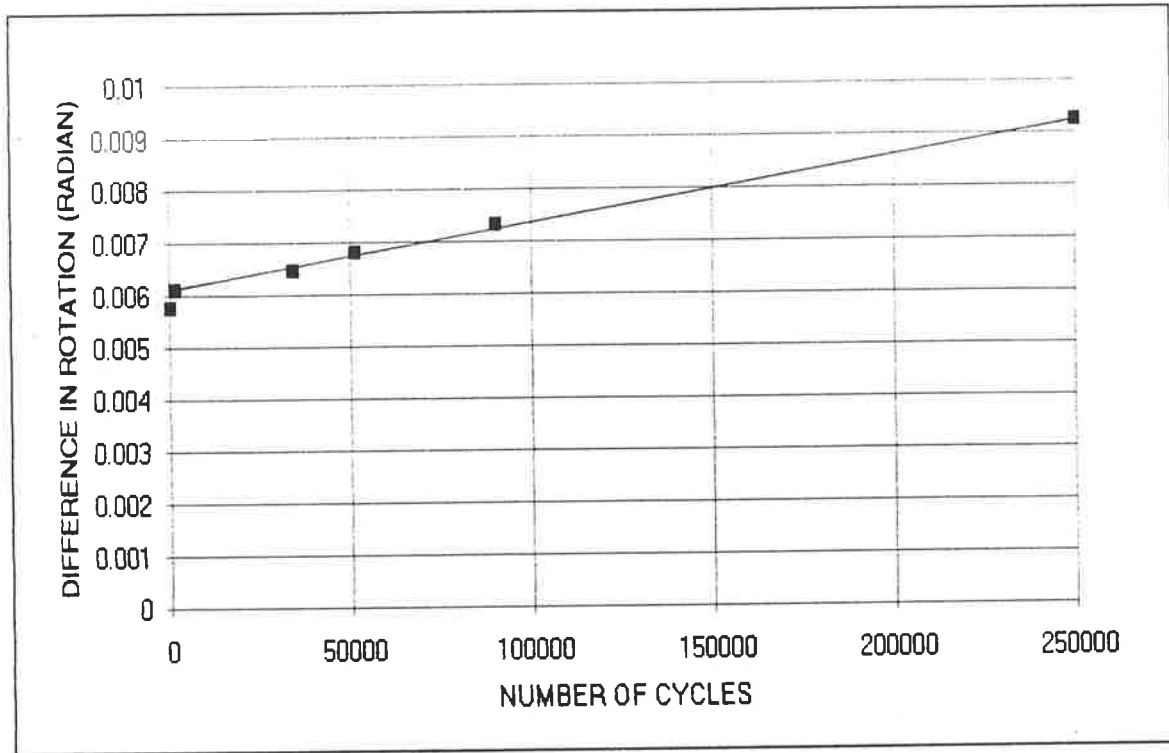
rotation within a cycle and the dynamic stiffness of the joint. Thus, the change in rotation, $\Delta\theta = \theta_{\max} - \theta_{\min}$, was plotted versus the number of loading cycles, N , and is shown in Figure 5.6. The difference in the joint rotations, $\Delta\theta$, was seen to steadily increase.

Figure 5.6 Difference in rotation vs number of cycles for specimen 2

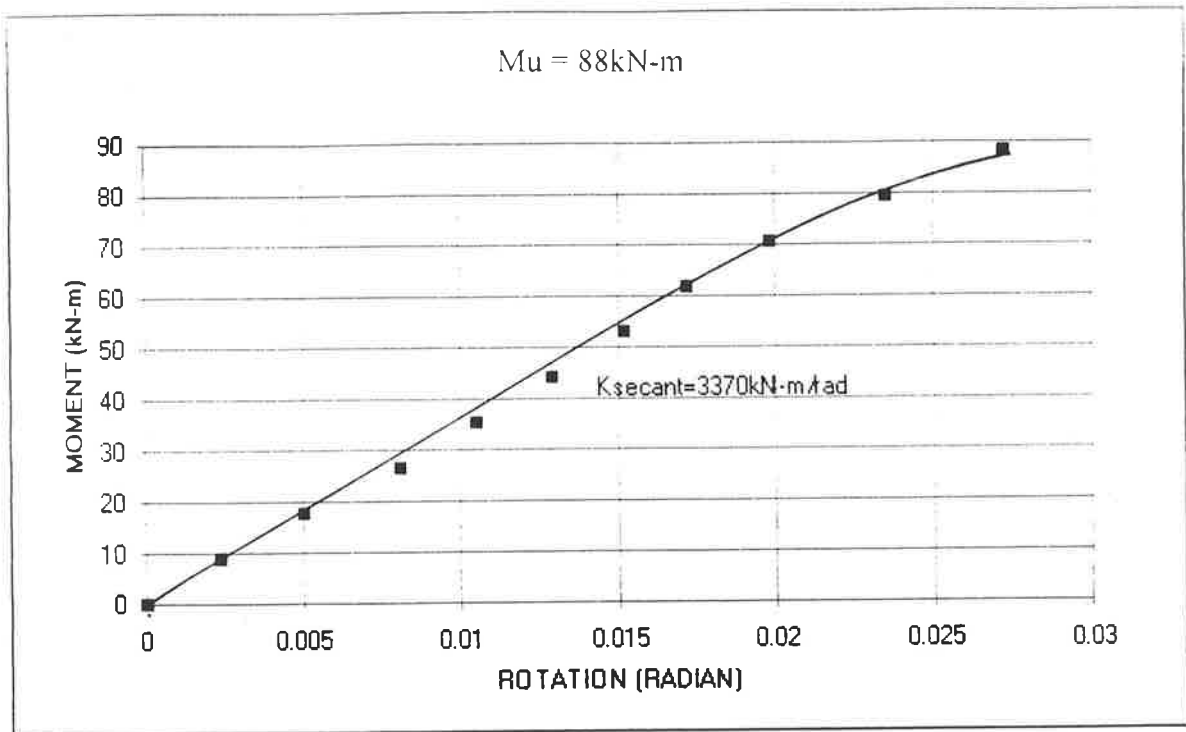
Figure 5.8 shows the results of the static test conducted after the 250,000 cycles of fatigue loading had been applied and from this curve, the secant stiffness of the joint was estimated to be 3370kN-m/rad.

Figure 5.8 Moment vs rotation for specimen 2 (static test to failure)

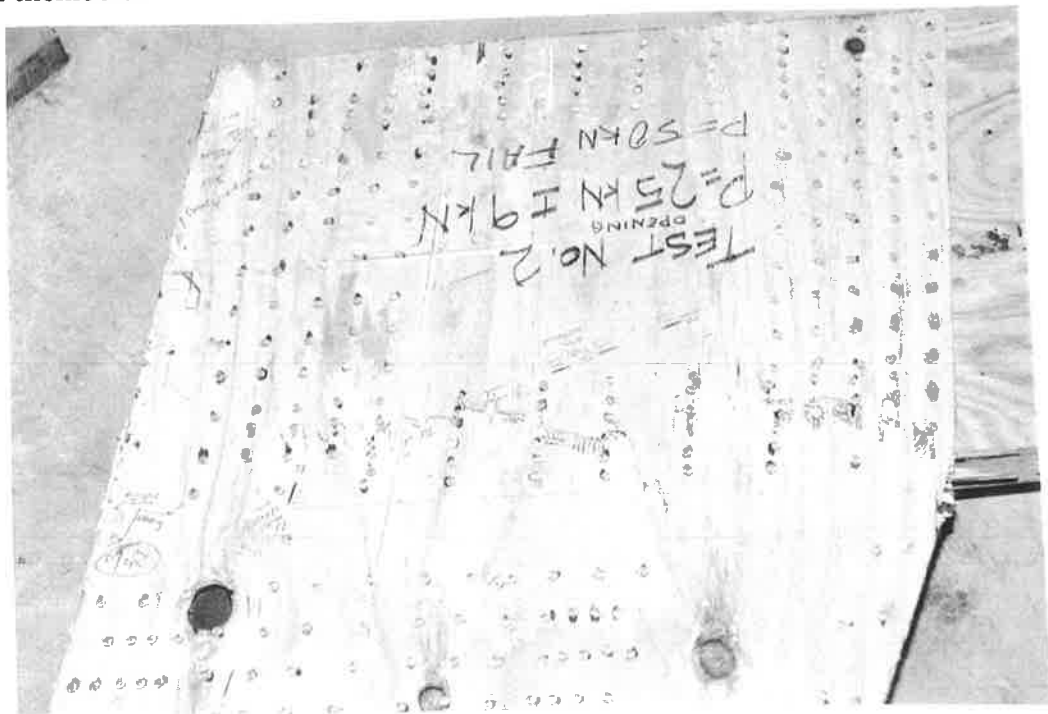
Figure 5.11 Failure mode of the specimen 2

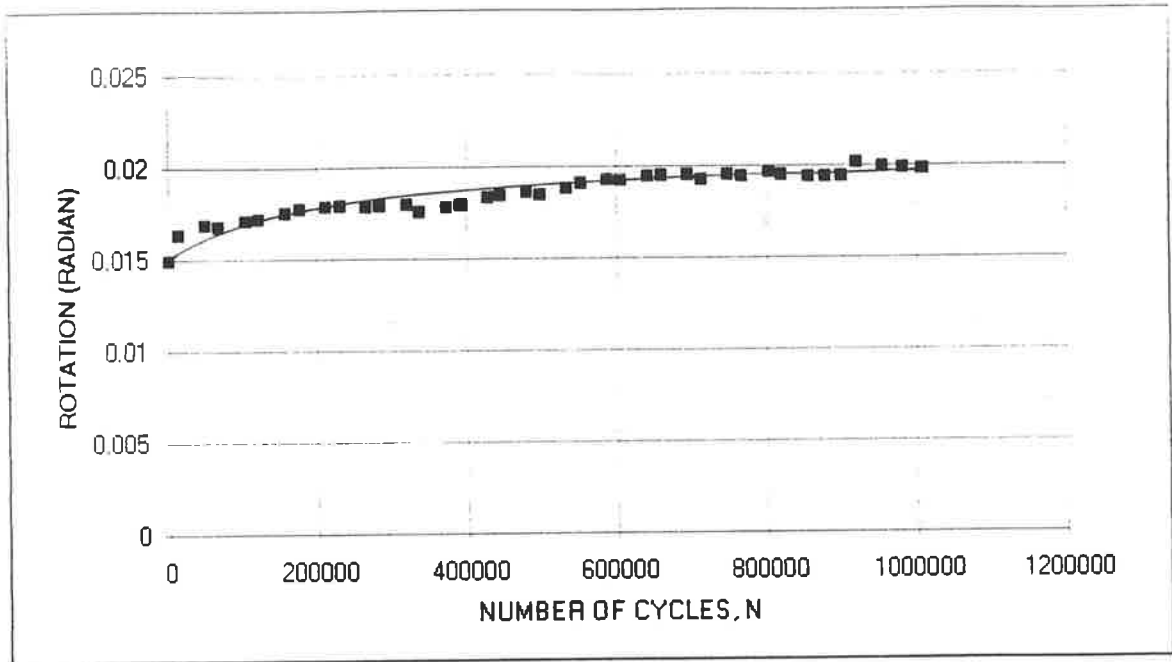
Figure 5.12 Rotation at 44kN-m vs number of cycles for specimen 3

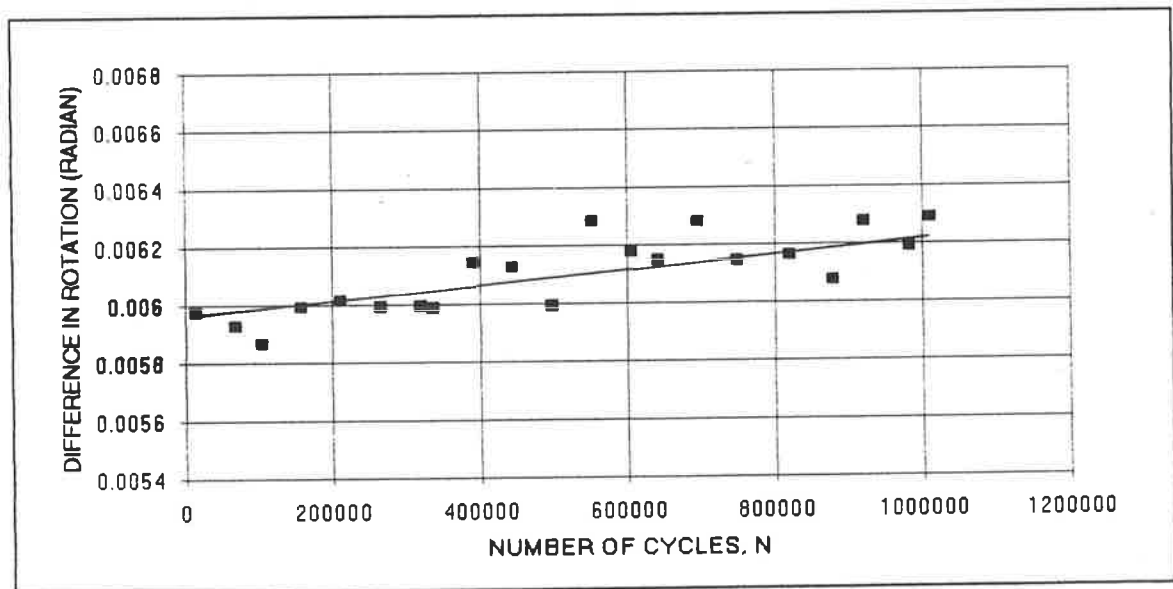
Figure 5.13 Difference in rotation vs number of cycles for specimen 3

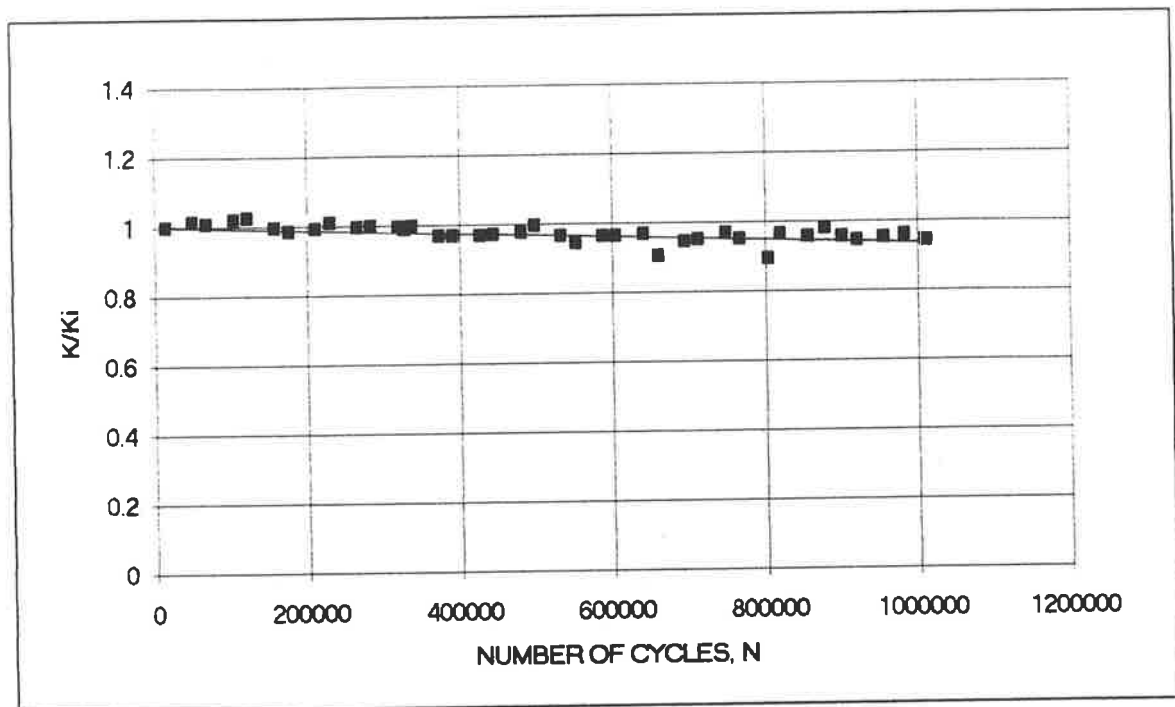
Figure 5.14 stiffness vs number of cycles for specimen 3

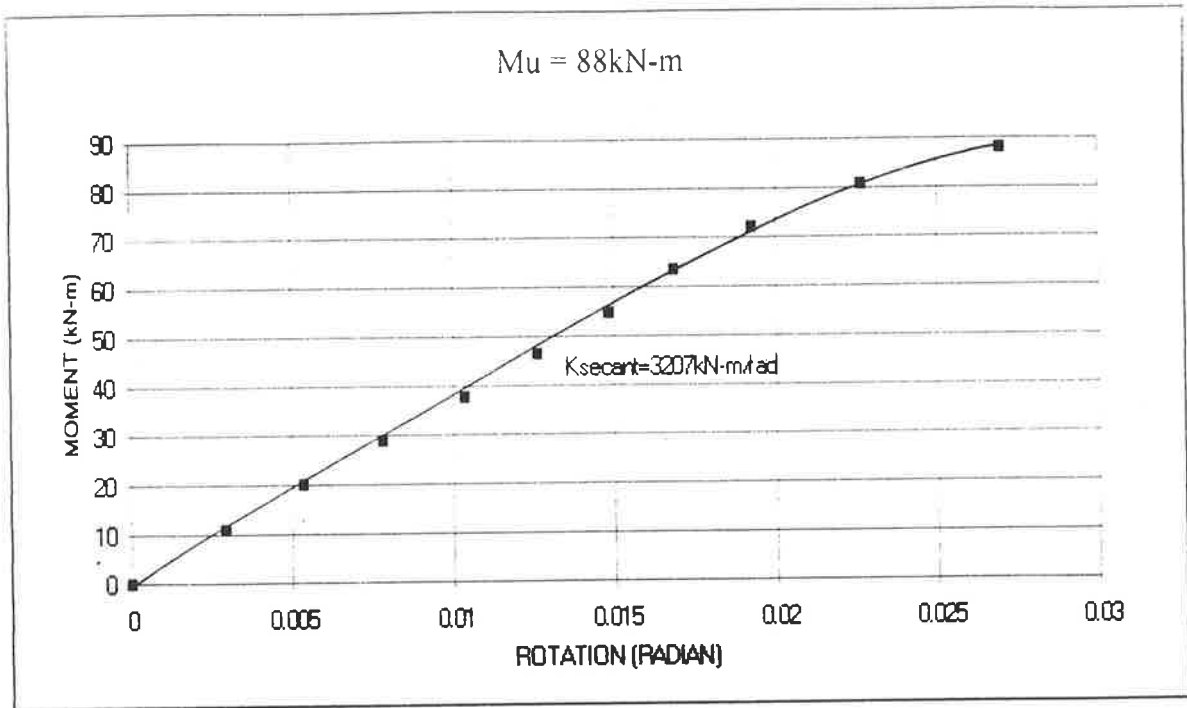
Figure 5.15 Moment vs rotation after 1,000,000 cycles for specimen 3 (static test to failure)

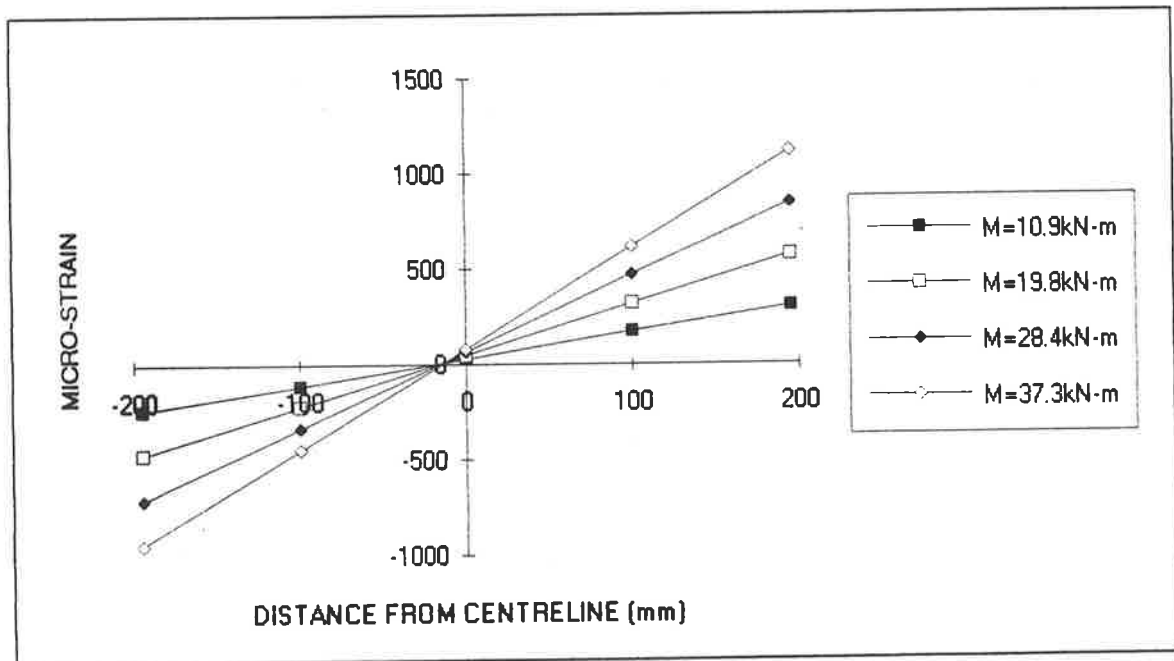
Figure 5.16 Strain across rafter during initial loading for specimen 3

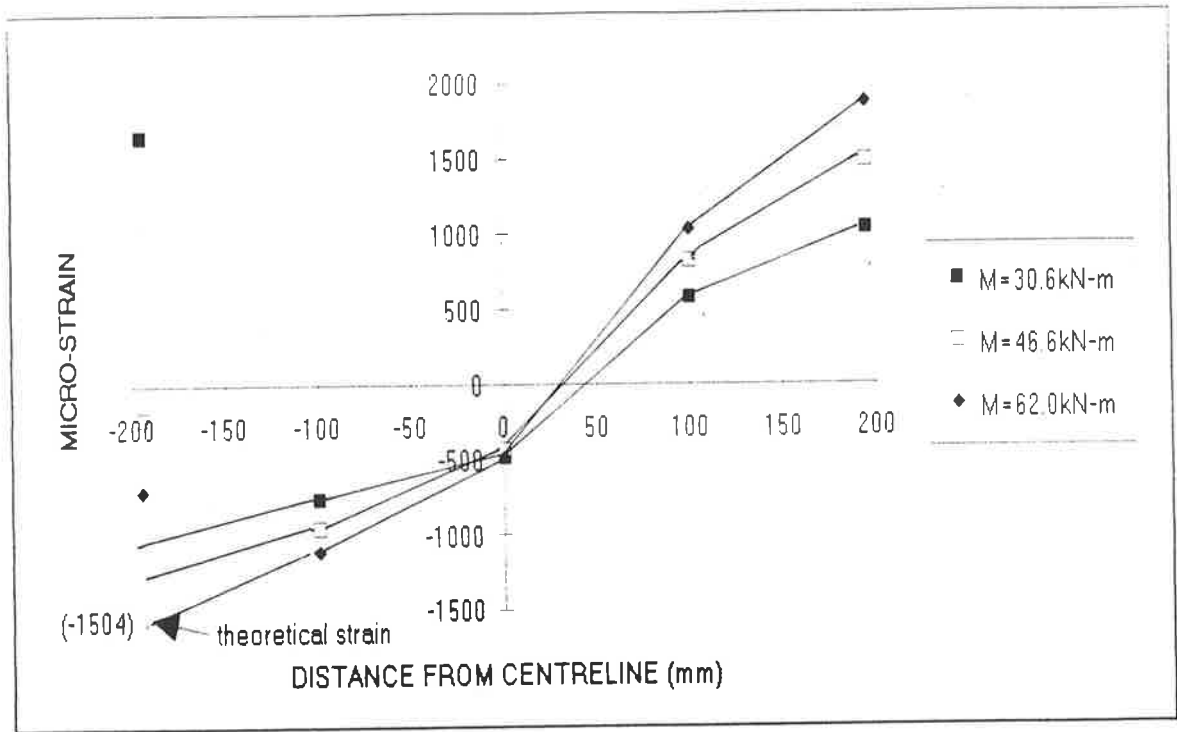
Figure 5.17 Strain across rafter at $N=1009752$ for specimen 3

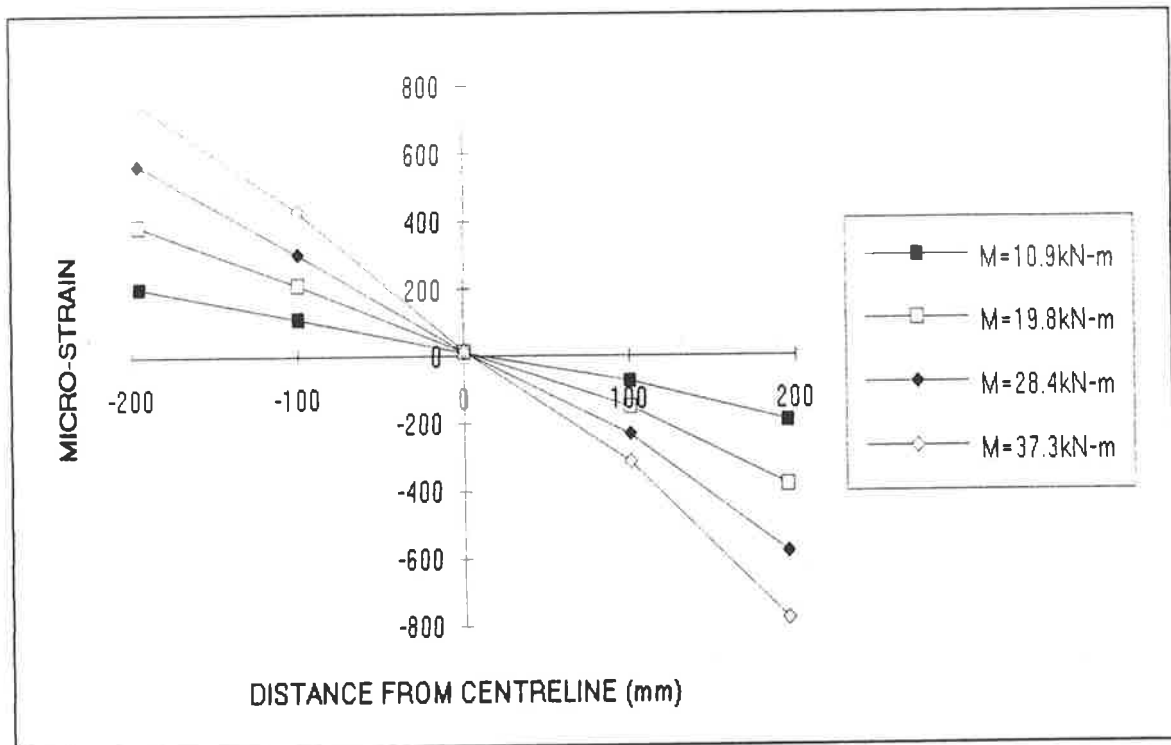
Figure 5.19 Strain across column at initial loading for specimen 3

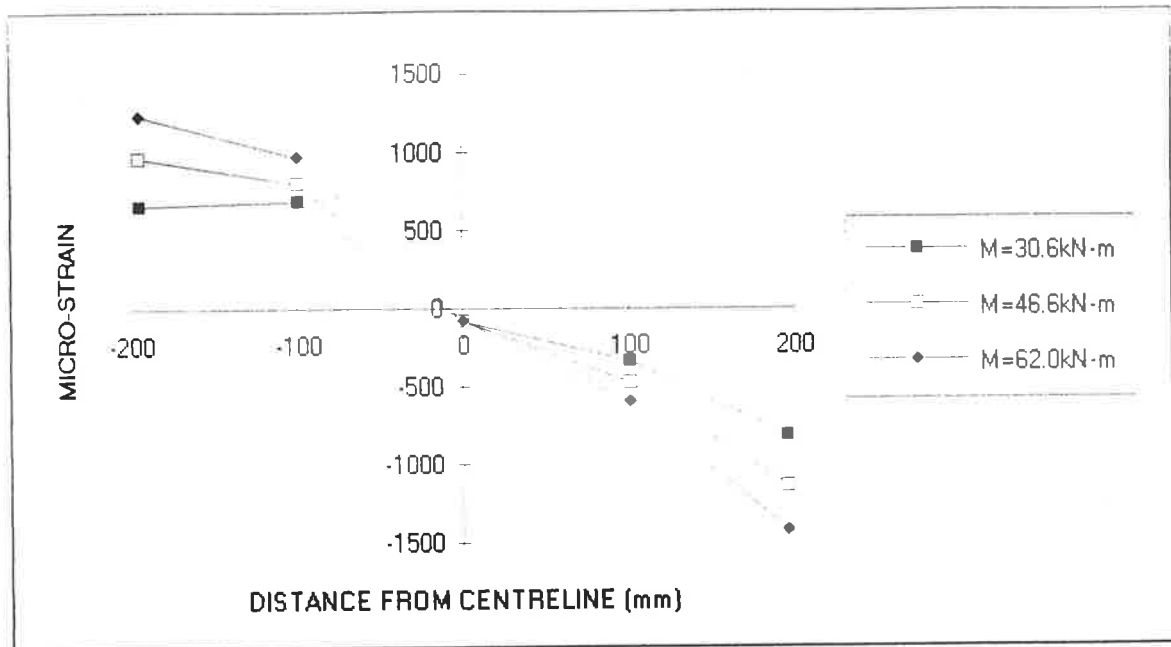
Figure 5.20 Strain across column at $N=1009752$ for specimen 3

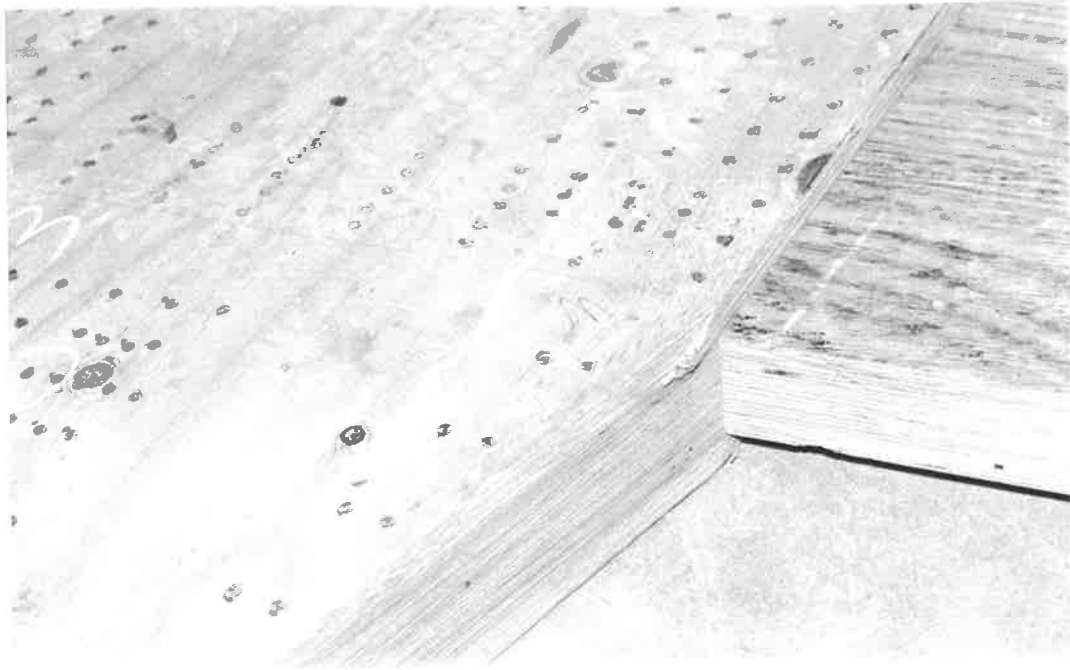
Figure 5.21 Failure mode for specimen 3

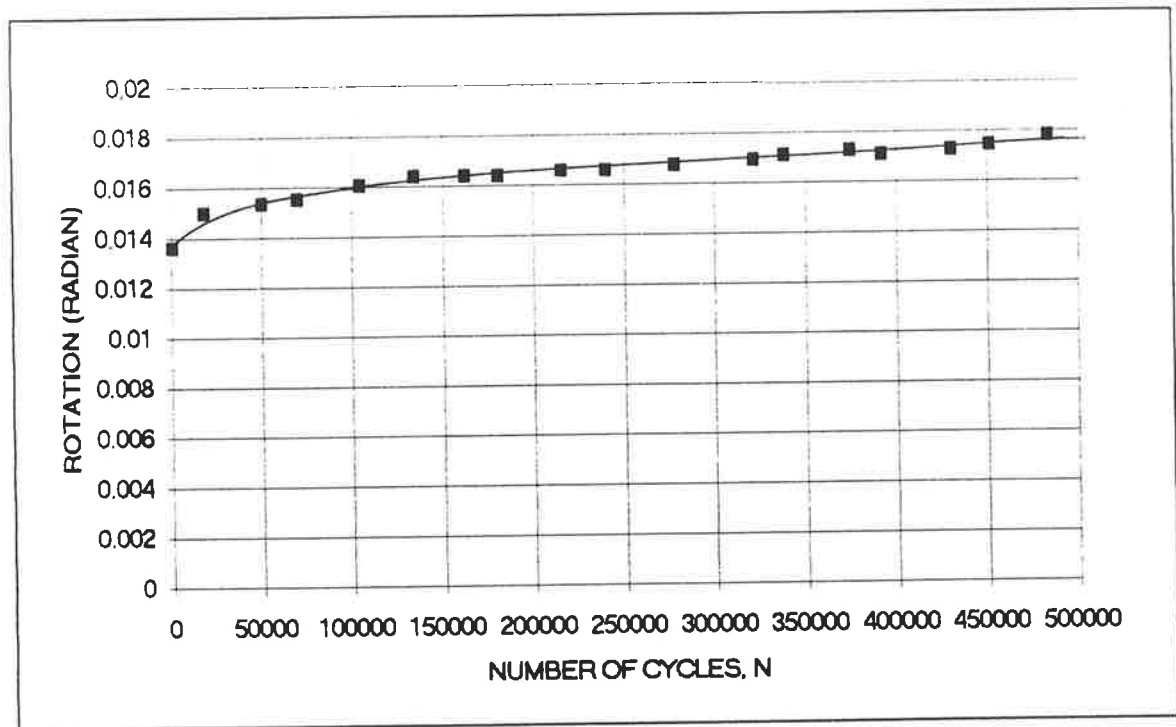
Figure 5.22 Rotation at 44kN-m vs number of cycles for specimen 4

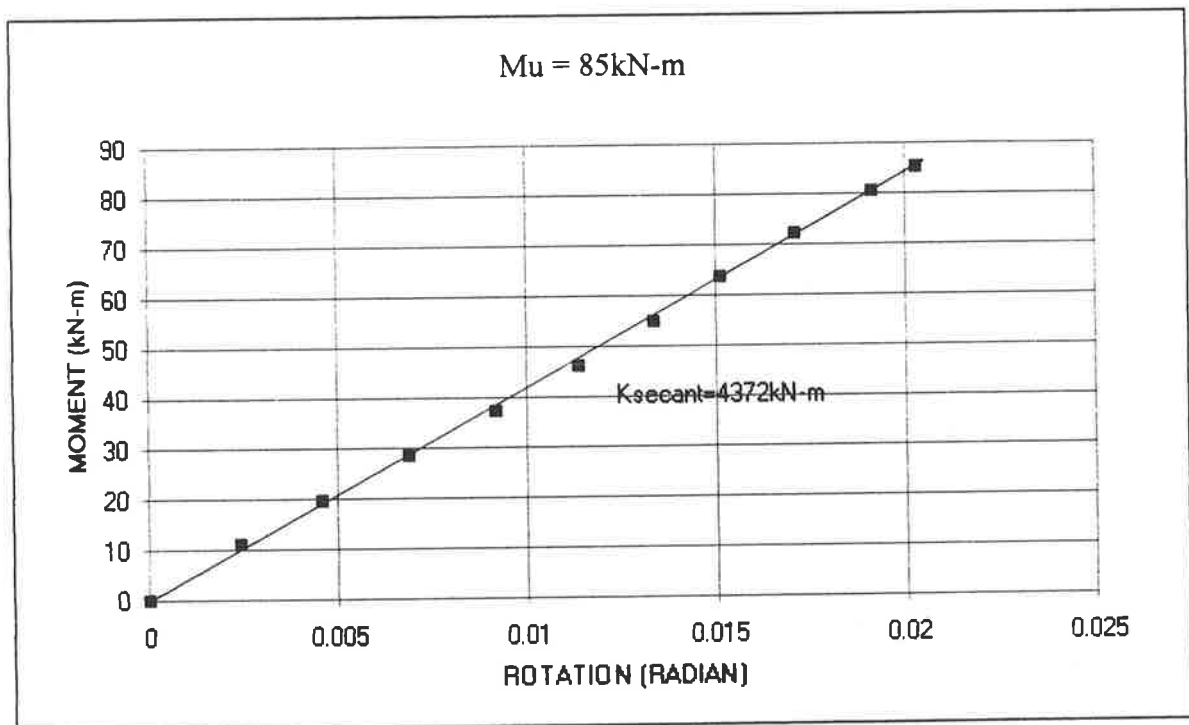
Figure 5.25 Moment vs rotation at failure loading for specimen 4
(static test to failure)

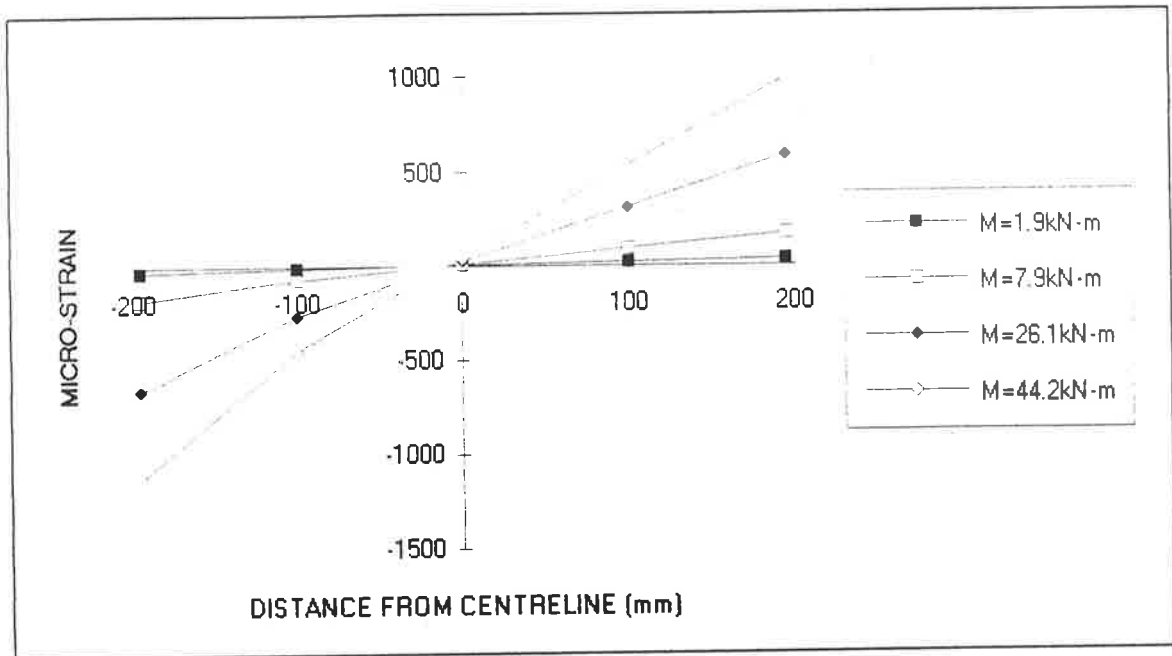
Figure 5.26 Strain across rafter at $N=206$ for specimen 4

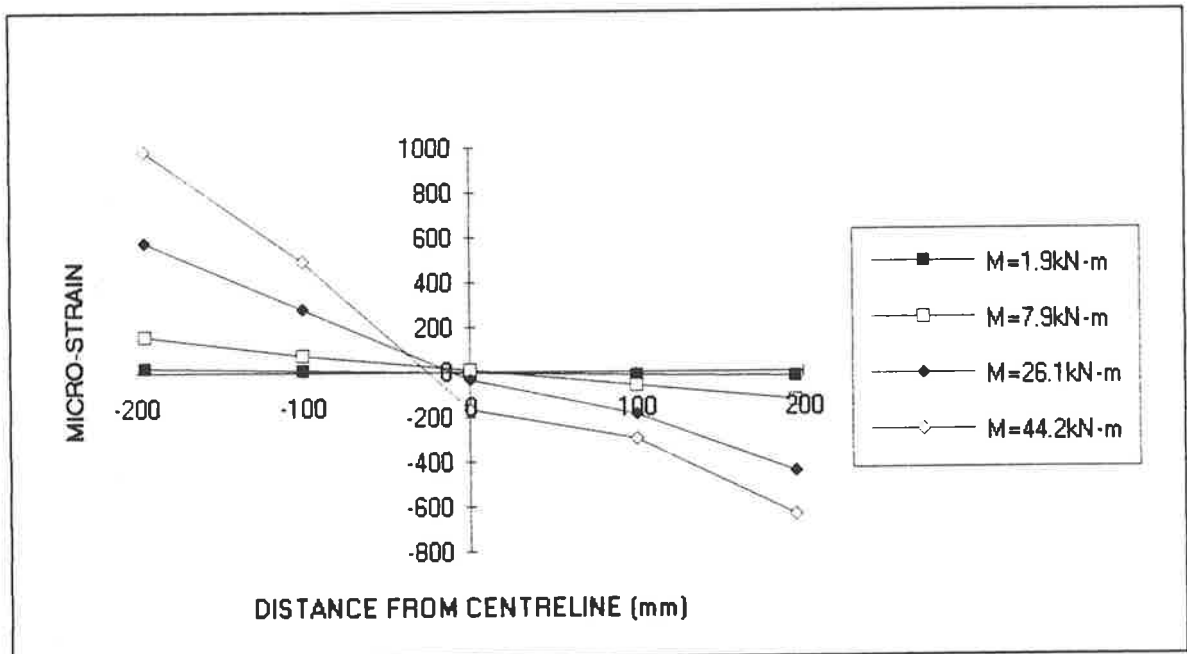
Figure 5.28 Strain across column at N=206 for specimen 4

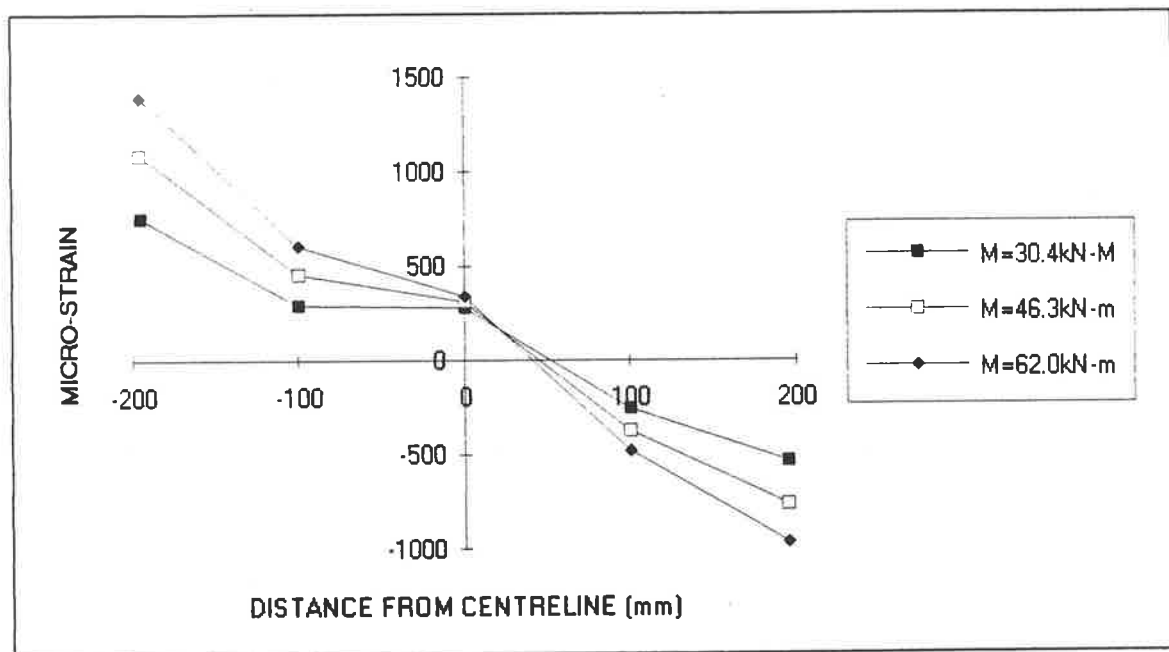
Figure 5.29 Strain across column at $N=483389$ for specimen 4

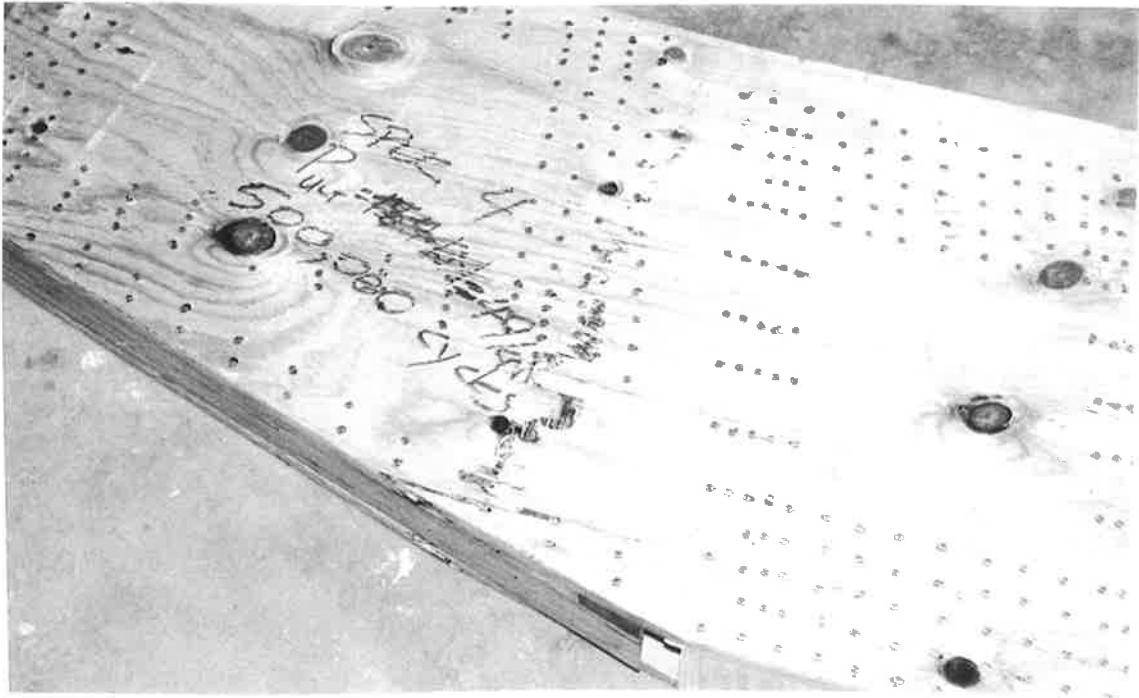
Figure 5.30 Failure mode of specimen 4

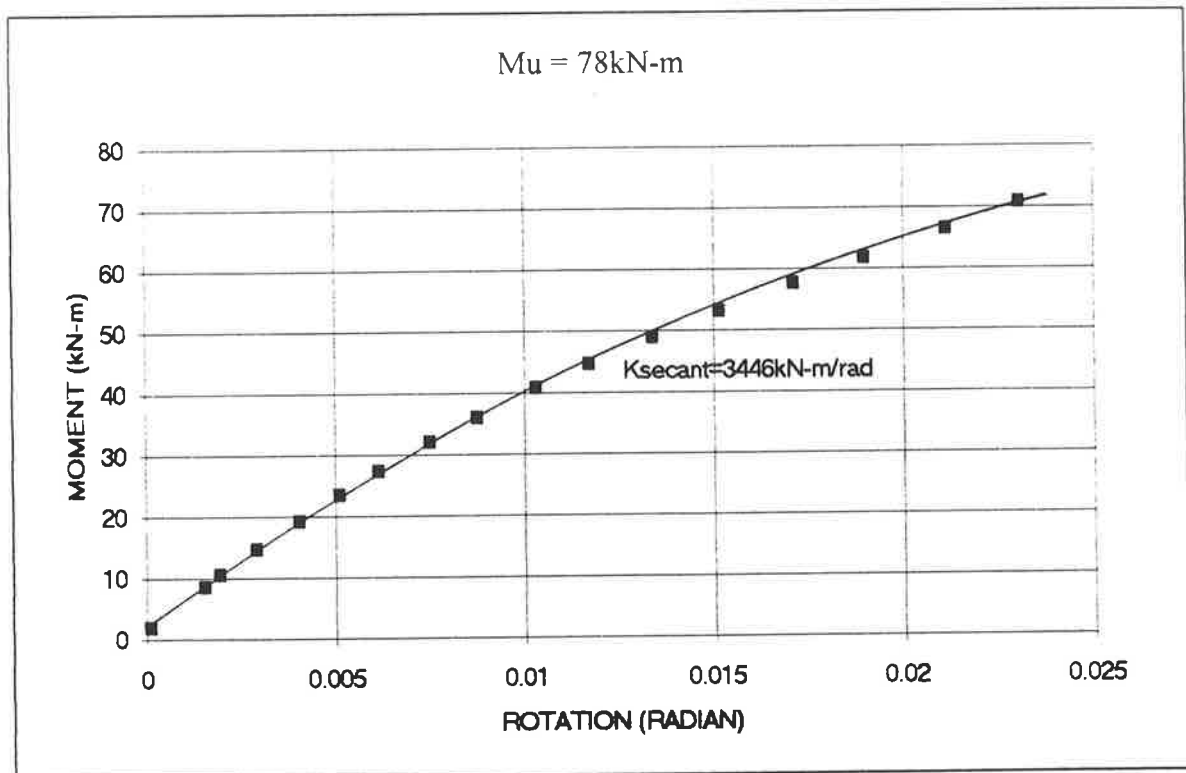
Figure 5.31 Moment vs rotation for specimen 5
(static test to failure)

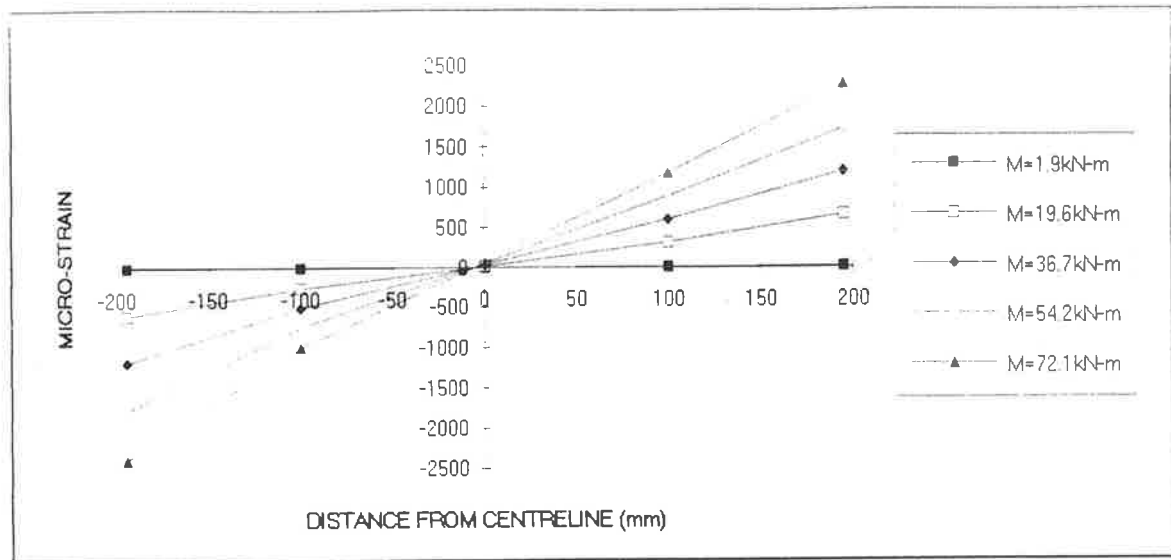
Figure 5.32 Strain across rafter for specimen 5

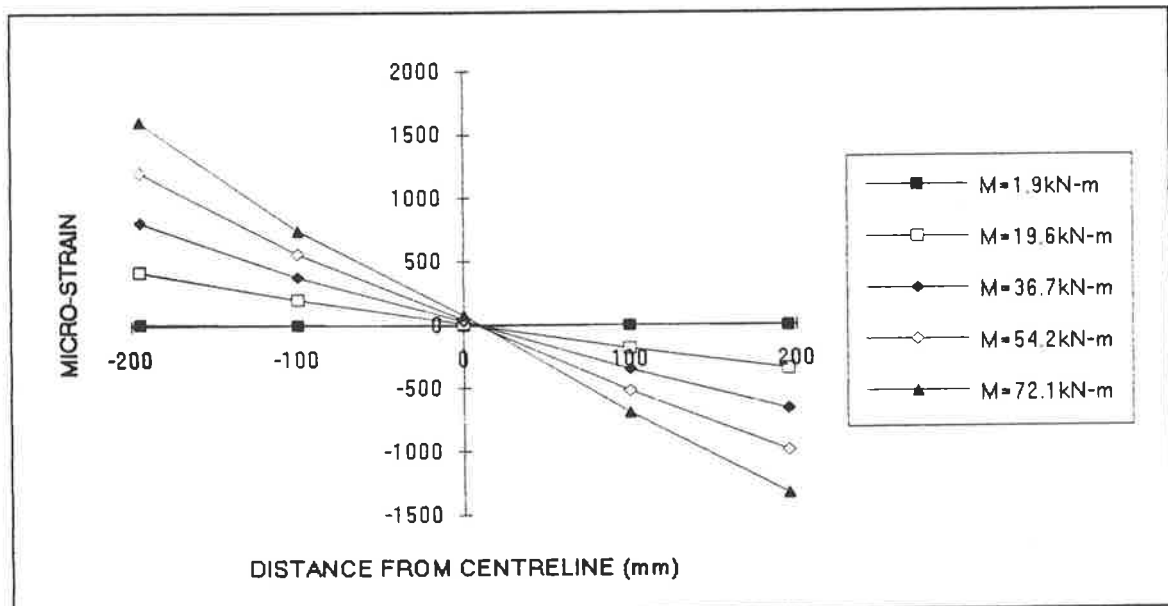
Figure 5.33 Strain across column for specimen 5

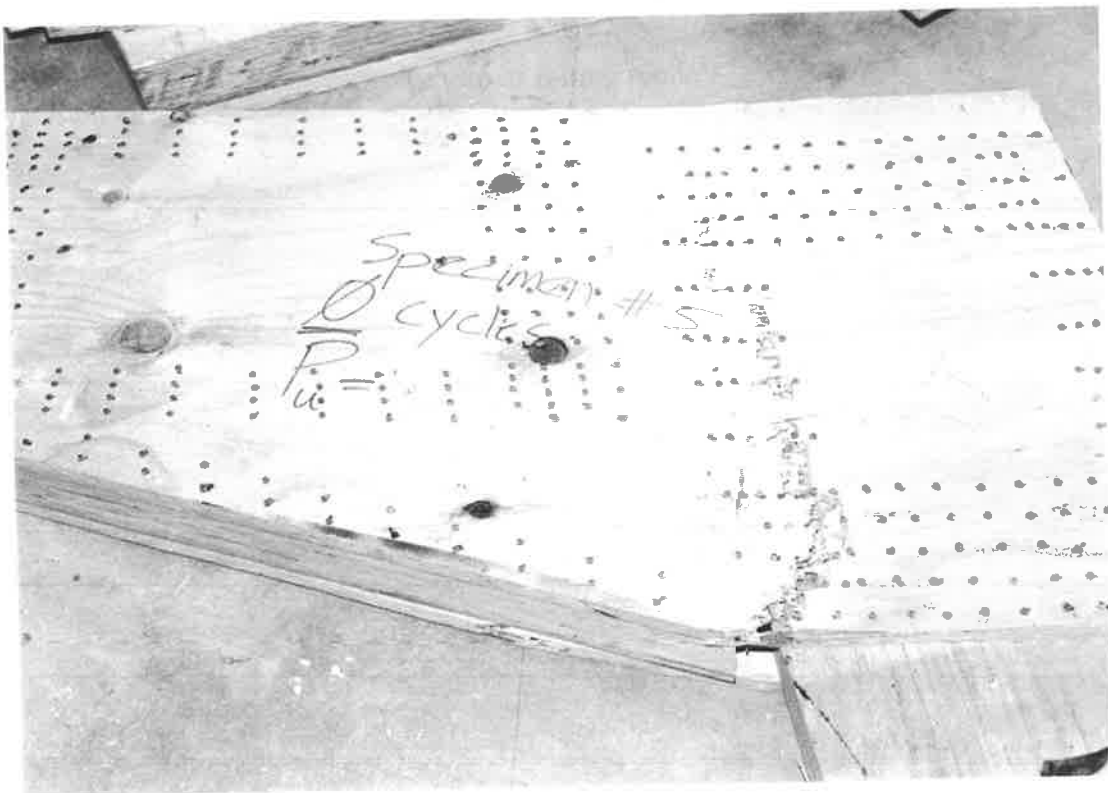
Figure 5.34 Failure mode for specimen 5

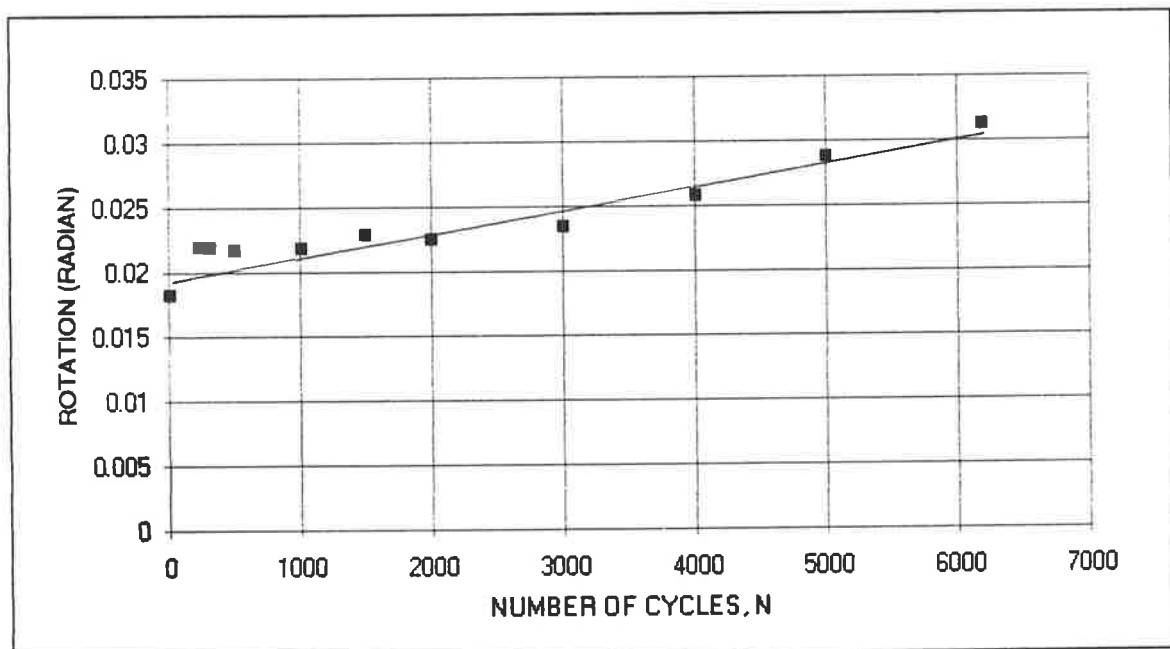
Figure 5.35 Rotation at 44kN-m vs number of cycles for specimen 6

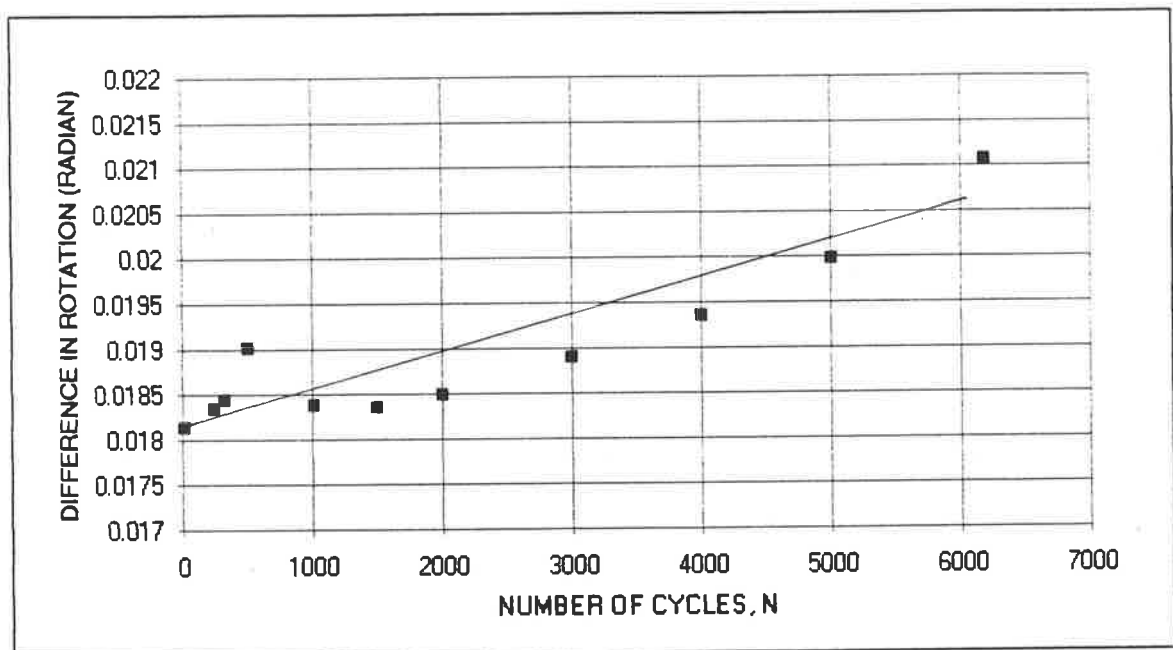
Figure 5.36 Difference in rotation vs number of cycles for specimen 6

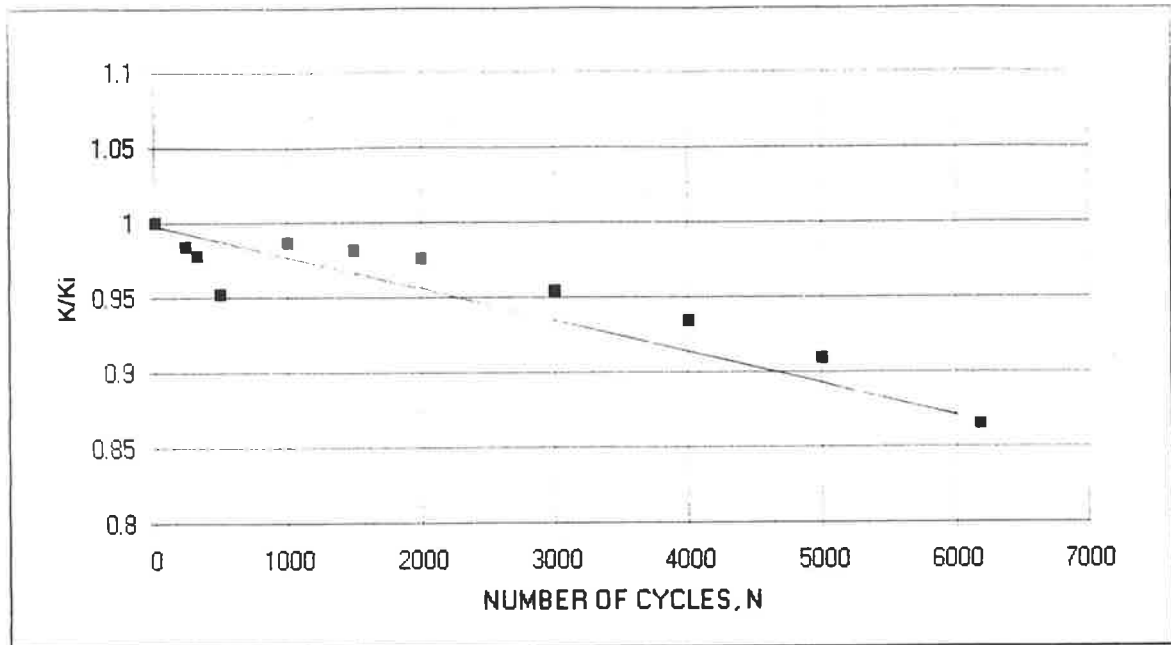
Figure 5.37 Stiffness vs number of cycles for specimen 6

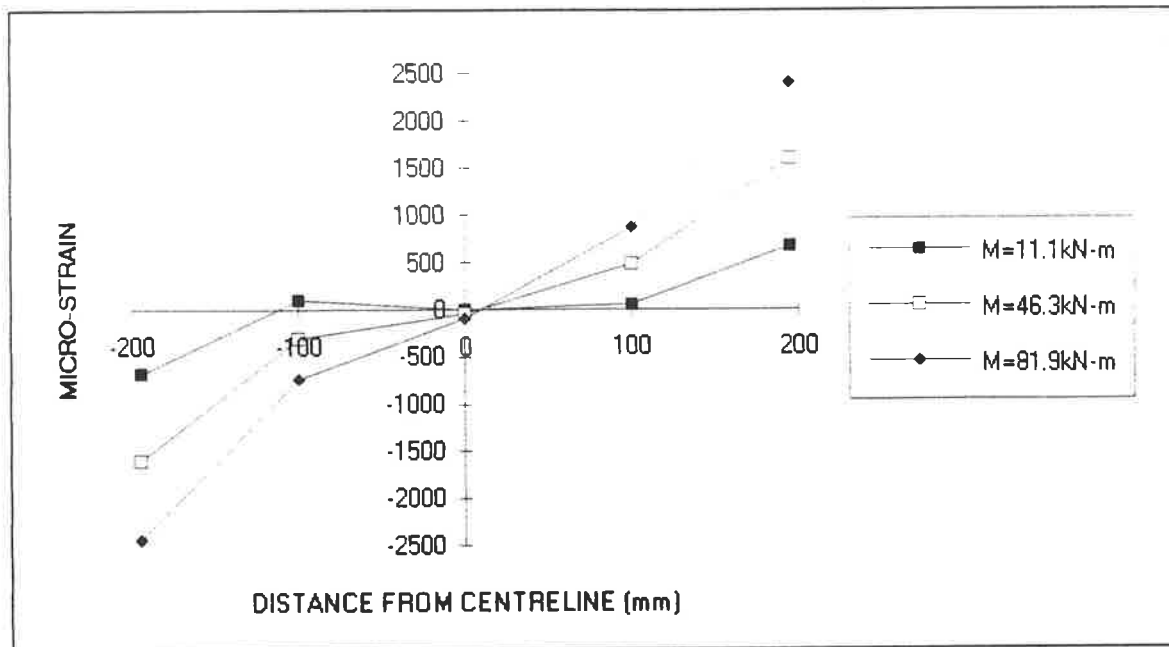
Figure 5.39 Strain across rafter at $N=6182$ for specimen 6

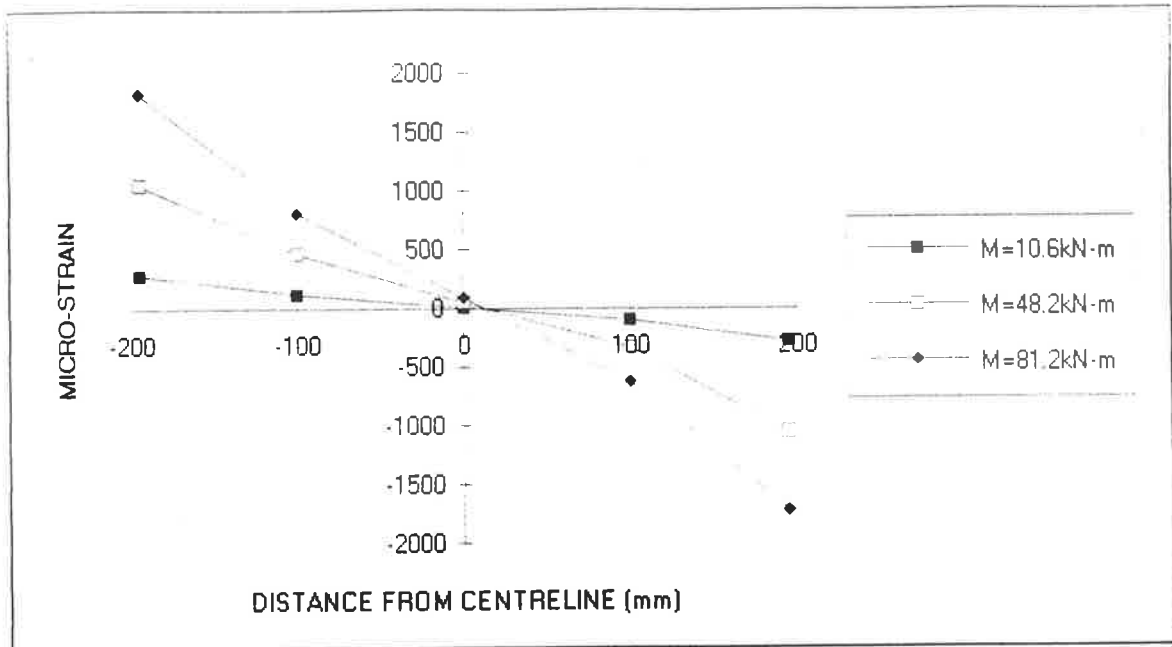
Figure 5.40 Strain across column at $N=10$ for specimen 6
