**PRELIMINARY STUDY OF FATIGUE BEHAVIOUR
OF TIMBER MOMENT RESISTING JOINT**

Thesis presented for the degree of
Master of Engineering Science
at the University of Adelaide
Australia

-August 1995-

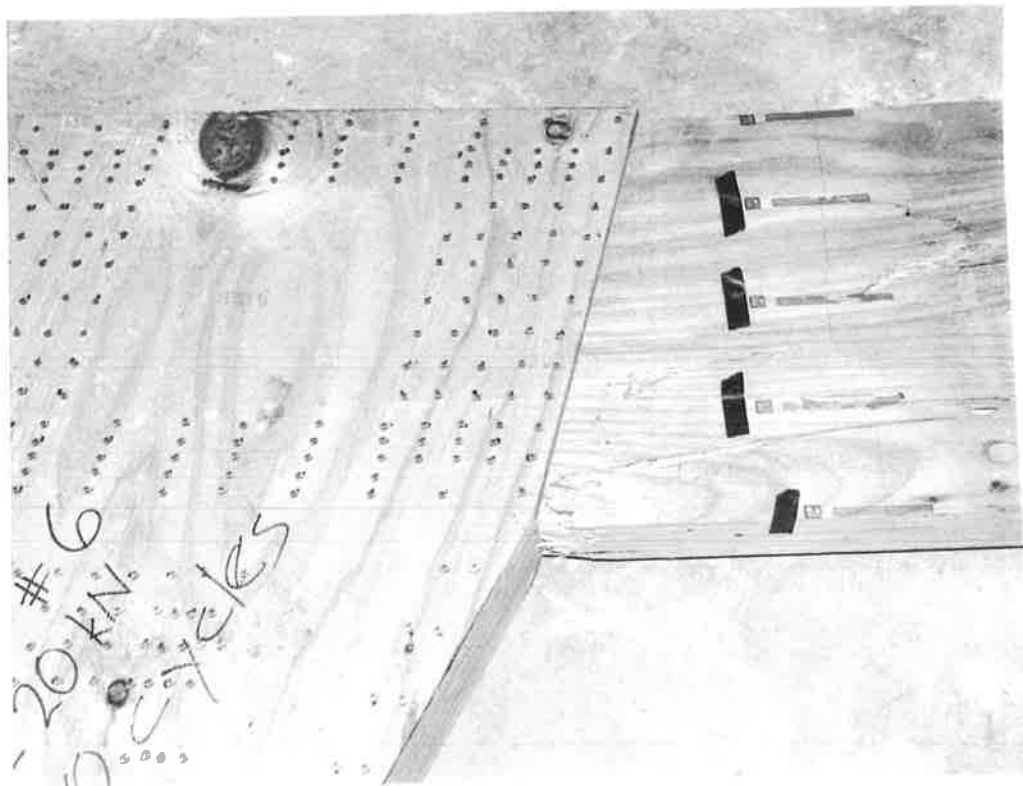
Figure 5.42 Failure mode of specimen 6

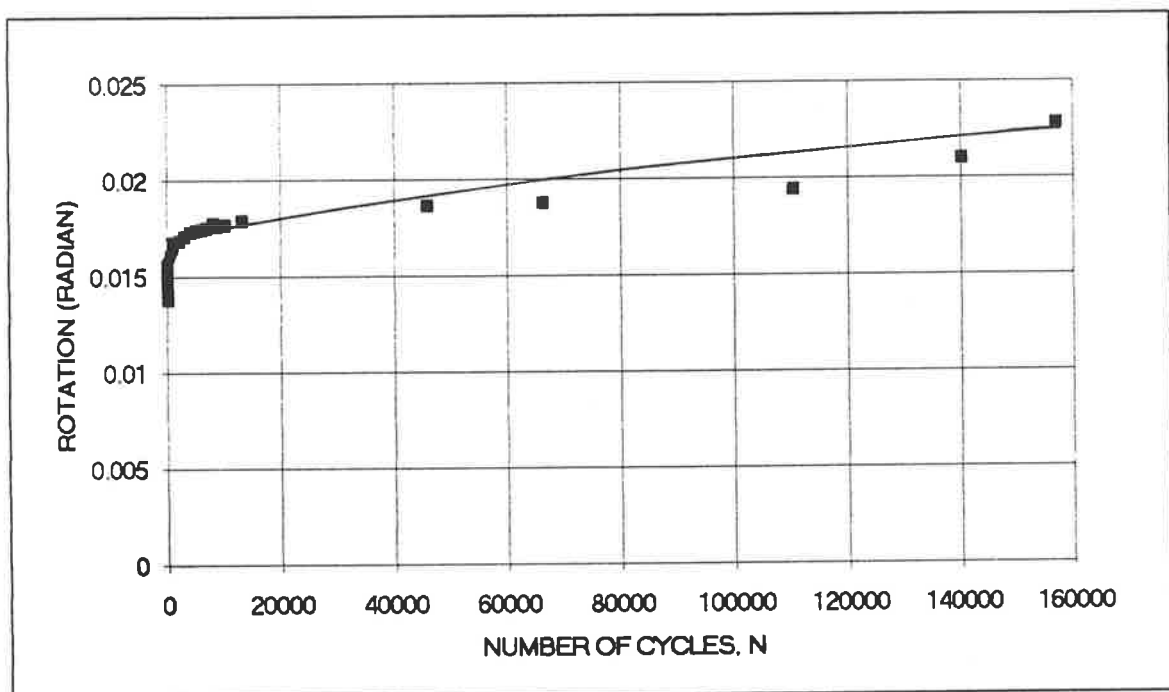
Figure 5.43 Rotation at 44kN-m vs number of cycles for specimen 7

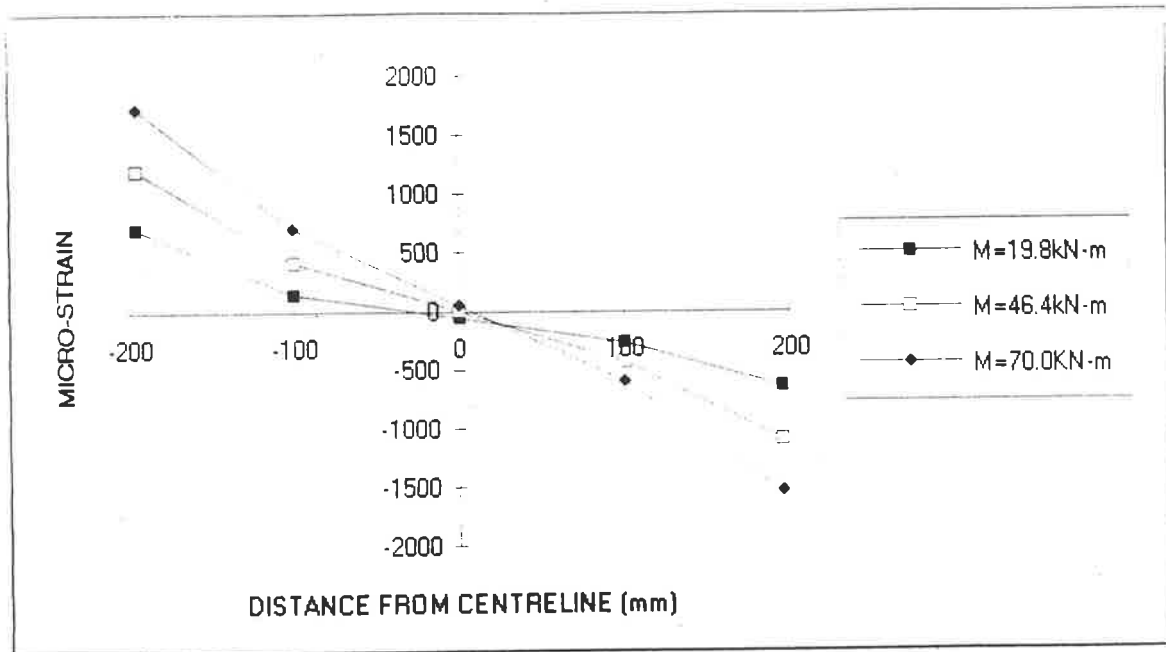
Figure 5.47 Strain across column at $N=157028$ for specimen 7

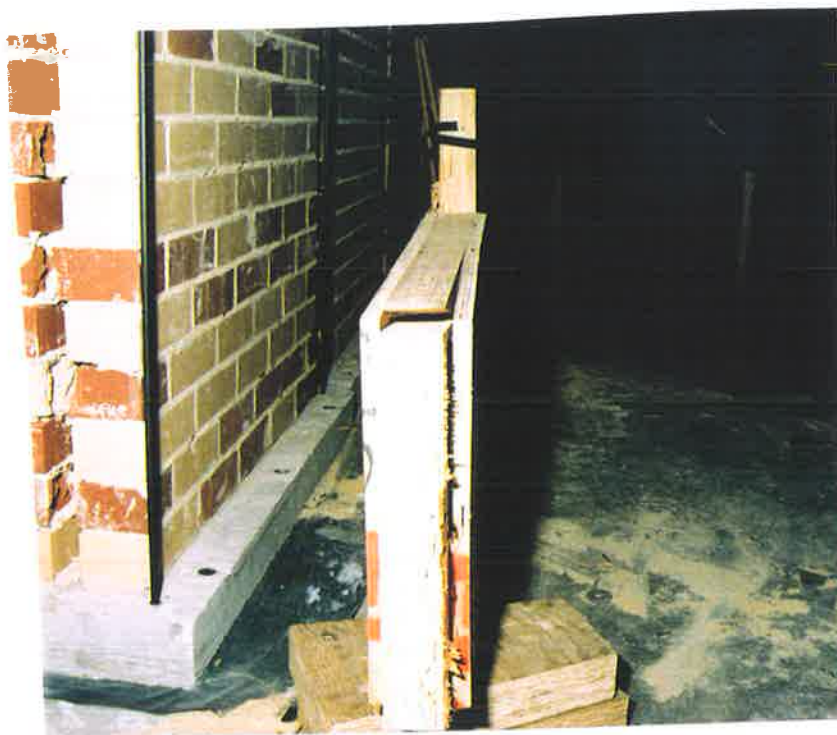
Figure 5.48 Failure mode of specimen 7

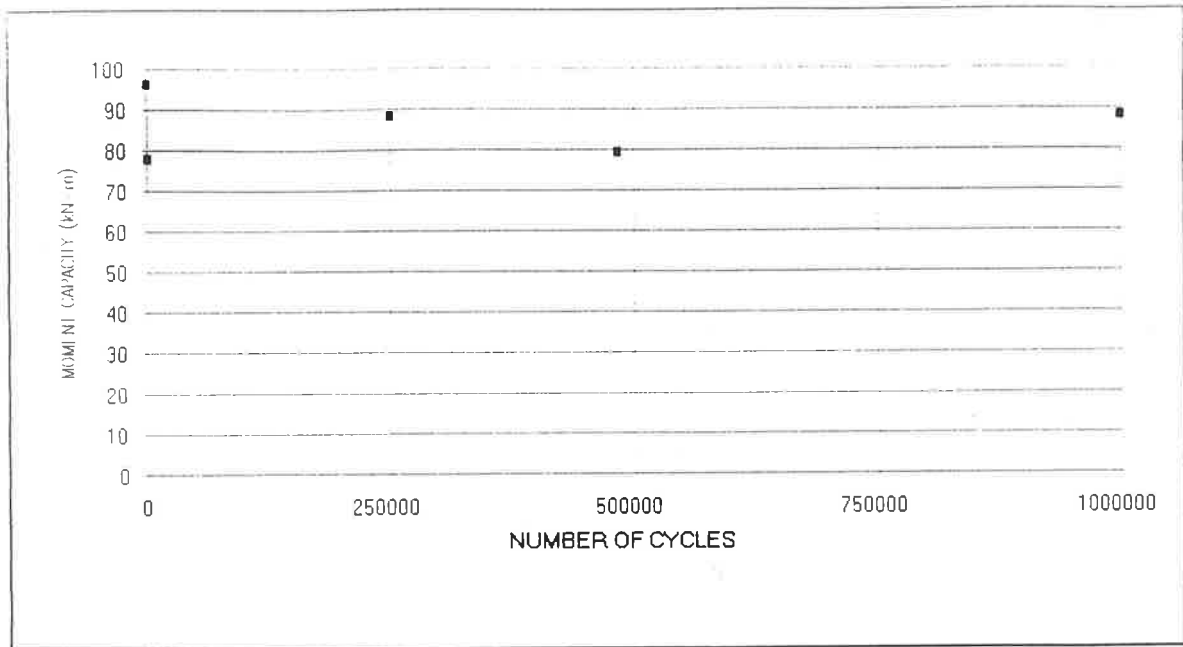
Figure 5.49 Residual strength vs number of cycles

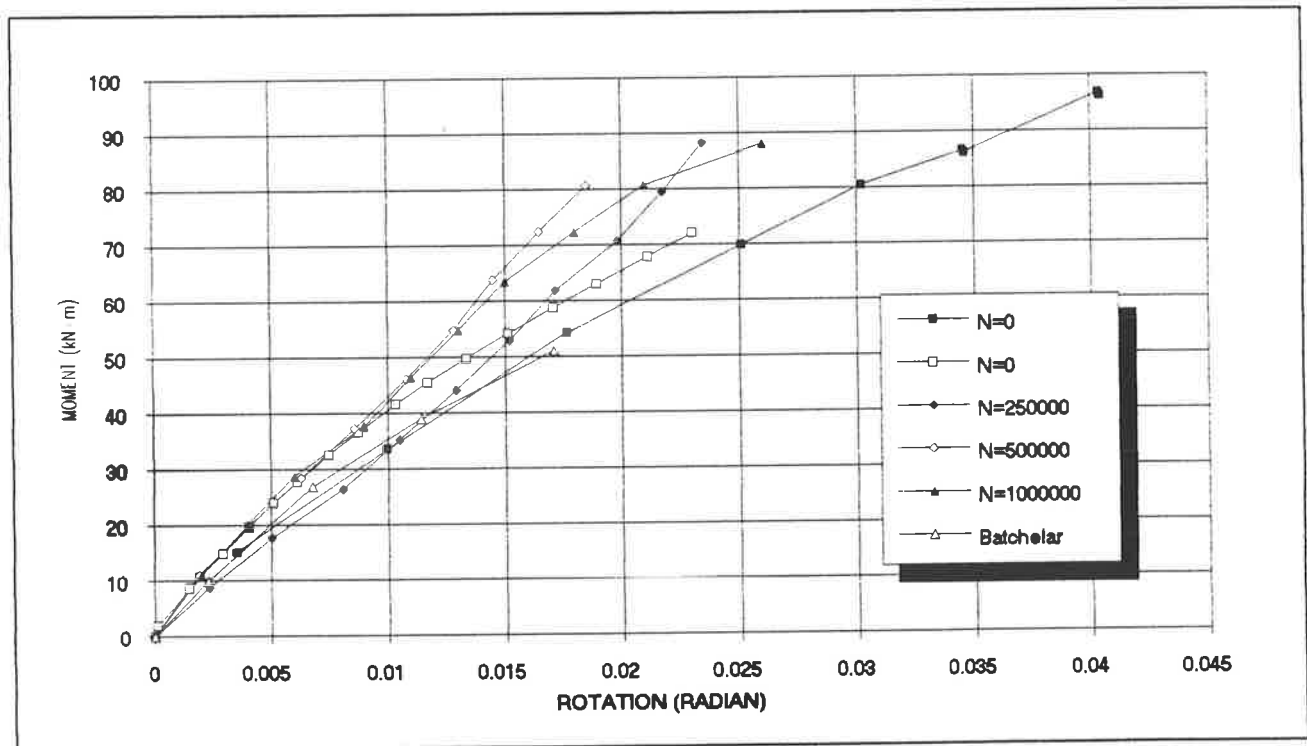
Figure 5.50 Moment vs rotation for all specimens

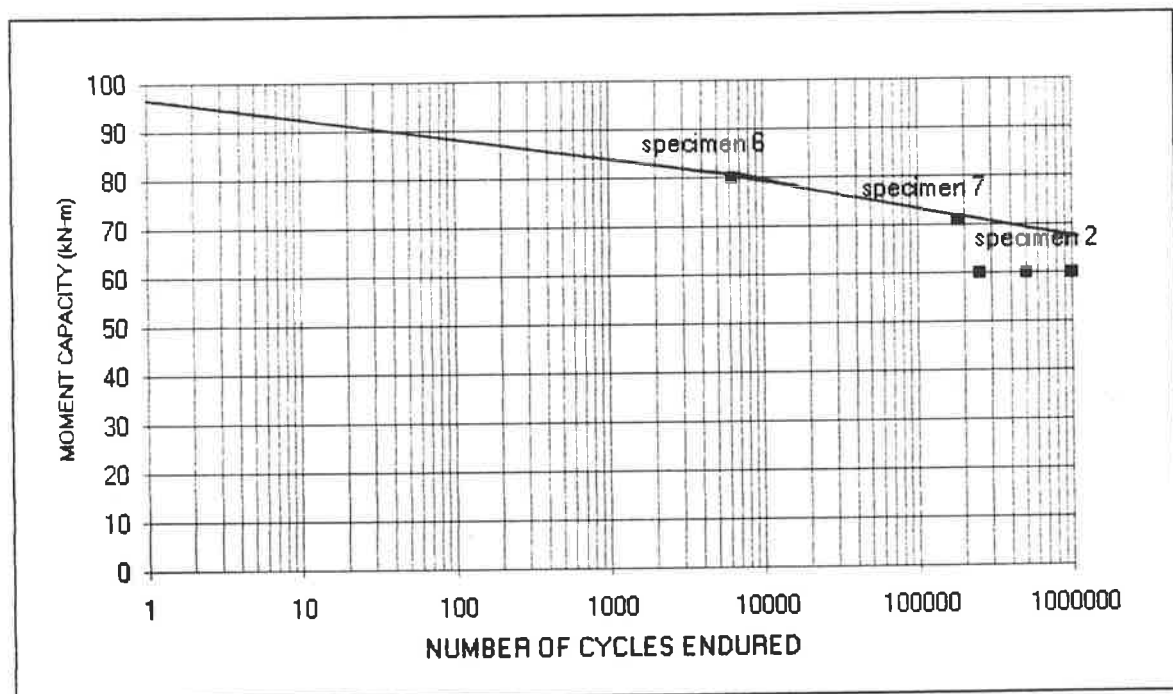
Figure 5.51 Endurance limit at different loading magnitude

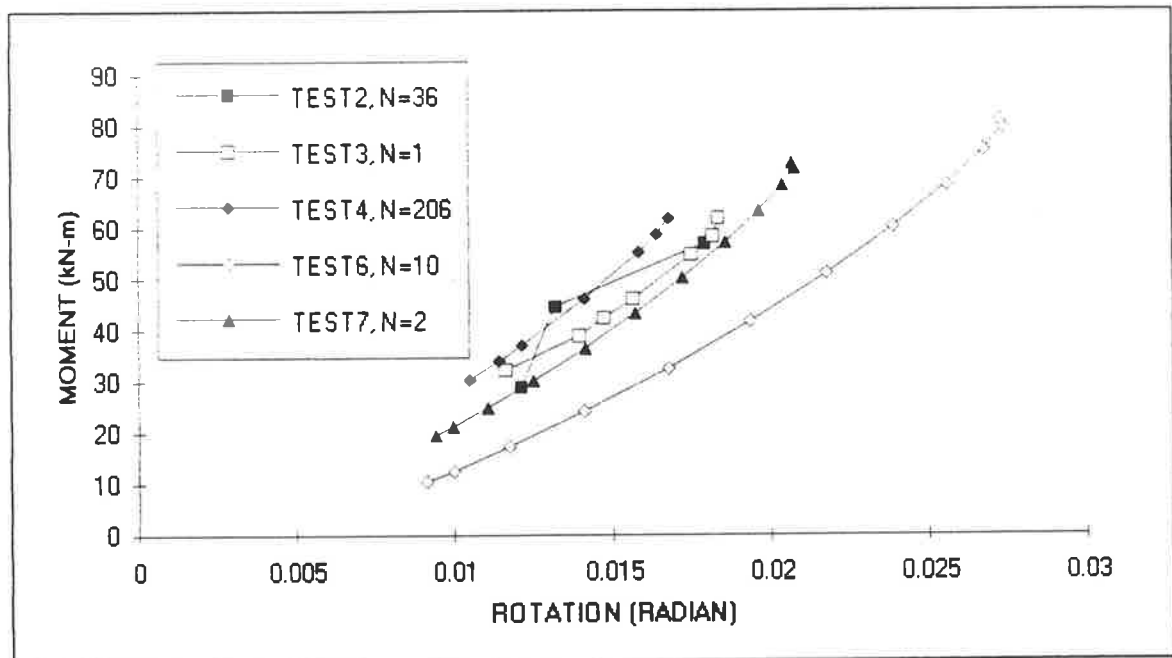
Figure 5.53 Moment vs rotation at initial cycles

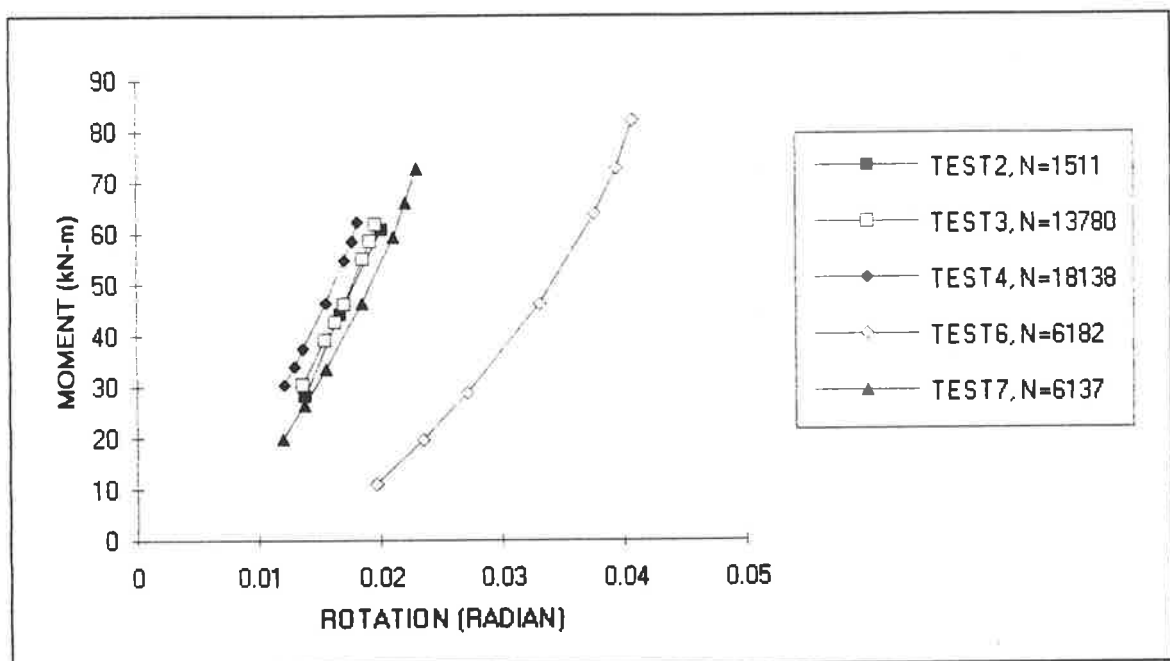
Figure 5.54 Moment vs rotation at certain number of cycles

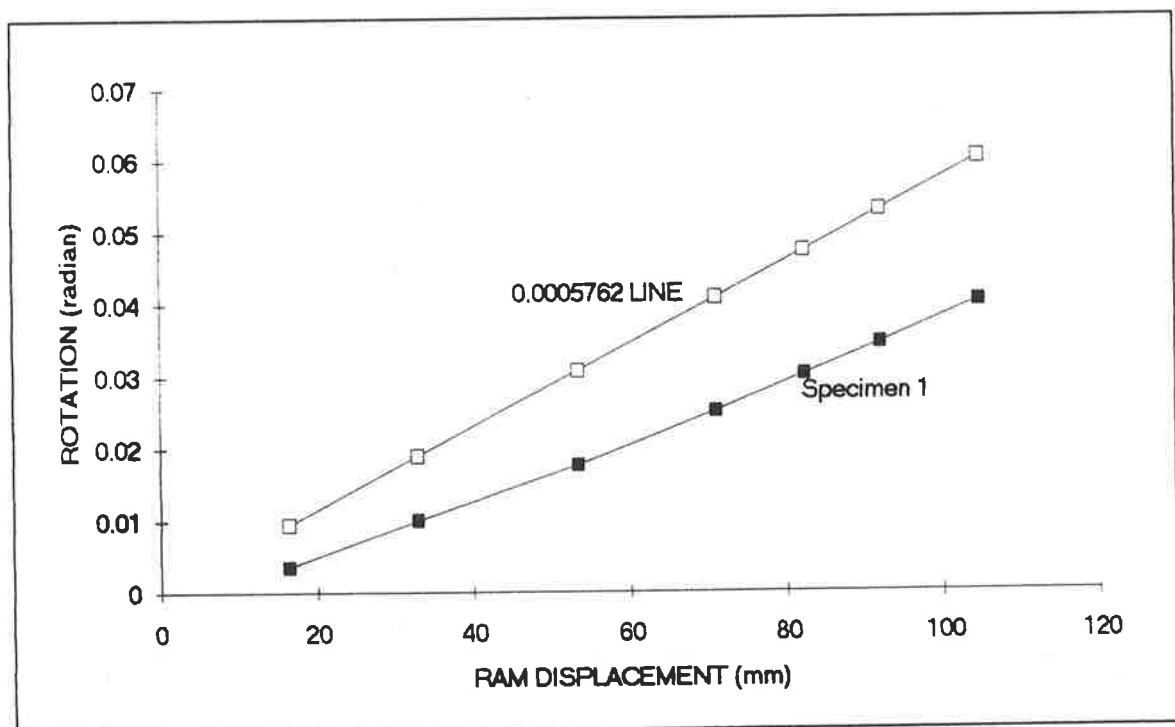
Figure 5.56 Rotation vs ram displacement for specimen 1

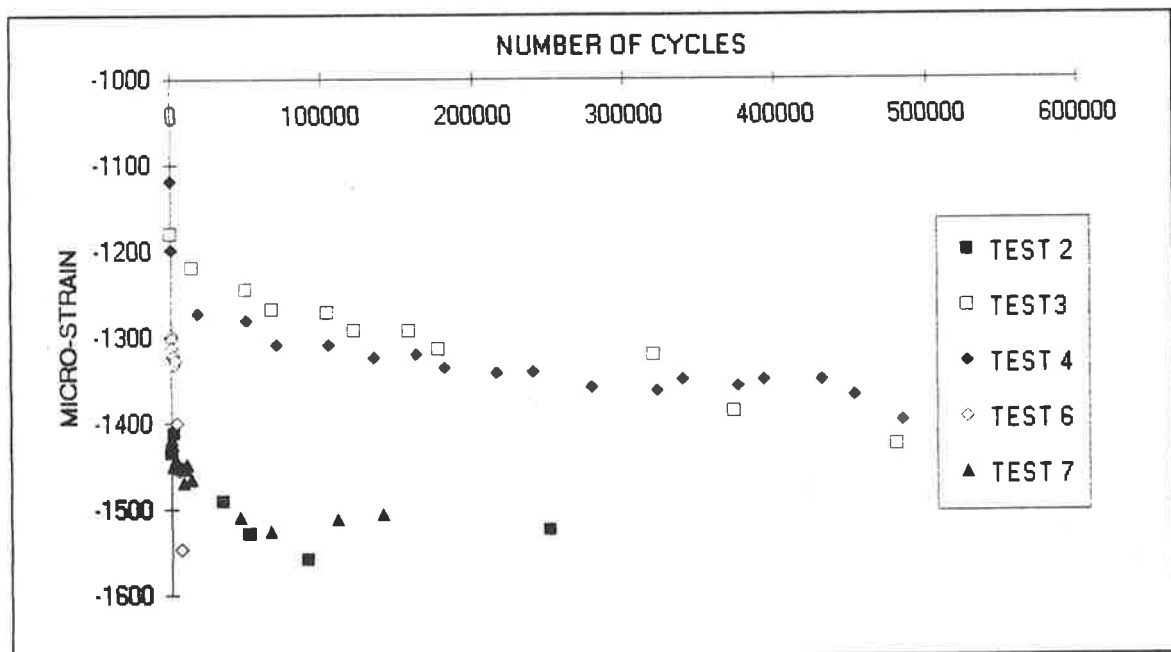
Figure 5.58 Strain vs number of cycles for all specimens

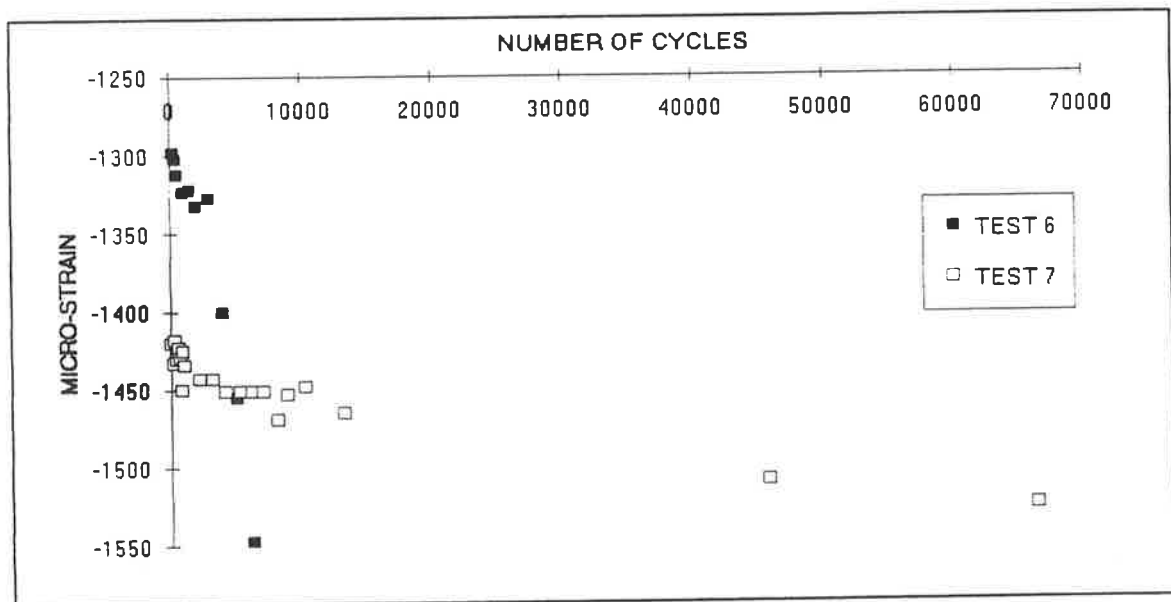
Figure 5.59 Strain vs number of cycles for specimens 6 & 7
