FIELD TESTING OF VINTAGE MASONRY: MECHANICAL PROPERTIES AND ANCHORAGE STRENGTHS

Burton, C., Visintin, P., Griffith, M., Vaculik, J.

Accepted manuscript, published version at: Burton, C., Visintin, P., Griffith, M. and Vaculik, J., 2020, December. Field testing of vintage masonry: Mechanical properties and anchorage strengths. In *Structures* (Vol. 28, pp. 1900-1914). Elsevier.

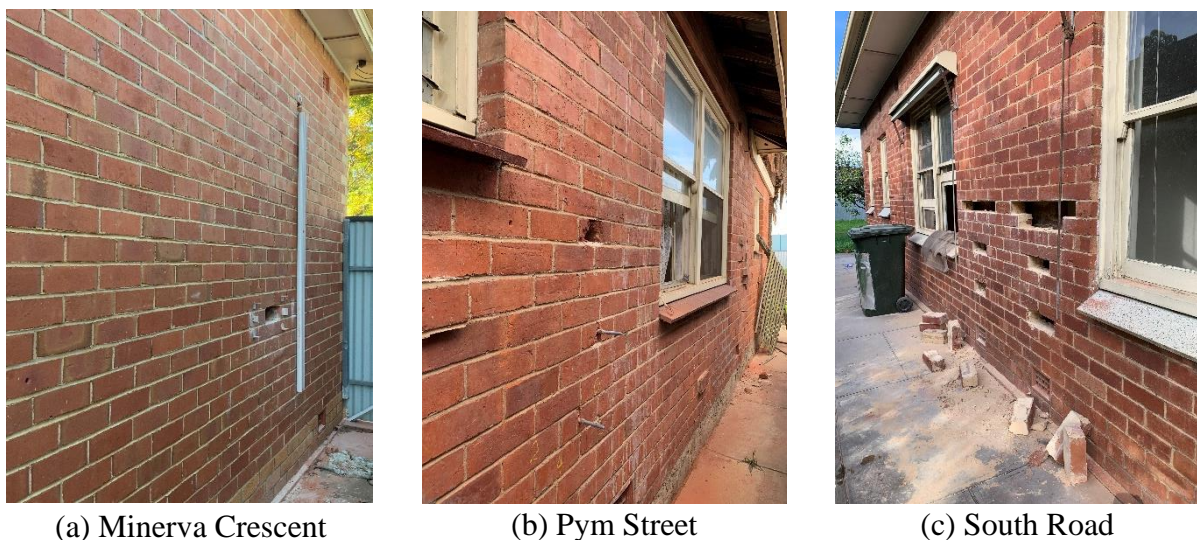
Figure 1 – Typical masonry at each site

1), are designated according to their locations (MC: Minerva Crescent, PS: Pym Street and SR: South Road) and are of double-clay-brick masonry construction using lime mortar. The sites were selected as they represented older, (vintage) masonry having been built using moulded (sandstock) bricks that were solid or frogged; these differing from more modern bricks which are commonly extruded, cored and fired at higher temperatures. The house at PS was constructed exclusively with solid (un-frogged) bricks, SR was from frogged bricks and MC exhibited a mixture of frogged and un-frogged. A typical frogged masonry unit (recovered from PS) with its nominal dimensions is shown at Figure 2.

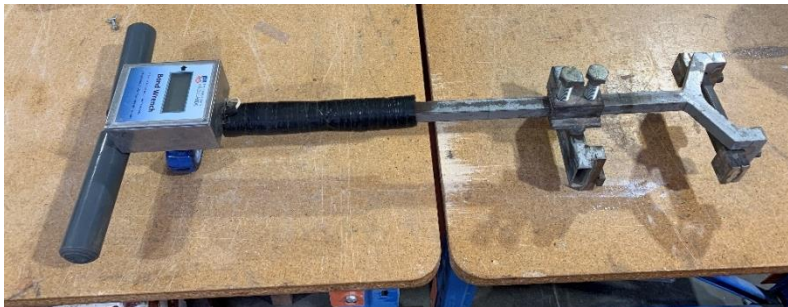
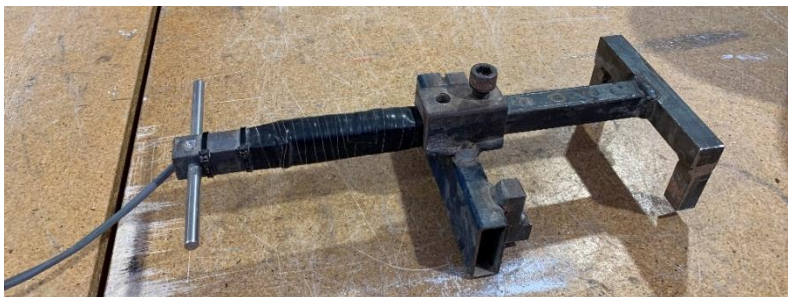
(a) – Schematic layout

(b) – Unit 1 with arm length 900 mm

(c) – Unit 2 with arm length 300 mm

Figure 4 – Bond wrench

To quantify the associated mechanical properties of the masonry the bond tensile strength was measured through bond wrench tests conducted according to AS3700 Masonry structures (Standards Australia 2018) at locations at similar heights and on the same walls on which the anchor tests were conducted (see Supplementary Material for locations). Figure 4 shows a schematic configuration of the typical unit and also the two units that were used in this research. Both units are instrumented with strain gauges to allow direct determination of the applied load, and hence moment with Unit 1 using a direct readout of applied load. The length of the lever arm and weight of Unit 1 precluded its use on the weaker masonry as the self weight and consequently applied moment would fail the joints before additional load was applied. To overcome this difficulty, Unit 2, with a much shorter lever arm was used. These tests were specifically undertaken close to the anchor pull out tests to minimise variations in the masonry, but removed from them at least two bricks distant to minimise any latent damage there may be to the mortar joints from those tests.

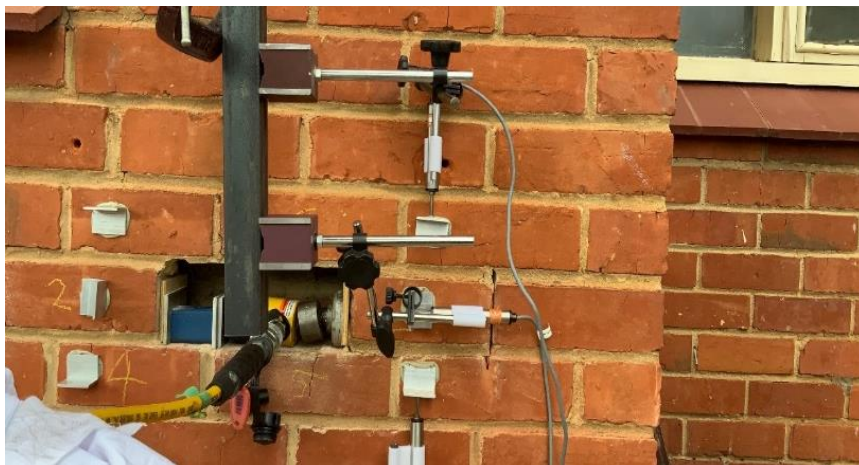
(a) Schematic layout

(b) Photograph after testing

Figure 5 – Simplified in-situ shove test

In this simplified configuration, (shown in Figure 5) the “test unit” deflects elastically as load is applied from the hydraulic ram until the shear capacity is reached, either through failure of the mortar, failure of the bond between the mortar and the test unit, or a combination of the two. During this elastic phase and the subsequent plastic displacement until the test is terminated, friction and dilation (vertical displacement of the units above and below the test

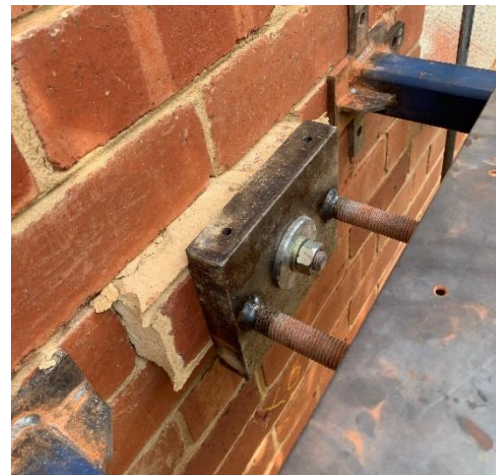
(a) Schematic layout

(b) Photograph during test

Figure 6 – Brick pull-out test

was trialled here at each of the sites with the test locations shown in the Supplementary Material. For this test, a stiff reaction frame (shown in Figure 6); the same as that used for the anchor pull out tests was used, but the configuration incorporated a steel backing plate with dimensions 200 mm wide x 50 mm high, approximating but smaller than those of the masonry unit mounted on a 16 mm diameter through bolt onto the back of the wall, in lieu of the chemical anchor. This configuration allowed the backing plate to bear entirely on a single brick without overlap which was then reacted against the puller plate bolted to the through bolt using a 1000 kN hydraulic ram reacting against the frame and the thrust plate bolted to the load transfer mechanism with the applied load measured using a pressure transducer located at the manual hydraulic pump. The lateral movement of the brick relative to the surrounding masonry was measured using a single 100 mm travel LVDT supported independently of the wall and reaction frame, measuring on the thrust plate. Dilatancy was not measured in these tests. By using a reaction frame with close centres, it was possible to extract a single masonry unit “squarely” from the masonry, with a typical “extraction” demonstrating the efficacy of the method shown in Figure 6 (b). The tests which were undertaken involved extraction of a brick from the outer leaf of the wall which was a minimally invasive procedure externally, but an opening was required through the internal leaf to allow the backing plate to be attached.

peak stress with an associated softening and that there is an on-going, albeit reducing capacity over a significant displacement and that the peak for the tests has occurred at a similar displacement suggesting repeatability. For all of the tests undertaken, the failure mode was extraction of a single masonry unit with no damage to the surrounding wall (see Figure 6b).

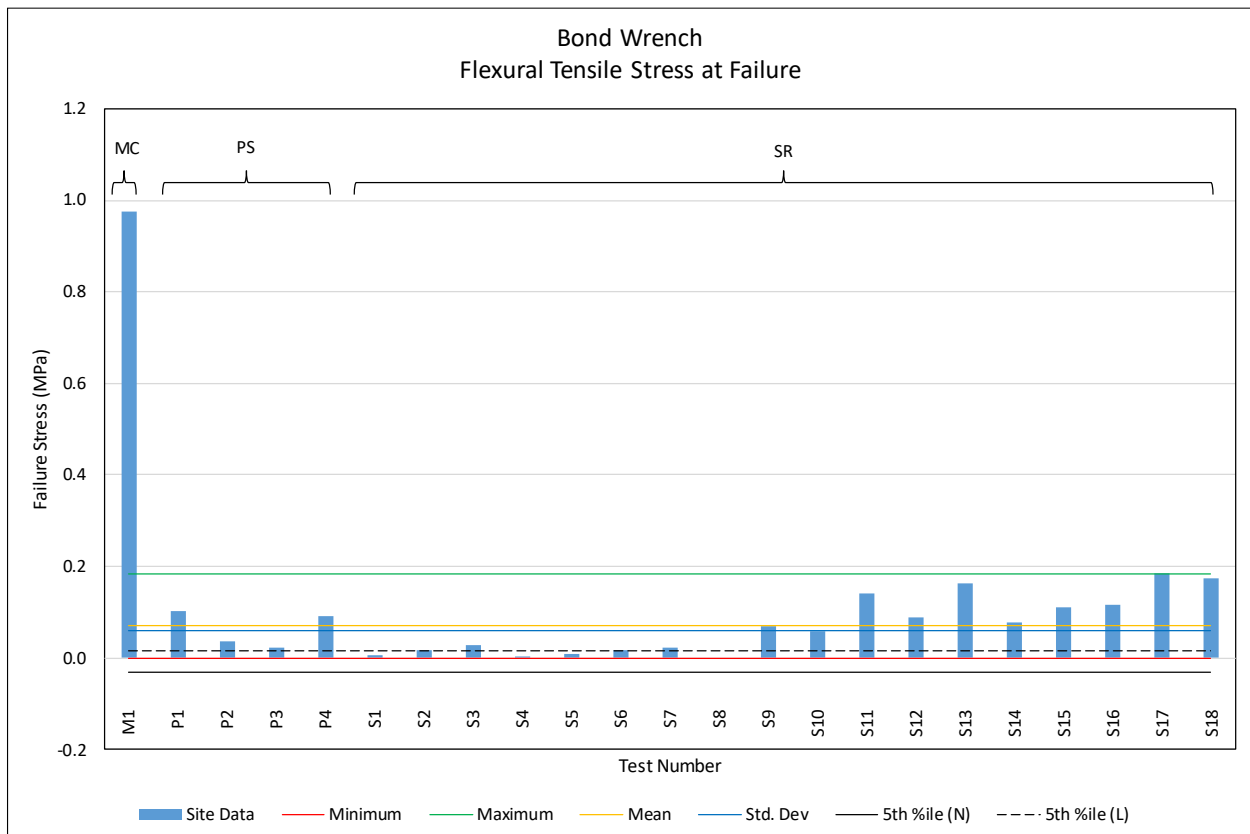
Figure 7 – Bond wrench test results

The bond wrench test was undertaken at each site and the data and statistics for each site and for the aggregated data is shown in Table 3 and the data and aggregated statistics are shown graphically in Figure 7. A number of the bond wrench tests were abandoned as a result of either the bed joint failing during the removal of the adjacent bricks and perpend or during installation of the bond wrench tool after preparation of the test brick and these have been excluded from the data set and the analysis. In addition, the M1 (MC Test 1) result was excluded as it was more than 15 standard deviations from the mean and was considered an outlier.

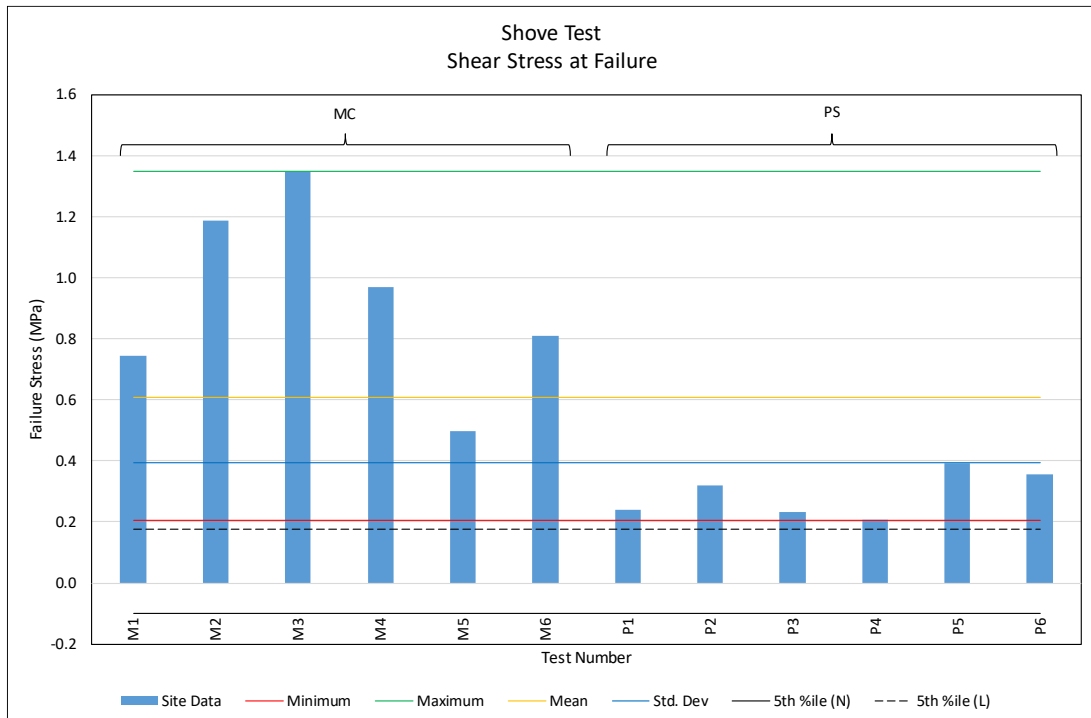
Figure 8 – Shove test results

Figure 8 summarises the results for the shove tests undertaken at MC and PS while the data and distribution statistics are shown in Table 4. The results for the individual sites are not as variable as those for the bond wrench test but still display a considerable coefficient of variation, although the 5th percentile values for the individual properties accord to the extremes of values published for designers in AS3700. Assuming that the data is normally

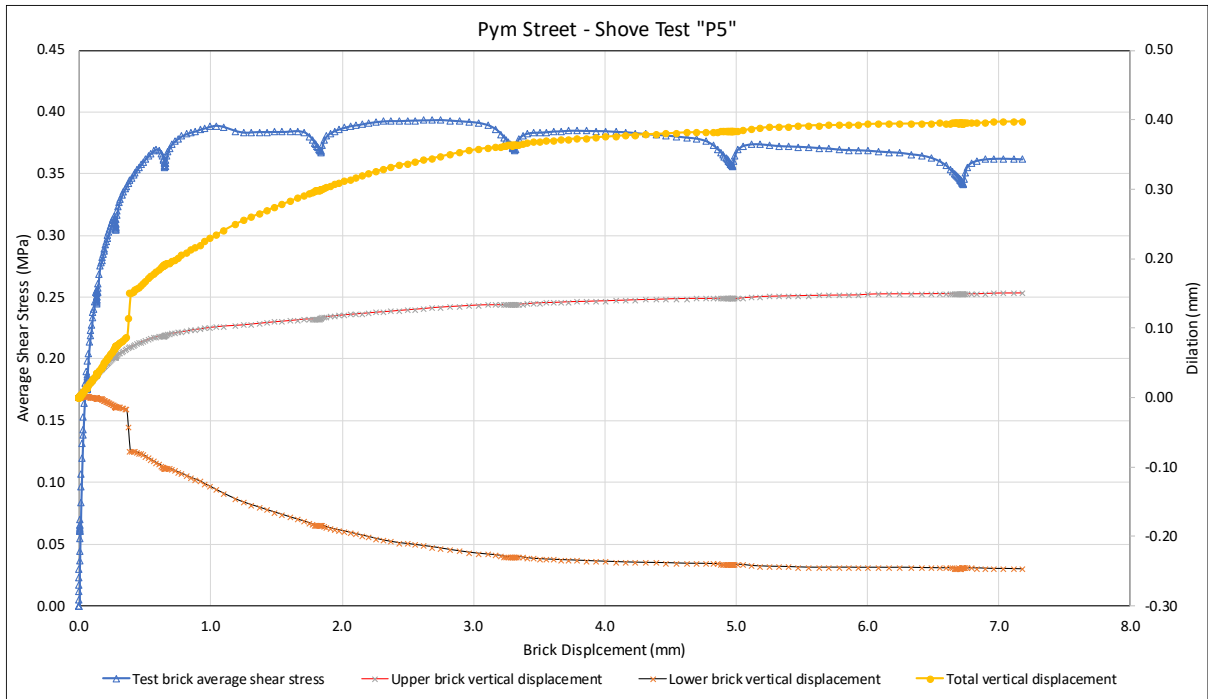
(a) Test P5

(b) Test P1

Figure 9 - Shove test dilatancy – (PS)

In addition to these issues, the test results can be difficult to interpret. Figure 9 (a and b) show the result of two discrete shove tests conducted on PS. The test depicted in Figure 9(a) (test P5) shows progressive dilatancy and longitudinal displacement up to close to peak load where a step is noted in the downward displacement (likely linked to the initial failure of the lower bed joint) with an associated flattening of the upward displacement, which is then followed with progressive “opening up” (increasing overall dilation) of the masonry until the experiment was terminated. It is suggested that the increasing overall dilation is a result of top and bottom faces of the test brick not being parallel, forming a small wedge, but this was not measured. Note that the downward “dips” which show particularly in the plot of longitudinal displacement are associated with cycling of the manual hydraulic pump as load was measured with a pressure transducer rather than a load cell.

The test P5 in Figure 9(a) was conducted centrally in a long section of wall whereas test P1 (Figure 9b), performed with the same apparatus by the same operators was conducted closer to one end of a different wall. Initial loading of the test brick in Figure 9(b) shows an upward displacement of the upper brick, and a downward displacement of the lower brick, but following initial failure, a significant drop of the upper courses can be observed. At the same time, the lower courses are seen to be moving upwards and that the combined displacement is also upwards over the majority of the test.

Inspection of the wall following the test revealed no observable signs that the wall, or part of the wall had failed locally around the test site and there was insufficient instrumentation to measure global wall movements. It is surmised however that having the test ram angled

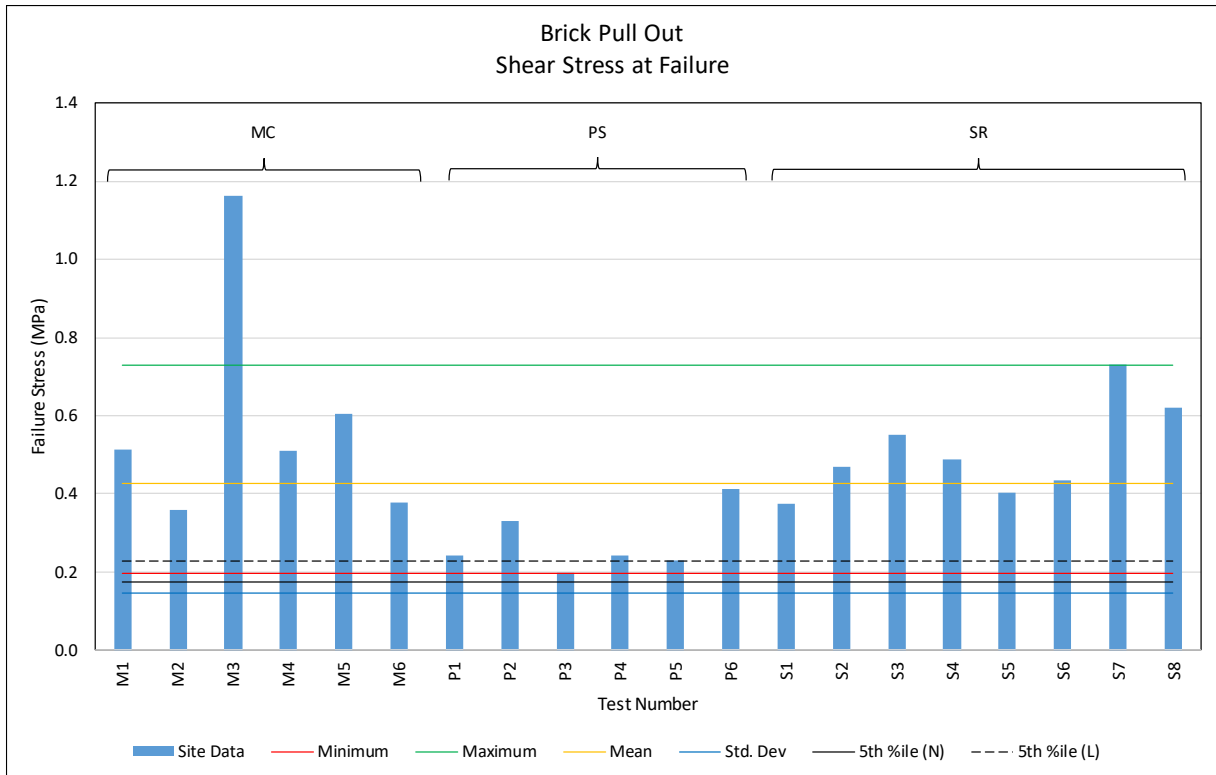
Figure 11 – Brick pull-out test results

Six each of these tests were conducted at MC and PS, and eight at SR with the data and statistics for the tests shown in Table 5 and Figure 11, and three typical stress vs displacement plots shown in Figure 12. This (Figure 12) shows that there is a well-defined

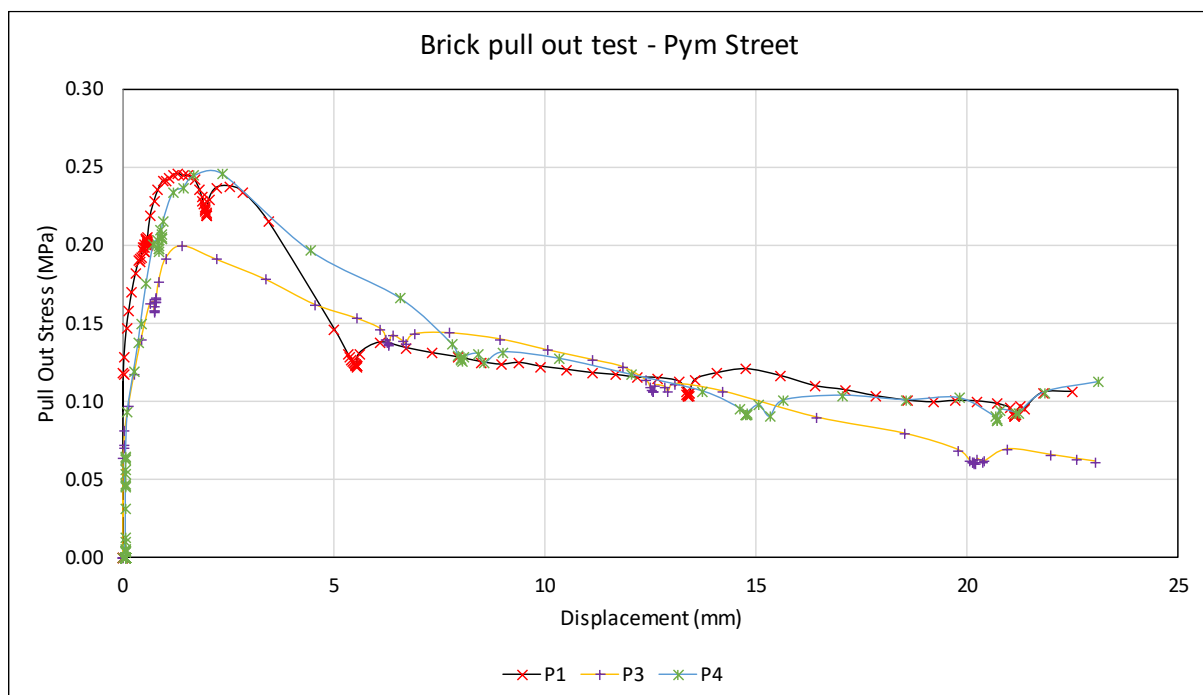
Figure 12 – Brick pull-out – stress vs displacement

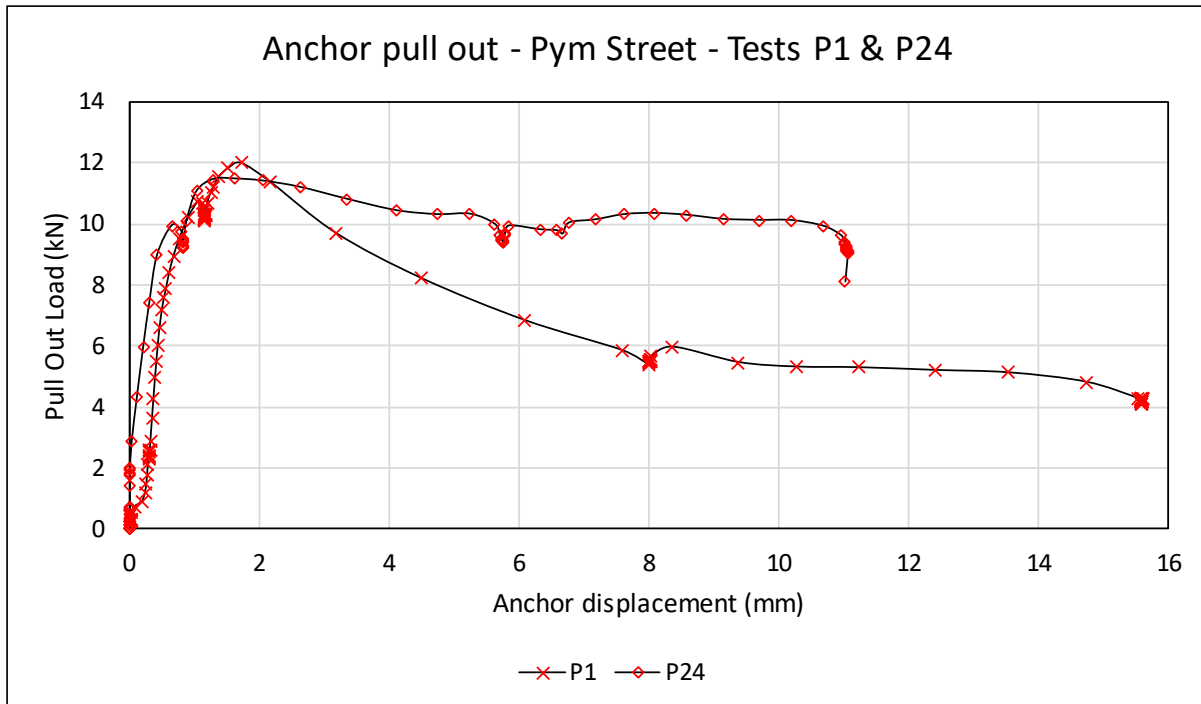
Figure 15 – Typical anchor load vs displacement - PS

consistently demonstrated some degree of ductile behaviour by continuing to provide useful load capacity/resistance at displacements well in excess of the displacement at peak load as shown in Figure 15 and as can also be seen in Figure 15, the displacement to failure is relatively linear with respect to applied load, and similarly after failure as the load capacity reduces. Additional data showing anchor displacement at peak load capacity and anchor capacity at the maximum measured displacement for MC and PS are shown in Table 8. The maximum displacements shown in Table 8 were limited to the available travel of the hydraulic ram or the LVDT used to measure the displacement and so do not reflect complete anchor extraction. Note that there are no details for SR as displacement measurements were not taken at this site.
