Structures, 2021; 34:901-930

LABORATORY INVESTIGATION OF PULL-OUT CAPACITY OF CHEMICAL ANCHORS IN INDIVIDUAL NEW AND VINTAGE MASONRY UNITS UNDER QUASI-STATIC, CYCLIC AND IMPACT LOAD

Burton, C., Visintin, P., Griffith, M., Vaculik, J.

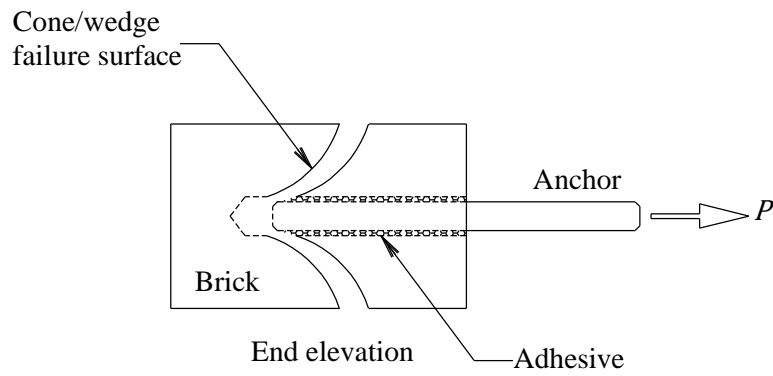
(c) – Cone or wedge type failure

Cone/wedge failure: When considering cone/wedge failure (Fig. 1c), analysis typically follows that of punching shear failure in concrete assuming the formation of a 45° (or similar) failure cone (e.g. Arifovic and Nielsen 2006, McGinley 2006, Pisani 2016). Unless the mortar strength and the bond strength between mortar and masonry unit is similar to that of the unit itself, (which is generally not the case with clay masonry and lime mortars), masonry is highly non-homogeneous in comparison to concrete. This leads to a truncated cone or wedge type of failure which has been considered in detail by Arifovic and Nielsen (2006) using theory borrowed from anchor failure in concrete.

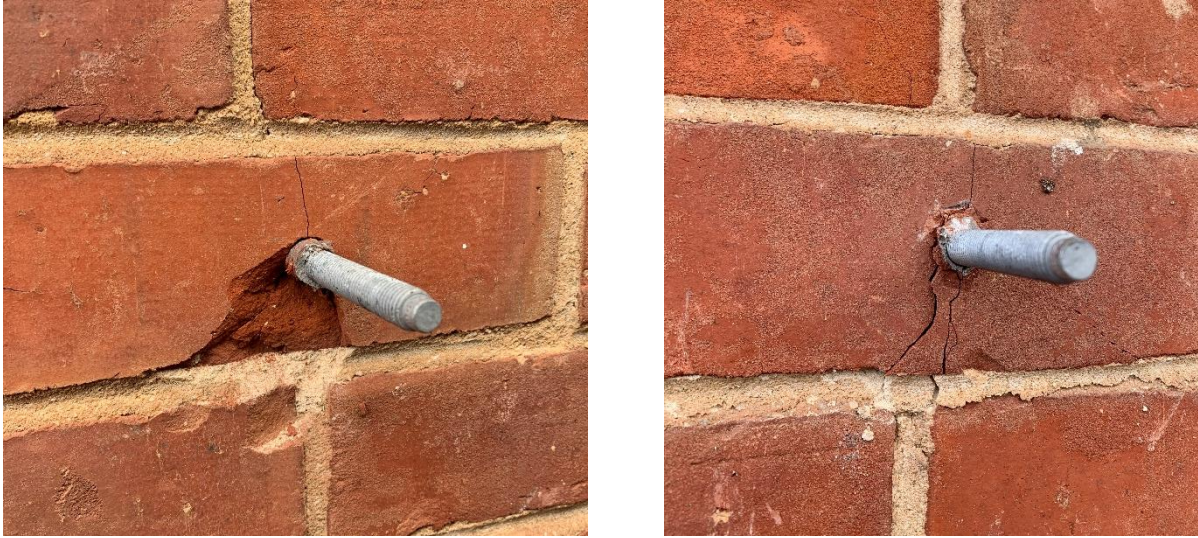
Fig. 4 – Typical anchor pull out splitting failures

Site investigations by Burton et al. (2020) observed that failure of anchorages using chemical anchors in vintage masonry loaded in direct tension was typified by splitting of the brick (refer Fig. 4) rather than a cone or wedge failure. The vertical cracking at the anchor location (mid-length) in the brick is typical of a tension failure caused by horizontal tensile stresses in the brick. These are developed through: (i) wedge stresses associated with roughness of the drilled hole and friction/cohesion between the adhesive and the hole; and (ii) bending stresses associated with applied load from the anchor and the support condition of the individual brick.

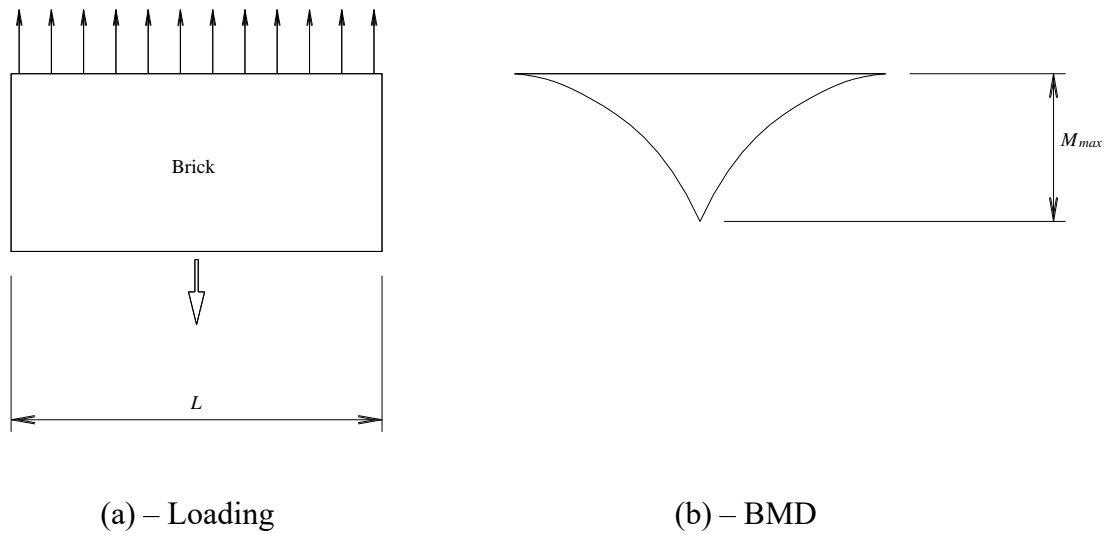
Fig. 10 – Single masonry unit bending moment

$$\sigma_{2-max} = \frac{M_{max}}{Z} = \frac{PL}{8Z} \quad (7)$$

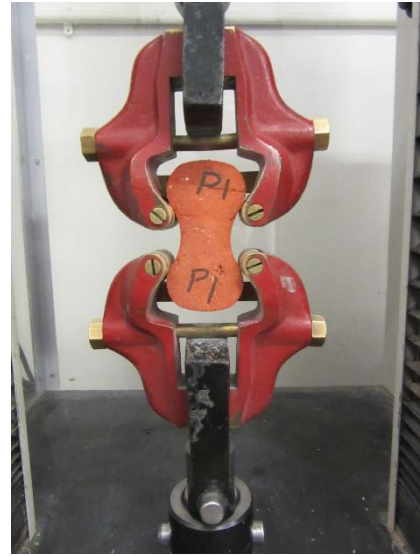
Fig. 14 – Dog bone direct tensile strength test

(a) Schematic layout

(b) Test apparatus

Direct tensile tests were also undertaken to determine the direct (rather than flexural) tensile strength of the brick samples. For this testing, dog-bone shaped specimens shown in Fig. 14(a) were water-jet-cut from individual masonry units. As shown in Fig. 14(b), the test specimen was subjected to a direct tensile load which is applied at the rate of 2 kN/minute through gimballed clamps to eliminate bending and torsional effects.

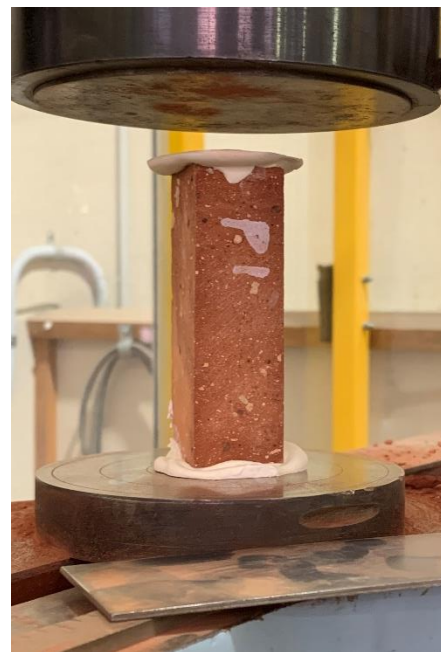
Fig. 15 – Brick unit compression strength test

(a) Schematic layout

(b) Test apparatus

Compression tests on brick specimens were used to determine the compressive strength of the individual brick units rather than the masonry as a whole. To achieve this, specimens were

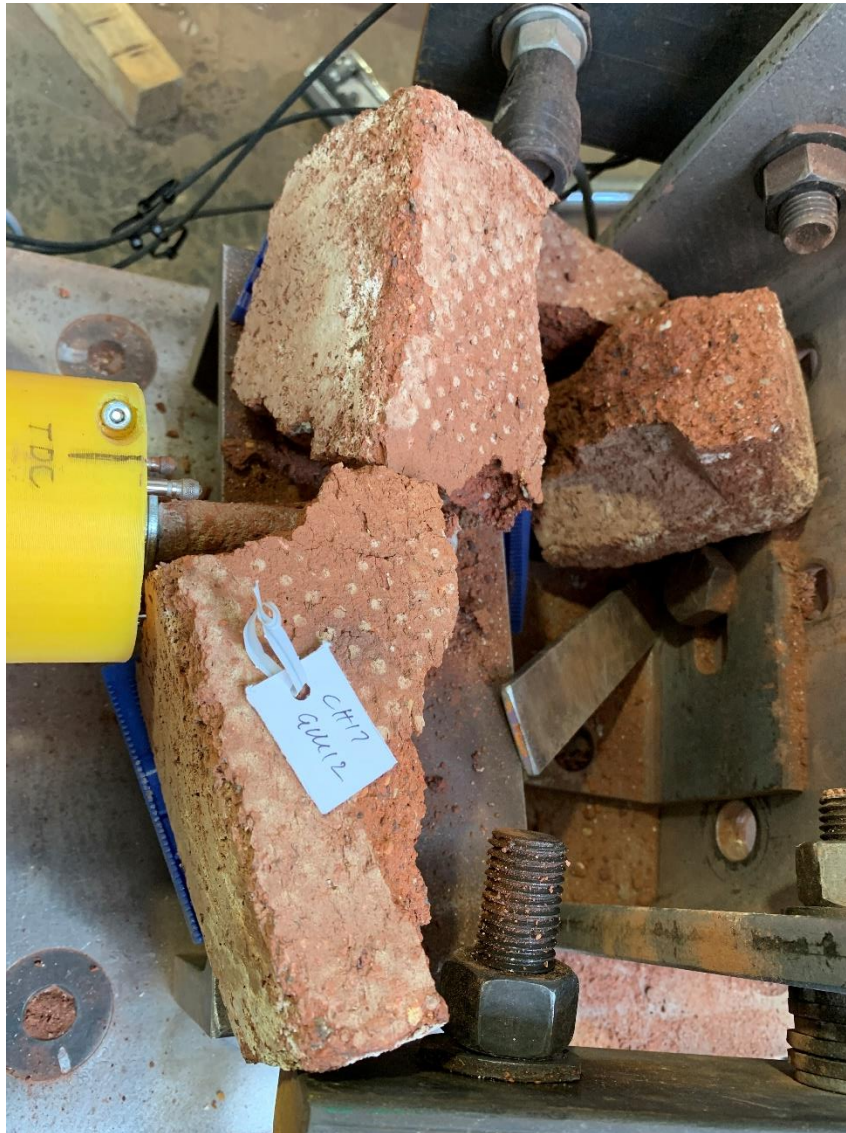
Fig. 17 – P_l test specimen (CH17GM12) fracture

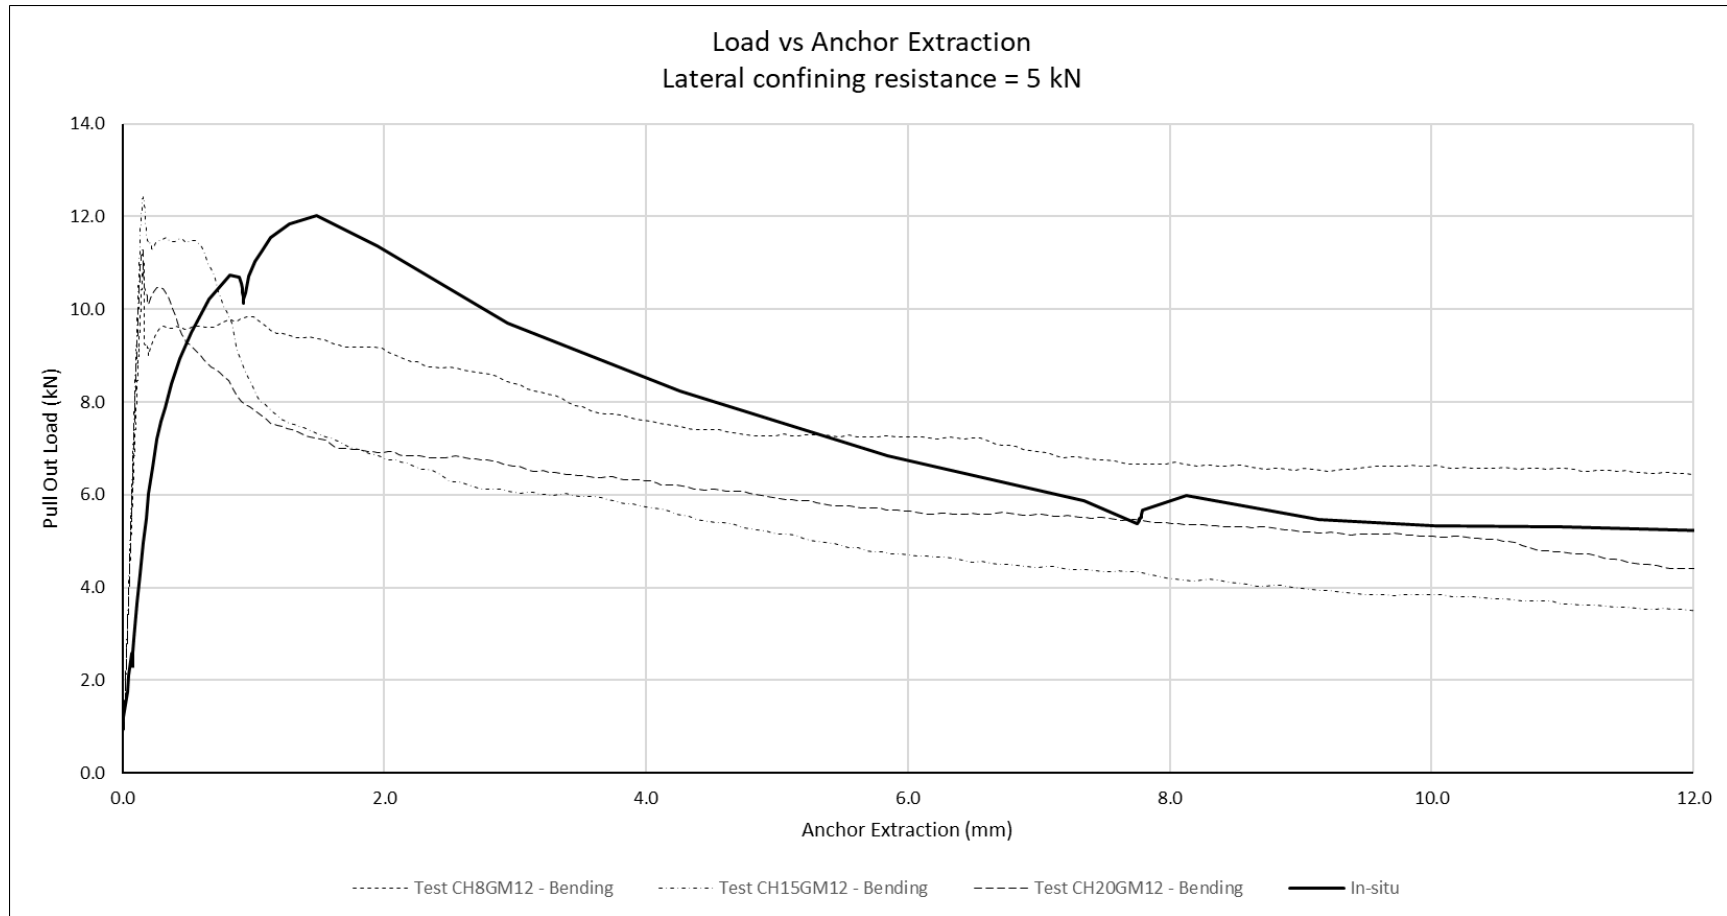
Fig. 18 – P_t validation tests – load vs displacement

Simulation of in-situ masonry conditions is always difficult in the laboratory even when full-scale testing is undertaken, as the time history of loading and thermal variations combined with variations in quality of manufacture, quality of materials and actual mortar mixes impacts the results. However, as shown in the load/slip plots in Fig. 18, which show the typical in-situ unit load slip curve, (which has been adjusted to “remove” the test apparatus and initial system deflection but keep the global masonry deflection), and the laboratory tests which utilise the 5kN lateral resistance, there is good agreement between the two.

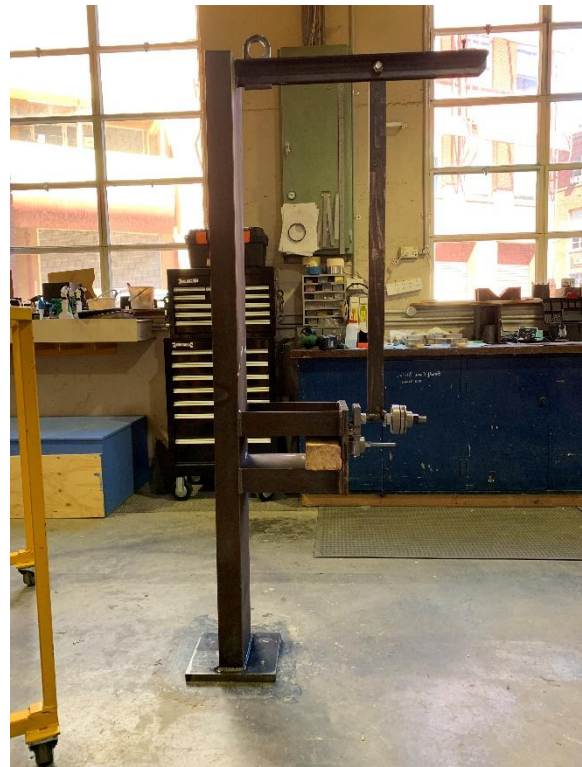
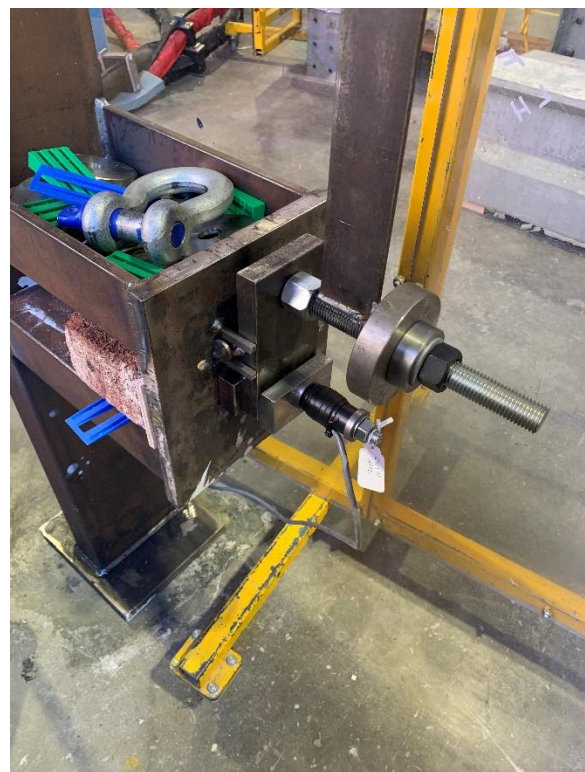
Fig. 20 – Impact load test machine

(a) Schematic layout

(b) Test apparatus

(c) Loading system

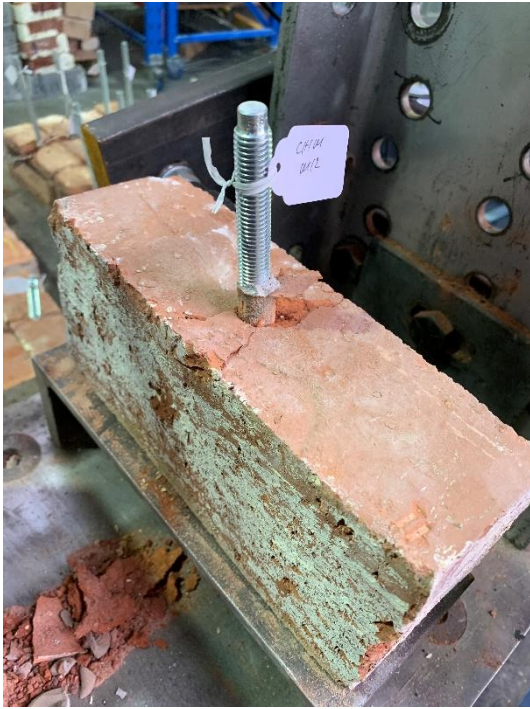
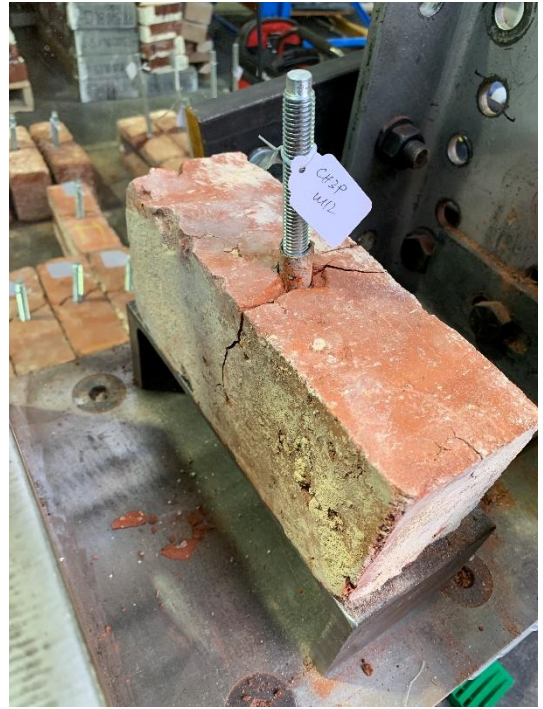
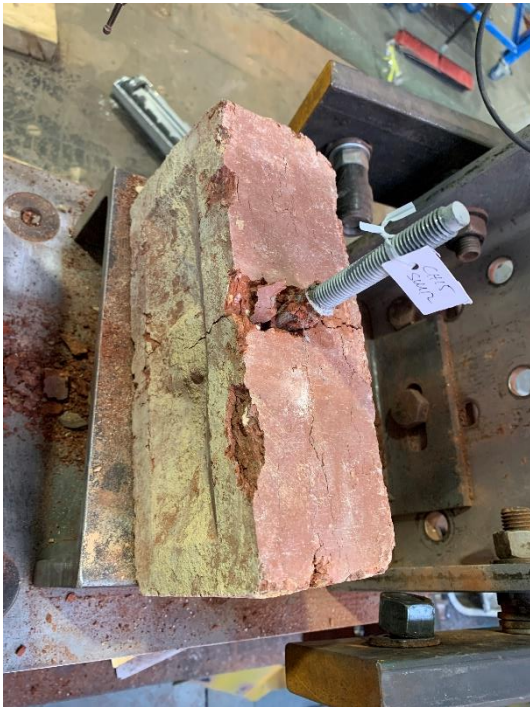
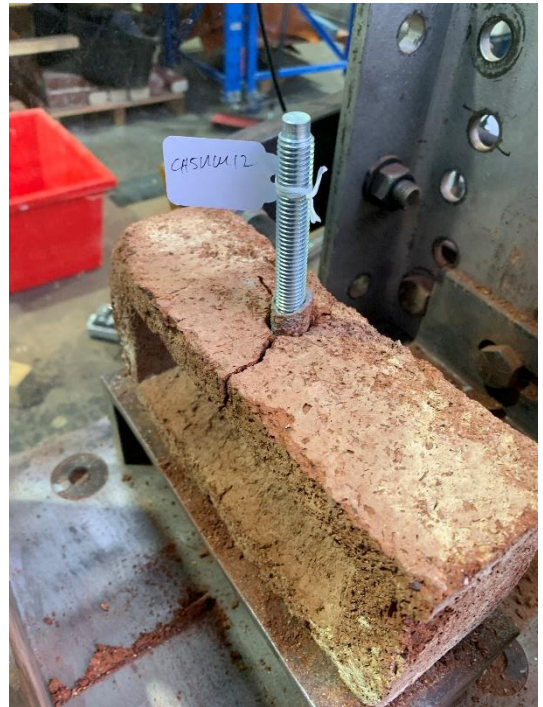
Fig. 22 – Anchor failure under quasi-static loading with good installation

(a) Minerva Crescent

(b) Pym Street

(c) South Road

(d) New brick

For the quasi-static and cyclic anchor pull-out tests that have been undertaken in this research, the virtually exclusive failure mode has been splitting of the masonry unit with a subsequent extended softening region, as reported by Burton et al. (2020). The test configuration that has been adopted has excluded a cone/wedge failure for standard embedment depth tests, and clearly does not allow for brick pull-out failure, but even for poor installation tests, masonry splitting was still the exclusive failure mode. The exception to this were the poor quality installation tests that used short embedment where a cone failure was typical. The impact loading tests used masonry units that did not have lateral support and so the failure generally consisted of the brick splitting, without extended softening. Some typical anchor failures are shown in Figs. 22 to 25.

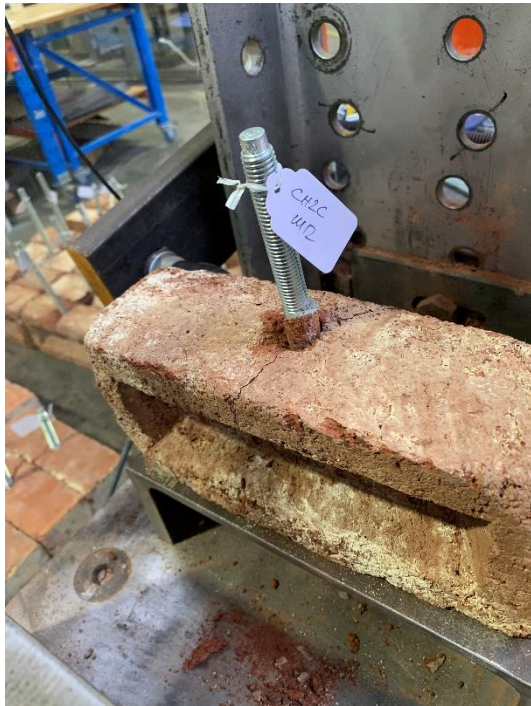
Fig. 23 – Anchor failure under cyclic loading – new brick

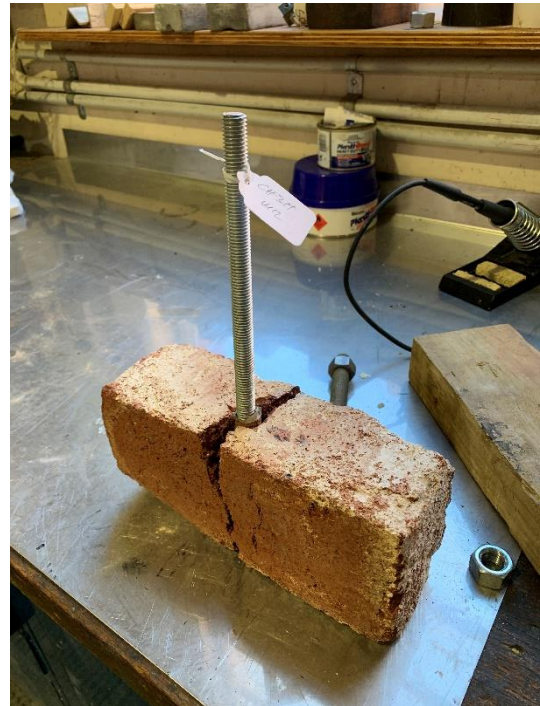
Fig. 24 – Anchor failure under impact loading – new brick

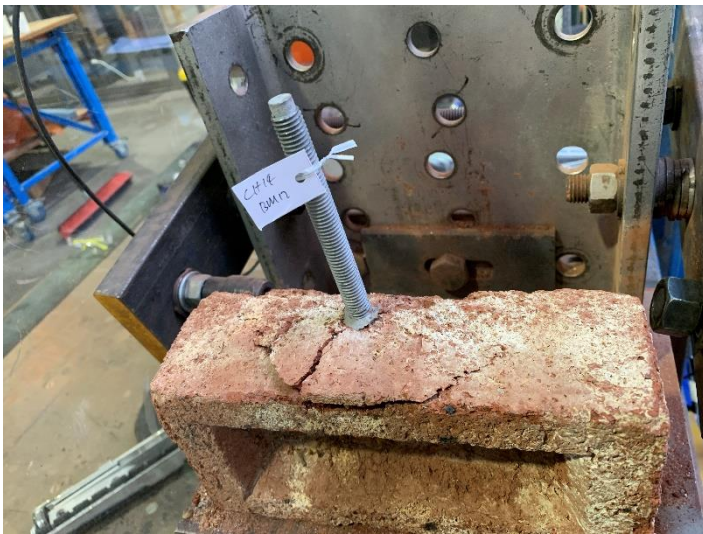
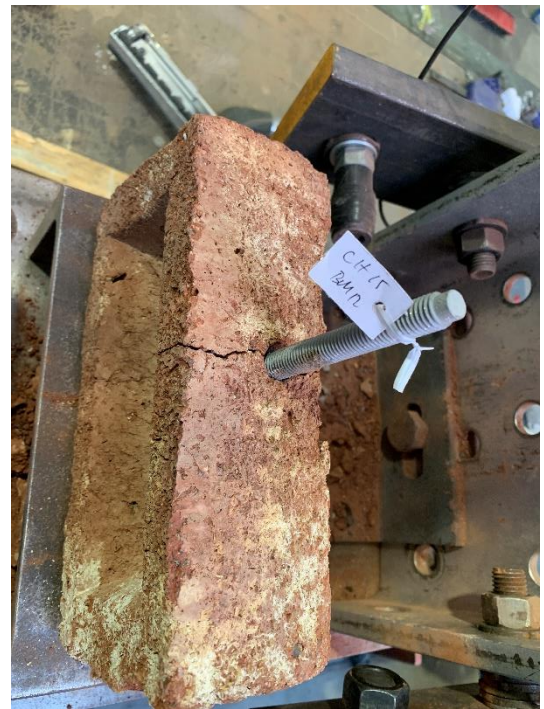
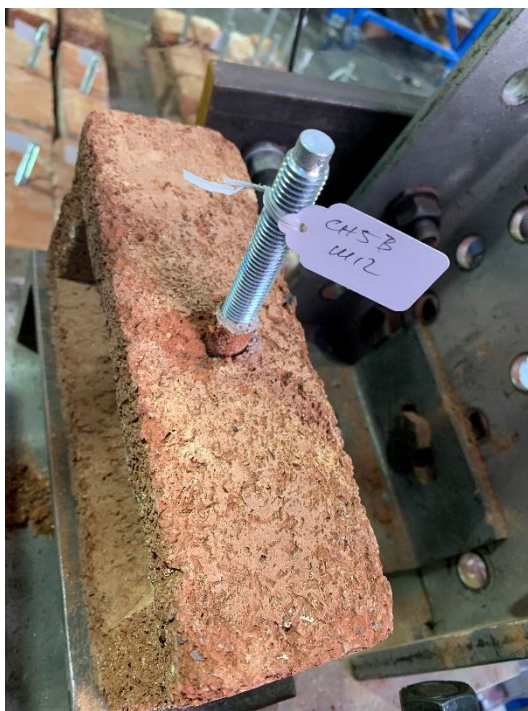
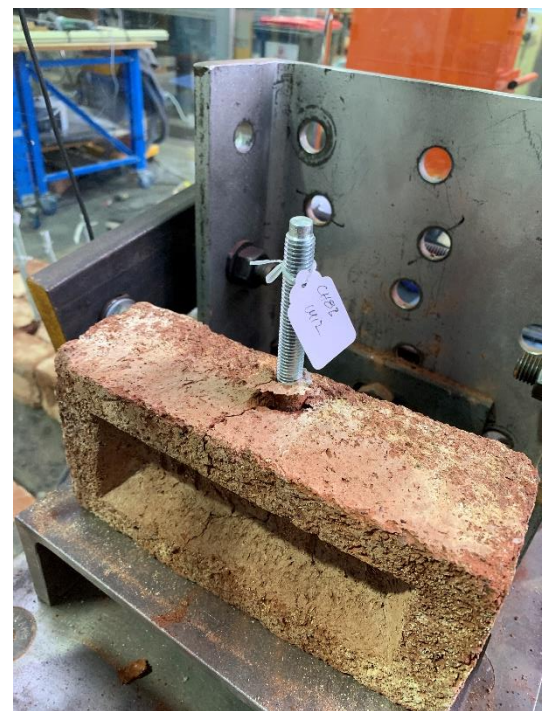
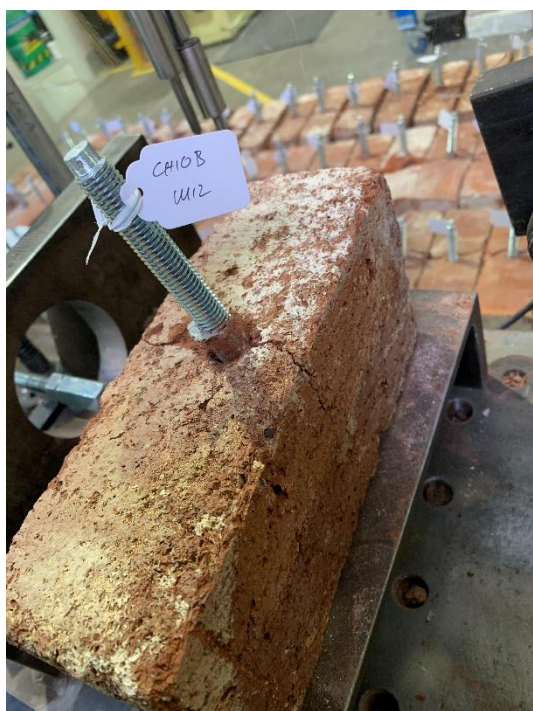
Fig. 25 – Anchor failure under quasi-static loading with poor installation quality (new bricks)

(a) short hole
(note localised cone failure)

(b) long hole

(c) not brushed

(d) not blown

(e) not cleaned

(f) half filled

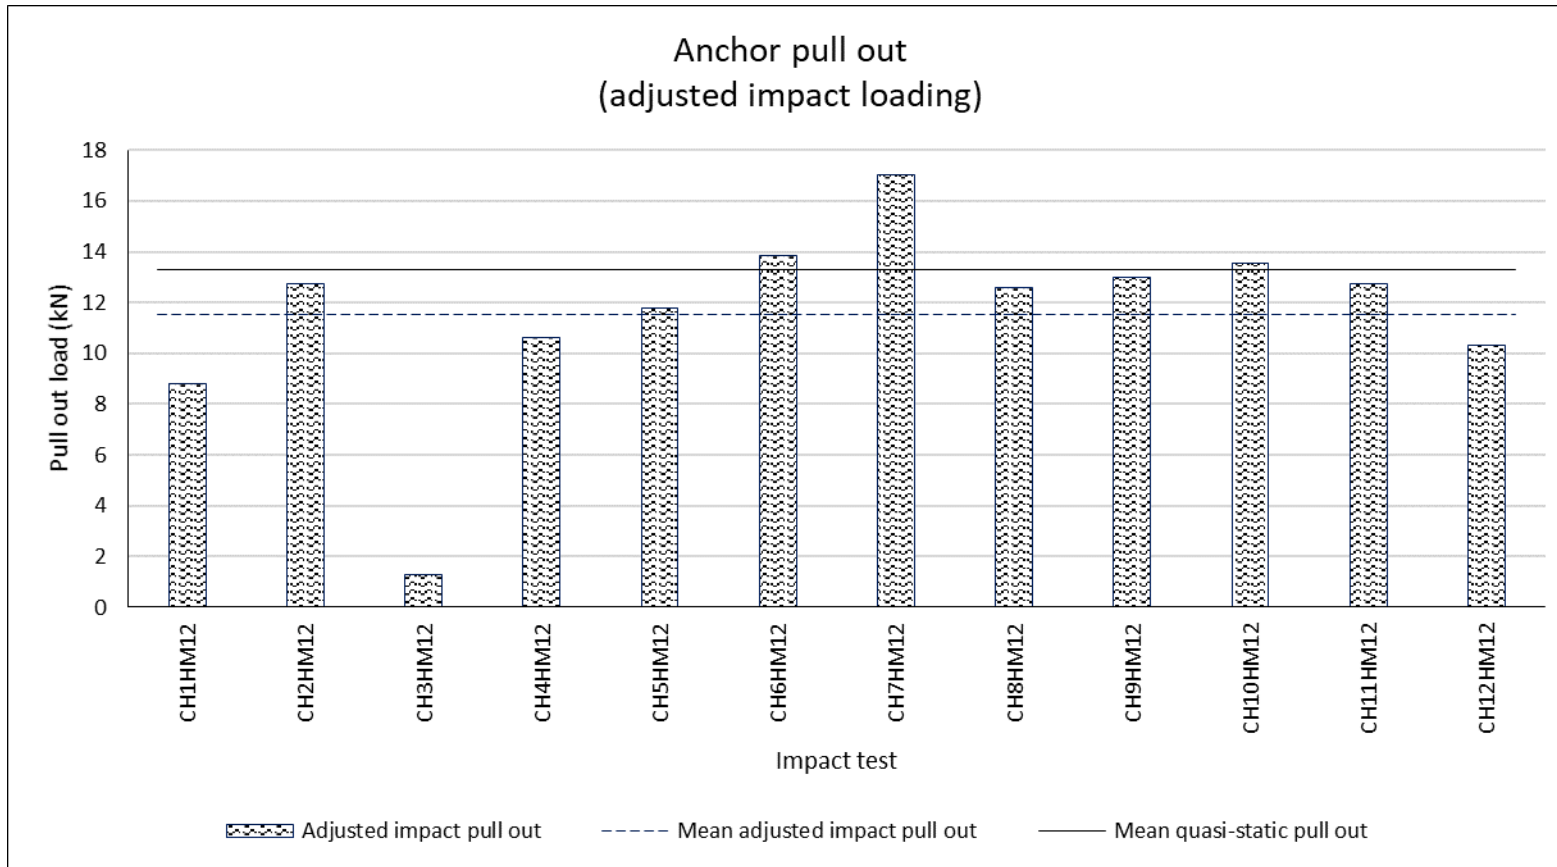
Fig. 27 – Adjusted impact loading

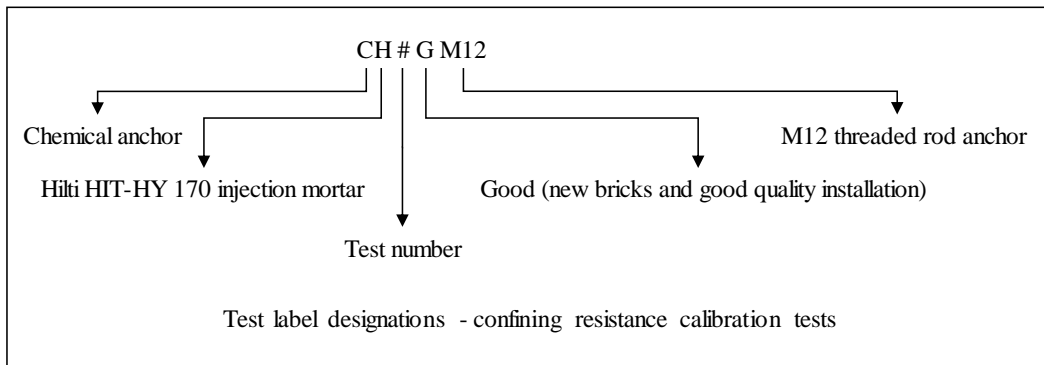
Fig. B1 Experimental test designations

Fig. B1 provides the basis of the experimental test designation used throughout the paper and Figs. B2-B6 provide the experimental load slip relationships for 0, 2,5,10 and 15 kN lateral confining resistance respectively

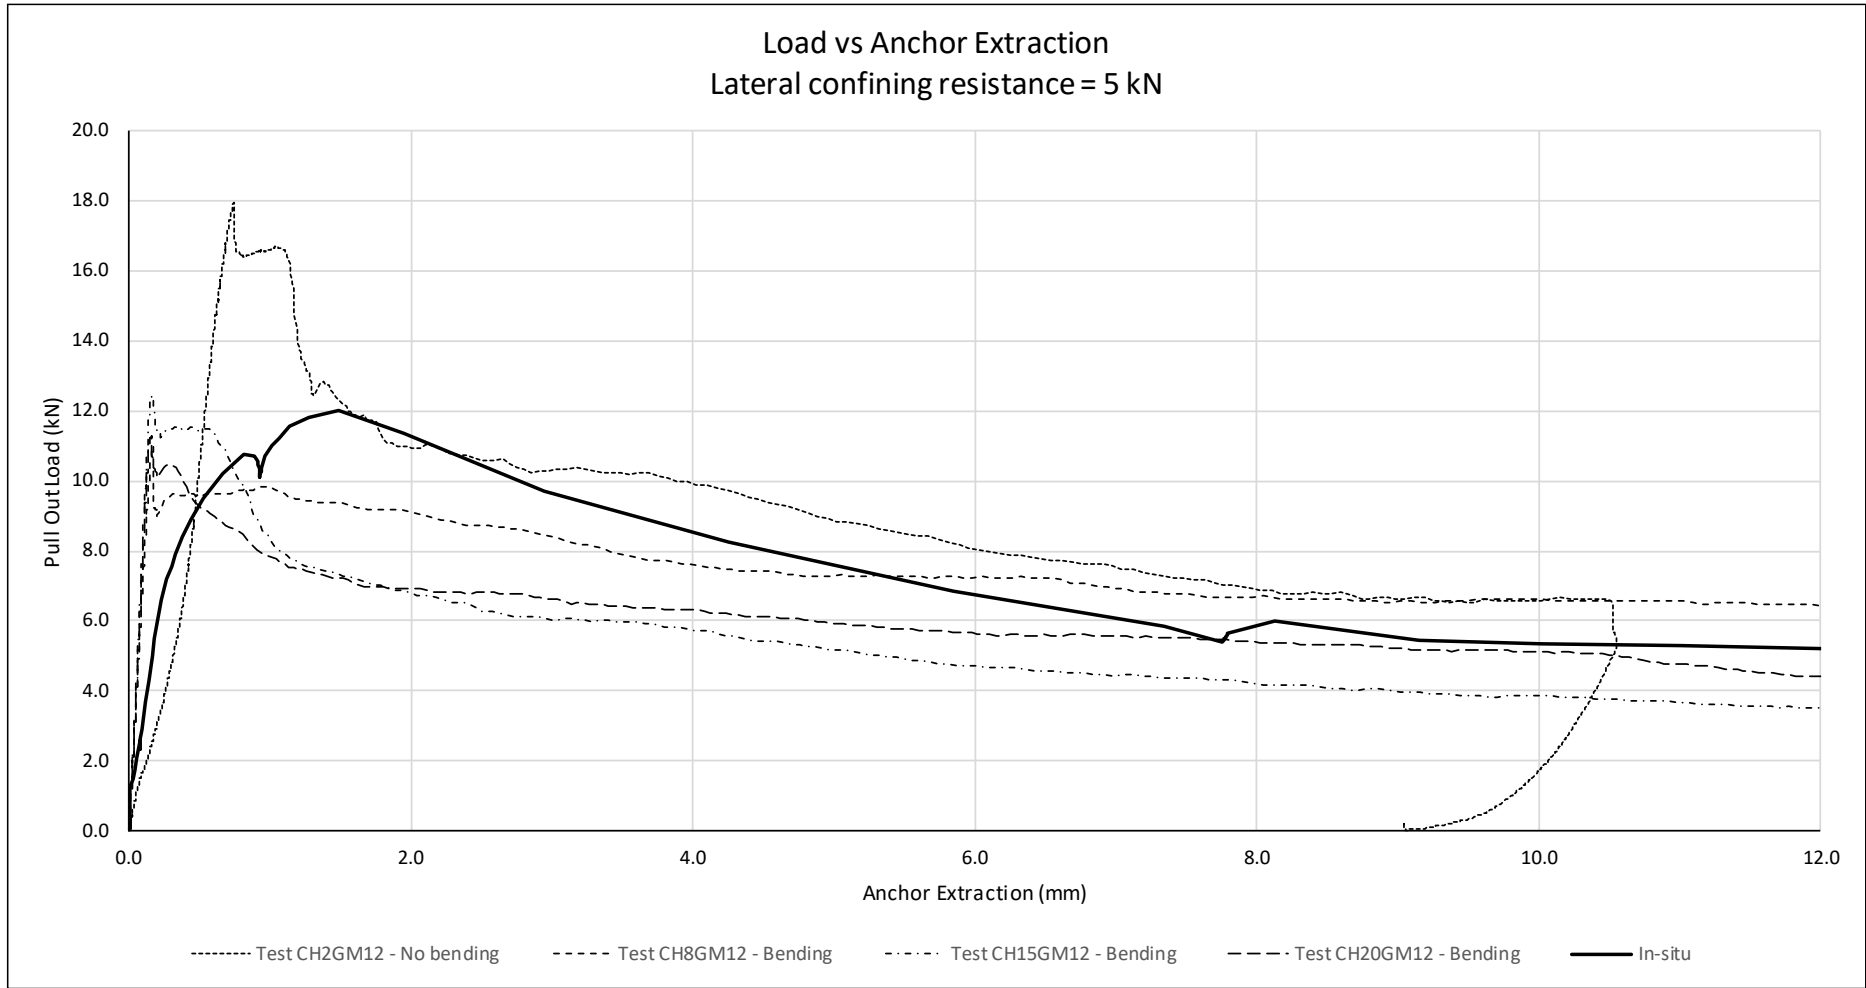
Fig. B4 – Load/slip relationship for anchor extraction with 5 kN lateral confining resistance

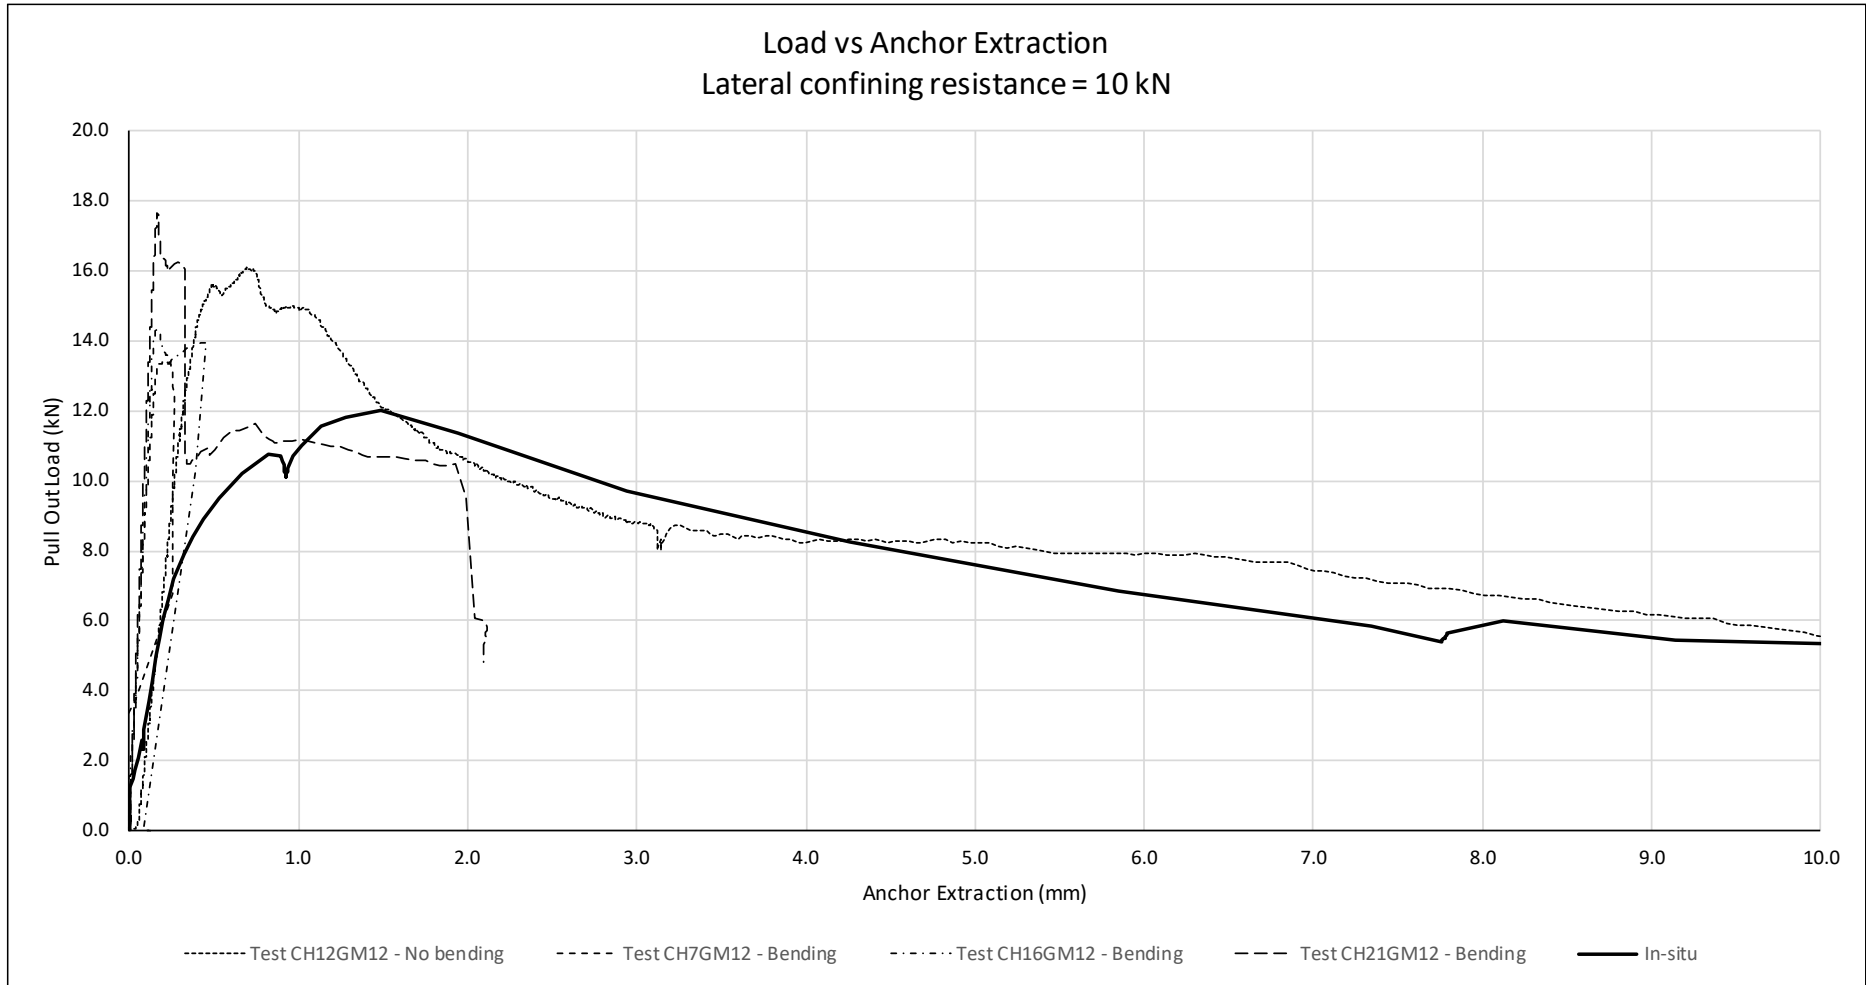
Fig. B5 – Load/slip relationship for anchor extraction with 10 kN lateral confining resistance
