Reconstruction of a Rollover Crash for Thoracic Injury Etiology Investigation

Tana Tan ^{*}, Mario Mongiardini, Raphael Grzebieta

Transport and Road Safety (TARS), University of New South Wales, Old Main Building (K15), Sydney, NSW 2052, Australia; mario.mongiardini@unsw.edu.au (M.M.); r.grzebieta@unsw.edu.au (R.G.); gmattos@friedmanresearch.com (G.M.)

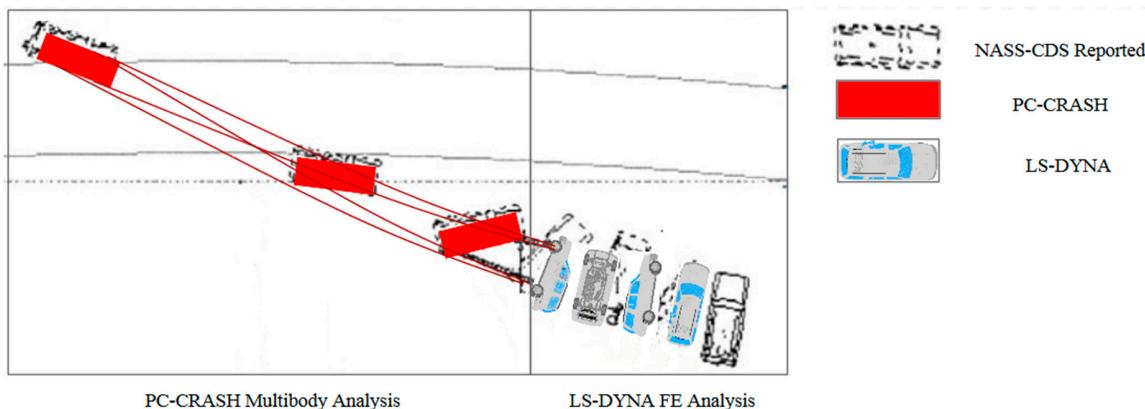
In the second part of the crash modelling (Figure 1), an FE simulation was performed with LS-DYNA. An FE model of the third generation SUV is publically available and was validated against full-scale front and side impact tests as well as quasi-static roof strength tests [30,31]. This model was previously modified to match the roof strength of the second generation SUV [6], which was then used in this study. Three ballasts of 75 kg were added to represent the mass of each occupant in their seated positions. This mass is similar to that of anthropomorphic test devices (ATDs) above the 50th percentile. This combined approach of using PC-CRASH and LS-DYNA to reconstruct a vehicle rollover takes advantage of the strengths of each model. That is, PC-CRASH is able to accurately model the vehicle's trajectory with low computational time, and LS-DYNA is able to more accurately calculate the vehicle's and occupant's kinematics but with significantly greater computational time [6].

Figure 1. Overlay of the PC-CRASH the LS-DYNA simulations, and the NASS-CDS scene diagram.

The vehicle kinematics at the point of trip from PC-CRASH was used to define the initial conditions of the FE simulation of the rollover event. For the purpose of this study, the point of trip was defined as the point where the vehicle had rotated by ninety degrees about its longitudinal axis. A global system was defined with the positive x -, y - and z -axis' pointing east, north, and up, respectively. The vehicle's local coordinate system followed the Society of Automotive Engineer (SAE) standard definition with the positive x -axis pointing forward of the vehicle along the longitudinal axis, the positive y -axis pointing to the right of the vehicle along the transverse axis, and the positive z -axis pointing downwards of the vehicle along the vertical axis of the vehicle [32]. It is also noted that the vehicle's linear velocity and roll rate was filtered with SAE Channel Filter Class (CFC) 60 [32,33]. The vehicle's kinematics at the point of trip is presented in Table 3.

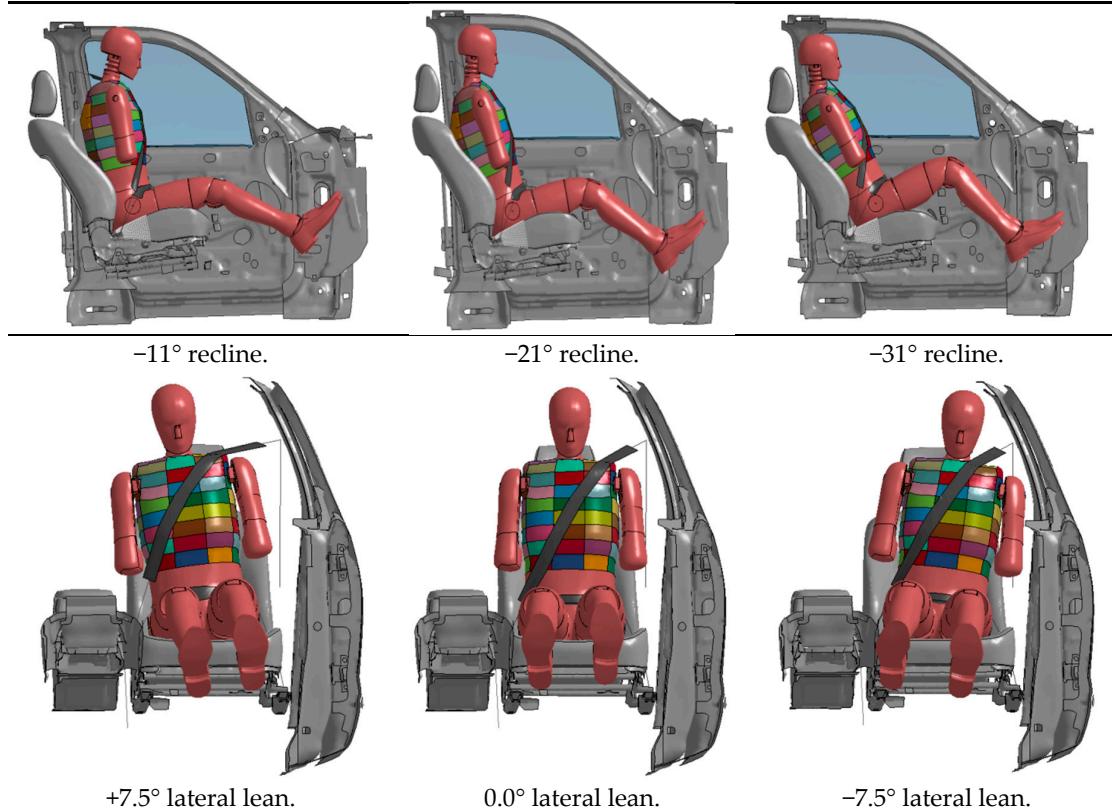
The seat was located mid-track and the B-pillar D-ring was positioned in the “full up” as documented in the NASS-CDS case report. The posture of the ATD in the driver’s seat of the SUV FE model was guided by previous studies [41,42]. That is, the anterior-posterior recline and lateral lean angles of the EuroSID-2re, relative to the vertical axis, were based on the anterior-posterior recline and lateral lean angles of Post Mortem Human Surrogates (PHMS) and ATDs from the studies performed by Lessley et al. [43] and Zhang et al. [41] when their buck, representing a vehicle, was rotated by 90 degrees. A total of nine different postures were attempted for this current study (Table 4). In all postures, the ATD was placed so that the ATD’s back and gluteus maximus contacted the seatback and seat base, respectively. Figure 2 shows the ATD’s anterior-posterior recline and lateral lean angles, respectively. For ease of reference and clarity, the nine postures are titled Position 1 to Position 9 henceforth (Table 4).

Figure 2. Anthropomorphic test device (ATD) anterior-posterior recline angles relative to the vertical axis (**top**) and ATD lateral lean angles relative to the vertical axis (**bottom**).

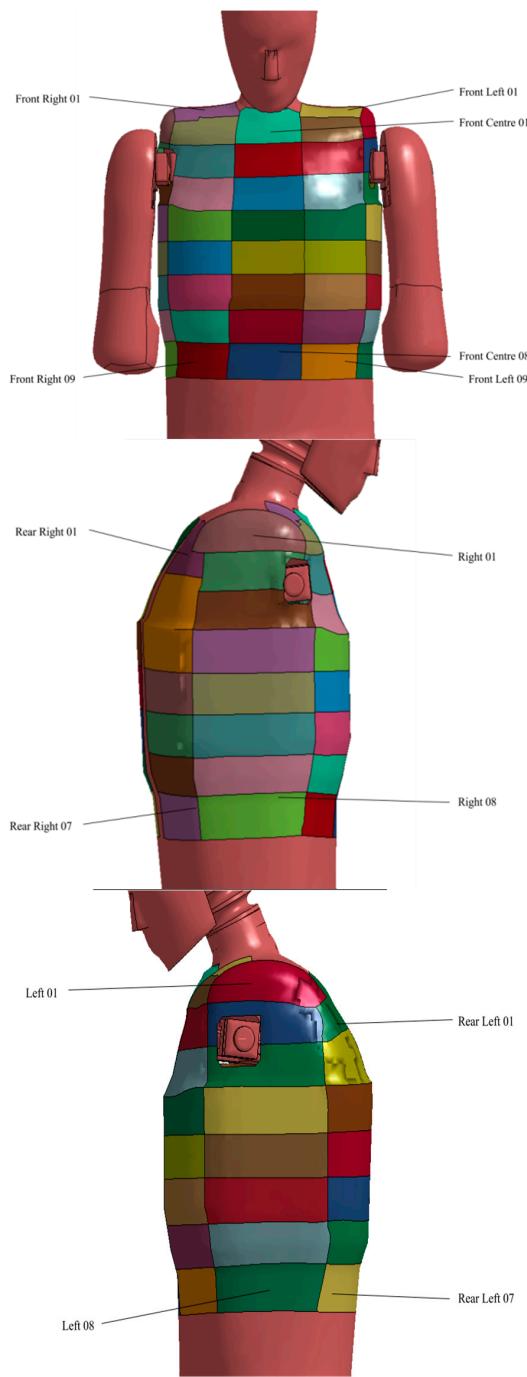
In addition to the five aforementioned IARVs, the ATD resultant thoracic force measurements were also obtained. In order to obtain thoracic force measurements, the thorax was divided into 56 segments (Figure 3) and the resultant force on each segment was obtained. Where thoracic deformations were observed to have occurred due to contact with the seatbelt or impact against vehicle interior components, the deformed segment's time-history resultant force was plotted and the peak resultant force identified.

Figure 3. Thorax divided into segments for force measurements. Only the top and bottom segments are titled. Segments were numbered sequentially starting from “01” at the top.

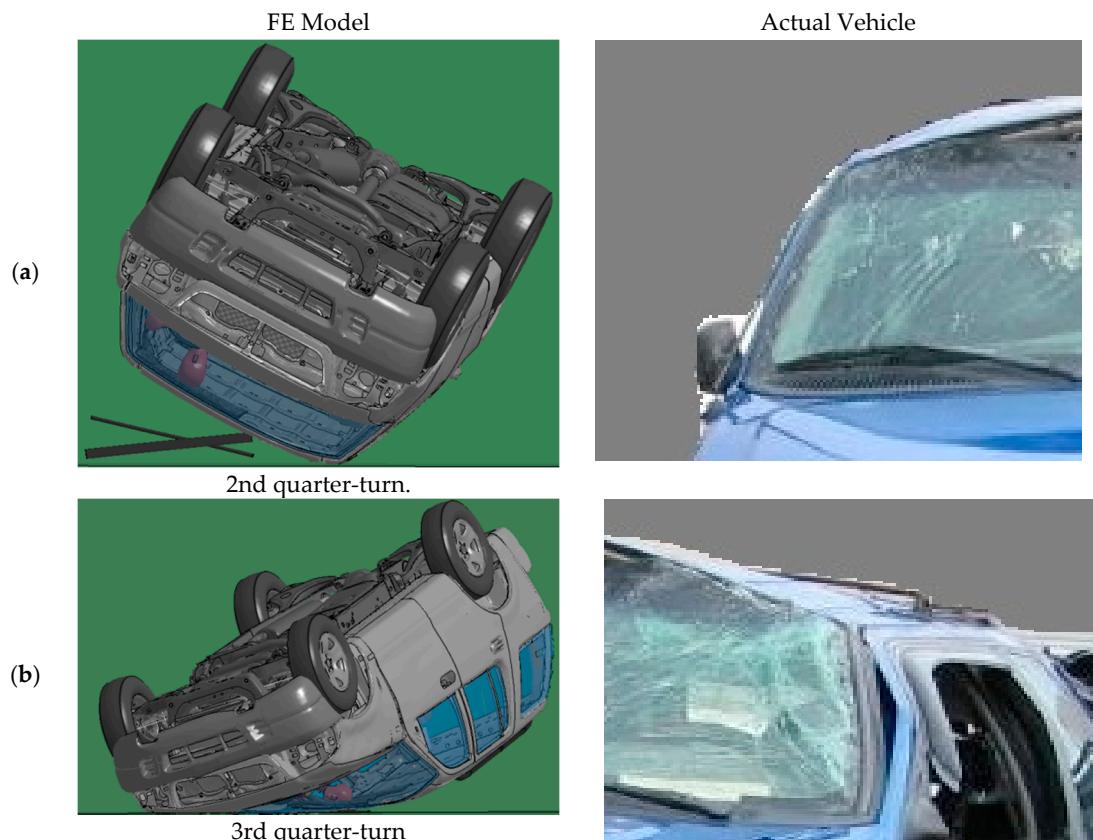
the skid marks, the point of trip, and the vehicle's final position, no other details were available from the NASS-CDS scene diagrams for comparison with the reconstructed trajectory. However, the key impact points between the FE vehicle model and the ground surface could be compared to the NASS-CDS case vehicle photos (Figure 4a,b). In the FE simulation, the right A-pillar was the first vehicle structure to contact the ground and correlated with the location and direction of the damage pattern of the case vehicle (Figure 4a). The subsequent impact occurred at the left A-pillar and left B-pillar (Figure 4b). Corresponding photos from the case vehicle are also presented in Figure 4a,b.

Figure 4. Finite element (FE) vehicle model during key ground impacts (left) with corresponding vehicle damage (right).

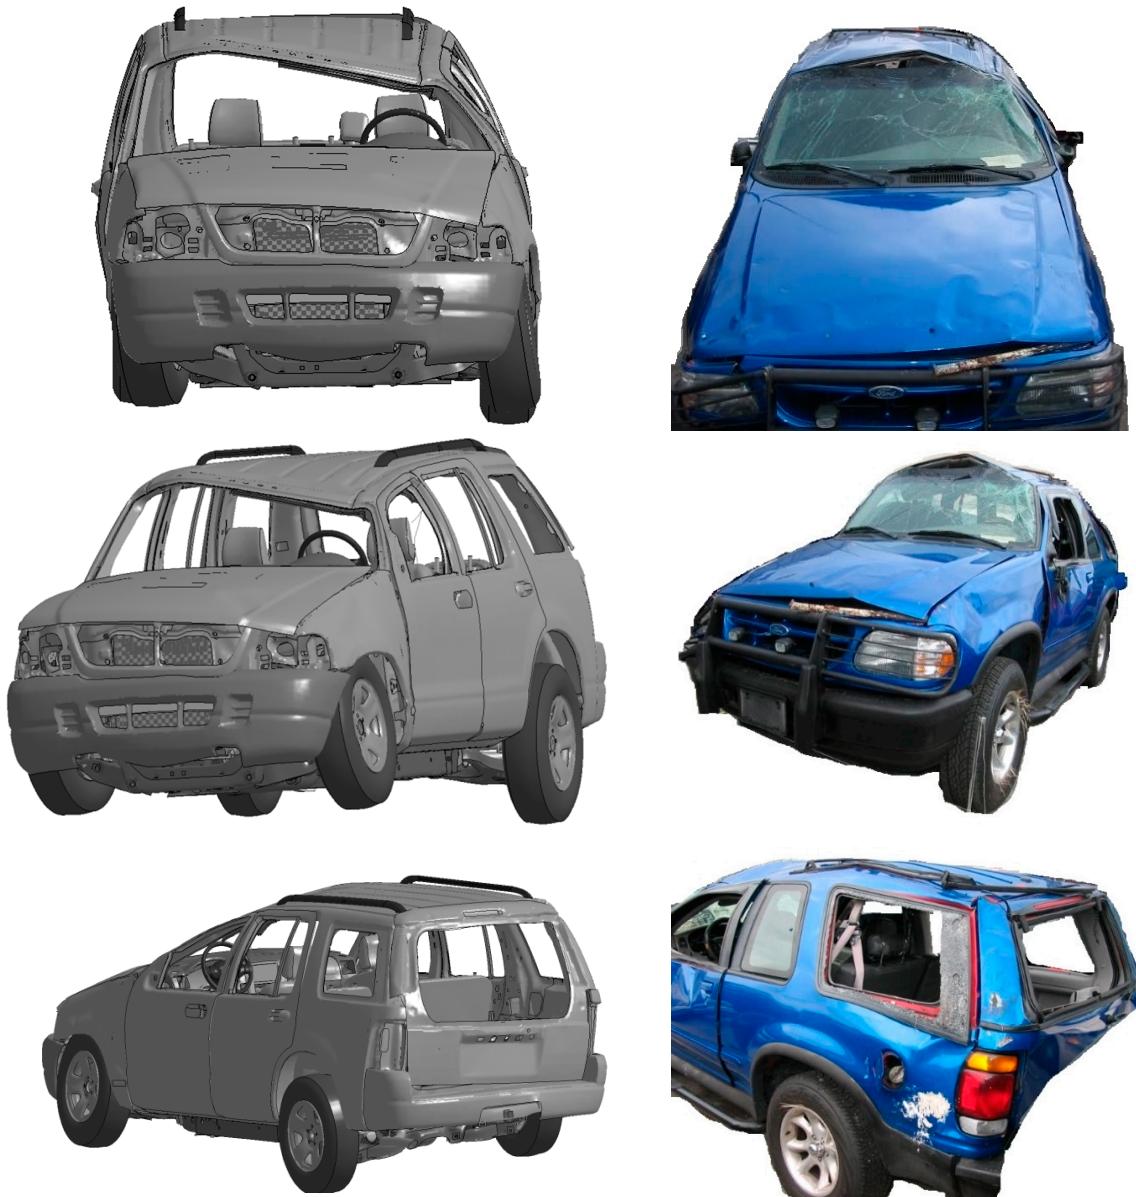
The roof damage of the case vehicle and the FE model is presented in Figure 5.

Figure 5. Roof damage of the FE model (left) and the case vehicle (right).

The FE simulation resulted in the vehicle rollover occurring over a distance of 8 m. This was 2 m shorter than that reported in the NASS-CDS case report of 10 m. A number of variables were altered in order to increase the roll distance which included increasing and decreasing the vehicle-to-ground friction coefficient, increasing the vehicle's roll rate and increasing the vehicle's transverse velocity. However, it was not possible to increase the roll distance from 8 to 10 m without a resulting increase in quarter-turns. However, from the analysis of vehicle intrusion (Table 5), it is noted that the FE model's left A and B-pillar intrusion is similar to that reported by NASS-CDS in both magnitude and direction.

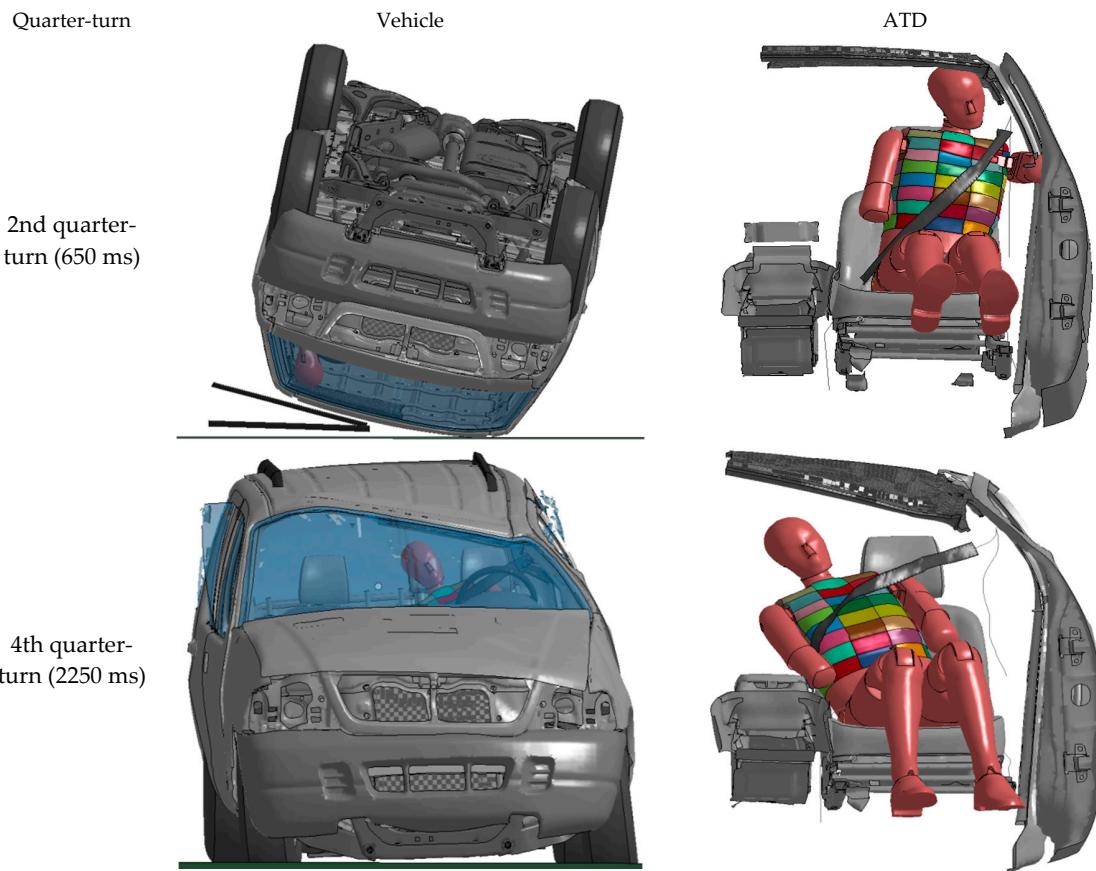
In all four simulations, the only significant thorax to vehicle interior impact was with the centre console that occurred during the vehicle's fourth quarter-turn (2100 to 2400 ms) as the vehicle's right wheels contacted the ground. This wheel-to-ground contact resulted in the dummy traversing from outboard to inboard and the right thorax impacting the centre console. This impact with the centre console (Figure 6) became a focus of this investigation.

Figure 6. Vehicle position at the 2nd and 4th quarter-turn (**left**) and corresponding ATD posture (**right**). ATD originally in Position 2 and ATD figures have been righted for clarity.

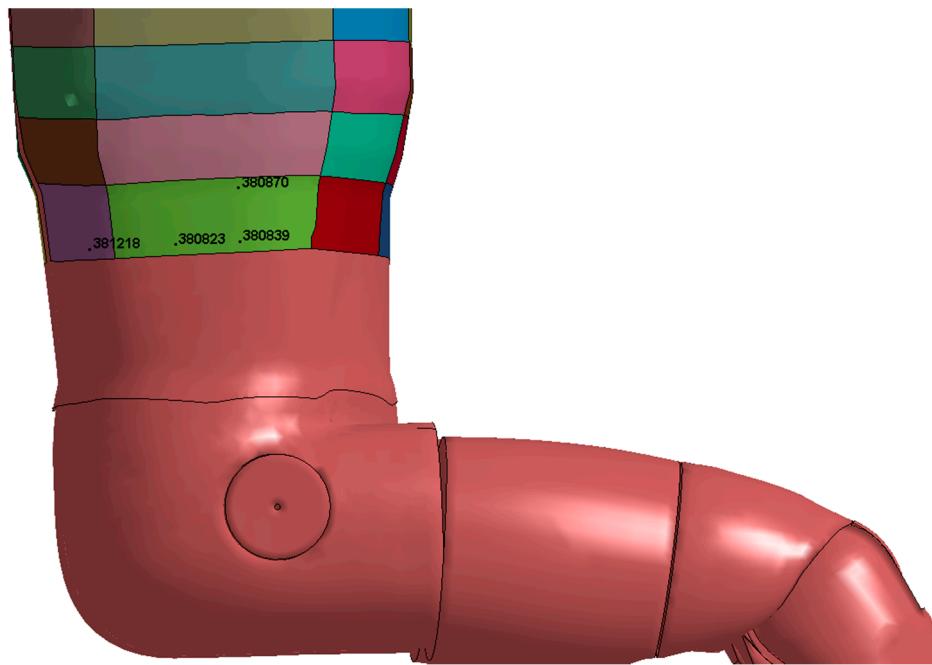
The peak lateral thorax impact velocity from each simulation is presented in Table 10. Figure 7 indicates the location of the Node IDs references in the table. A time-history plot of impact velocity for these nodes is presented in Appendix G.

Figure 7. Location of node IDs referenced in Table 10.

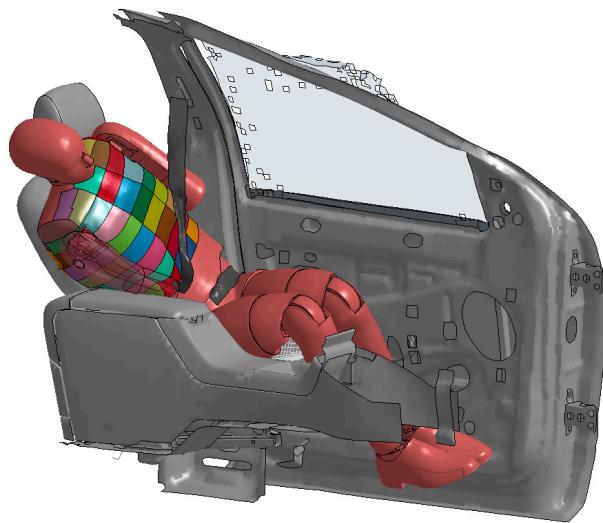
In all four simulations, the right thorax impacted the centre console between 2200 and 2400 ms. Of the four ATD positions, the ATD in Position 1 was subjected to the highest lateral thoracic impact velocity of 4.95 m/s when the ATD impacted the centre console (Figure 8). This impact velocity corresponds to a probability of an AIS3+ thoracic injury of 0.31. This indicates that the driver's AIS3+ thoracic injury may have occurred due to contact with the centre console, a finding similar to that by Tahan et al. [9] Previous studies by Robbins et al. [51] found that a blunt lateral thorax impact velocity of 4.2 m/s resulted in PMHSs sustaining between two (AIS 2) and seven (AIS 4) rib fractures, while Viano et al. [52] found that blunt lateral thoracic impacts of 3.62 m/s was sufficient to result in a PMHS sustaining 2 rib fractures (AIS 2). These reported injuries are similar to that sustained by the driver despite the impact velocities being lower than that in the reconstruction. Further, it is also noted that a significant decrease in the vehicle's lateral velocity (Appendix A) was also observed to have occurred when the ATD impacts the centre console, which suggests that a significant decrease in lateral velocity may be associated with an occupant sustaining a lateral thoracic injury.

Figure 8. Position 1—ATD impacting the centre console at 2300 ms.

It was also observed that a change in ATD lateral lean angle of 7.5° from Position 1 to Position 2 resulted in a decrease in maximum observed lateral thoracic impact velocity from 4.95 to 3.66 m/s and that the nodes that registered these velocities are located on the Right 08 thorax segment. These impact

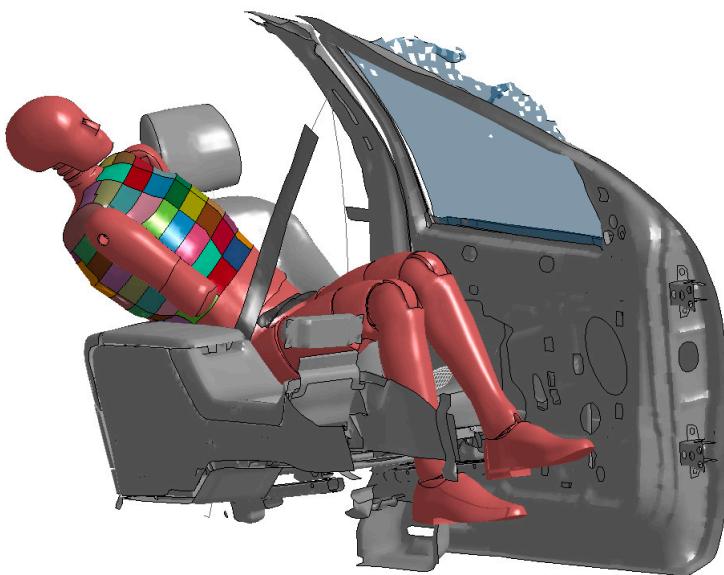
The highest thoracic resultant force due to the impact with the centre console was observed to be 0.53 kN at 2270 ms (Figure 9). Existing literature indicate that a lateral thoracic force of 7.4 kN and 10.2 kN results in an AIS0 and AIS3+ lateral thoracic injury, respectively [53,54]. Other studies estimated that a 5.5 kN lateral impact force results in a 25% probability of an AIS4+ thoracic injury [53,55]. The observed force of 0.53 kN is less than the reported injurious forces. Thus, lateral thoracic injury was not likely to have occurred due to the thorax's impact with the centre console. However, force may not be a suitable criteria for thoracic injuries as it does not take into account the viscous nature of the thorax nor does it take into account the area to which the force is applied [53].

Figure 9. Position 8—ATD with the right thorax impacting the centre console at 2300 ms.

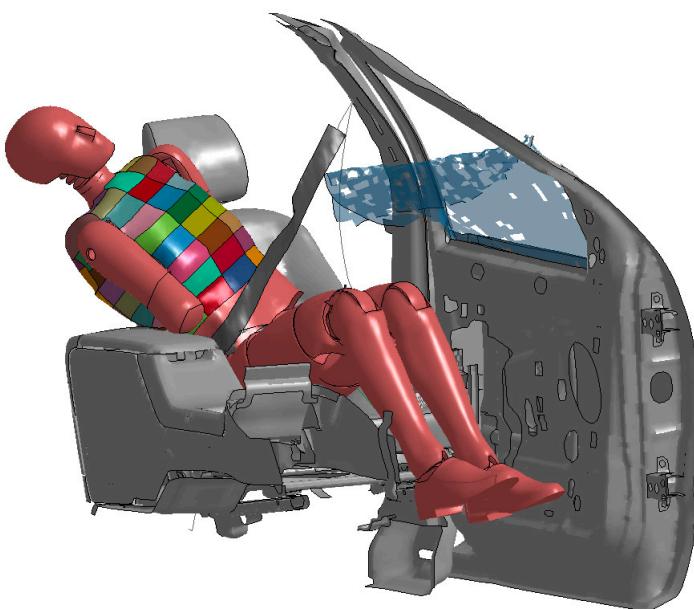
The ATD was observed to rotate about its z-axis during the rollover and to impact the centre console at an oblique angle. For example, Figure 10 shows the ATD right rear thorax impacting the centre console. Current side impact dummies do not adequately measure injurious accelerations, velocities, or forces under oblique loading conditions [50,60]. Oblique thoracic impact testing has been identified as important in side impact testing as the thorax of ATDs has been observed to rotate about their vertical axis during these crash tests [34]. Additionally, previous studies have also hypothesised that less chest compression is required to result in serious thoracic injury in oblique impacts compared to lateral impacts given the same impact velocity [57]. The results from this study indicate that

Figure 10. Position 2—ATD at 2300 ms with right thorax impacting against the centre console.

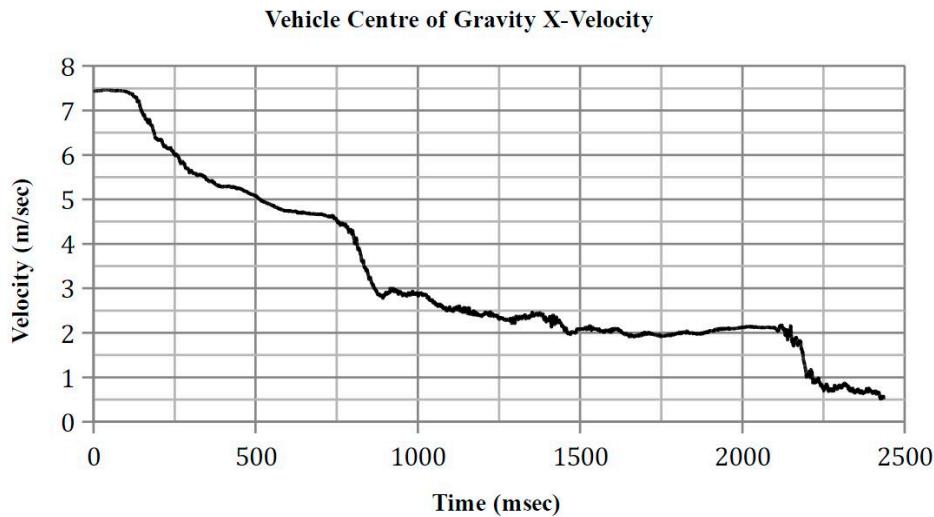
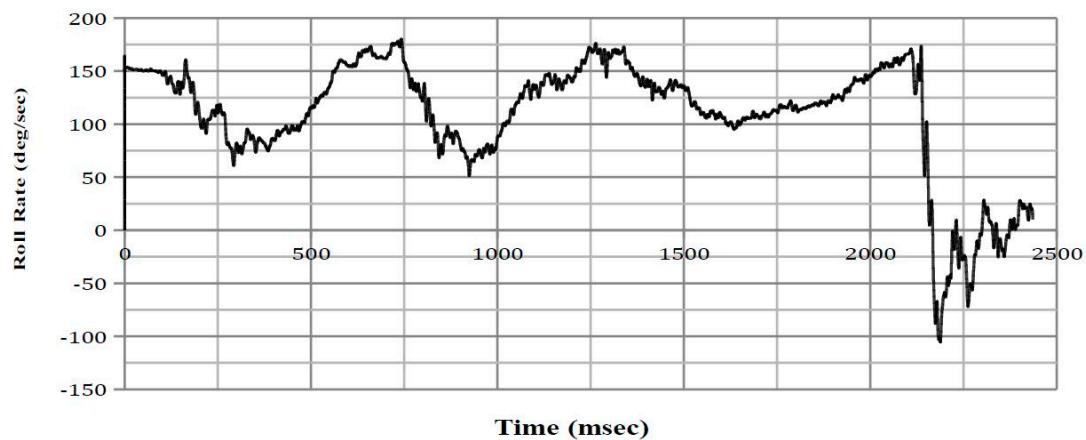
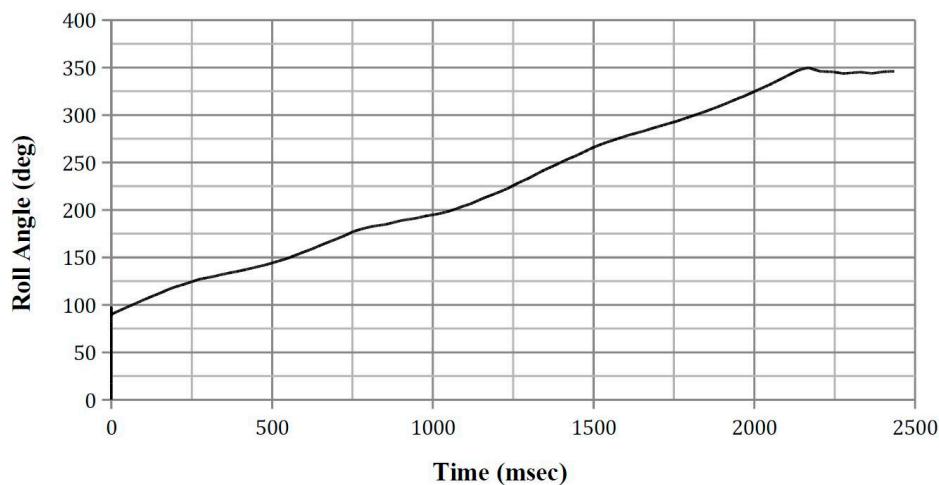
Vehicle kinematics time-history plots.

Figure A1. Vehicle centre of gravity lateral velocity (relative to the global x -axis).

Figure A2. Vehicle centre of gravity roll rate (relative to the vehicle x -axis).

Figure A3. Vehicle centre of gravity roll angle (relative to the vehicle's x -axis).

The trip conditions obtained from the PC-CRASH simulations and used in the FE analysis resulted in a four-quarter-turn rollover over a distance of 8 m. A plot of the vehicle global x -axis velocity and vehicle x -axis roll rate and roll angle is presented in Appendix A. It is noted that, apart from

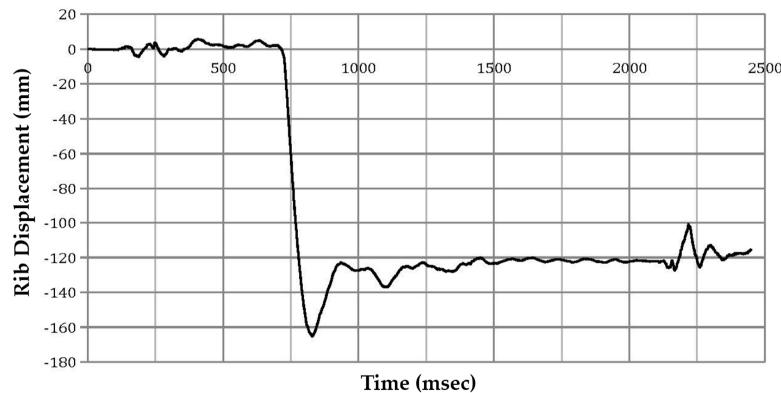
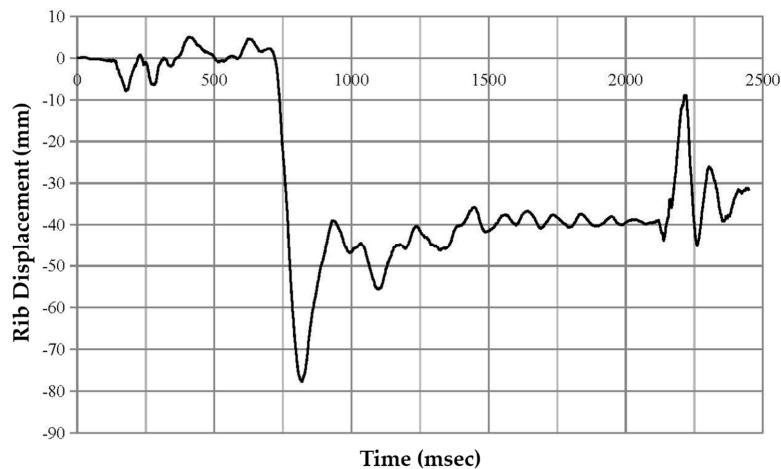
Roof deformation time-history plots.

Figure A4. Left A-pillar deformation.

Figure A5. Left B-pillar deformation.

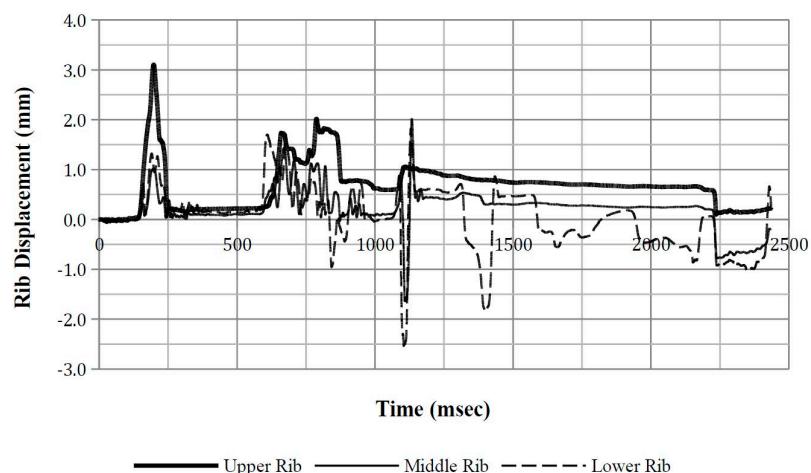
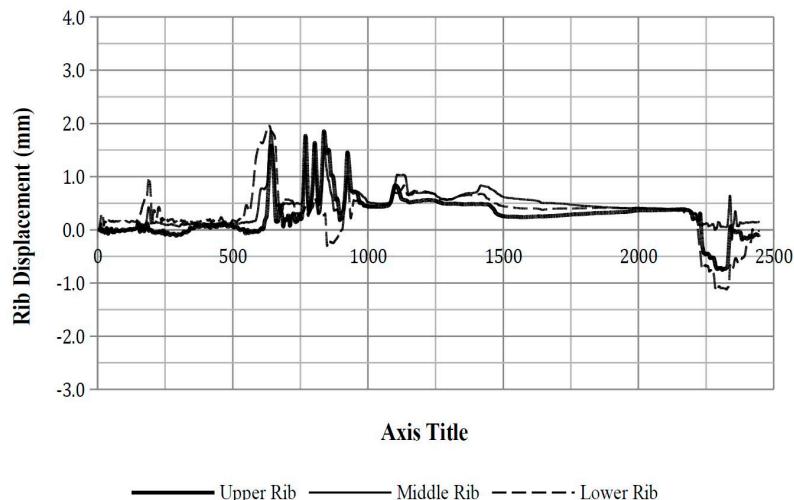
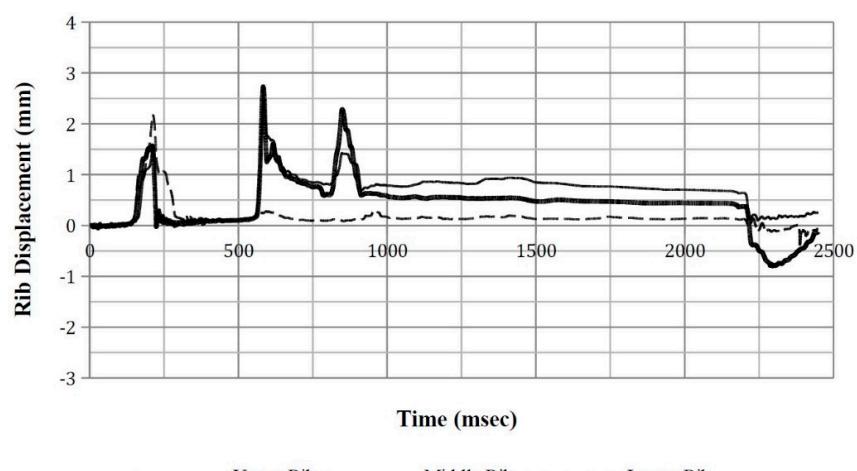
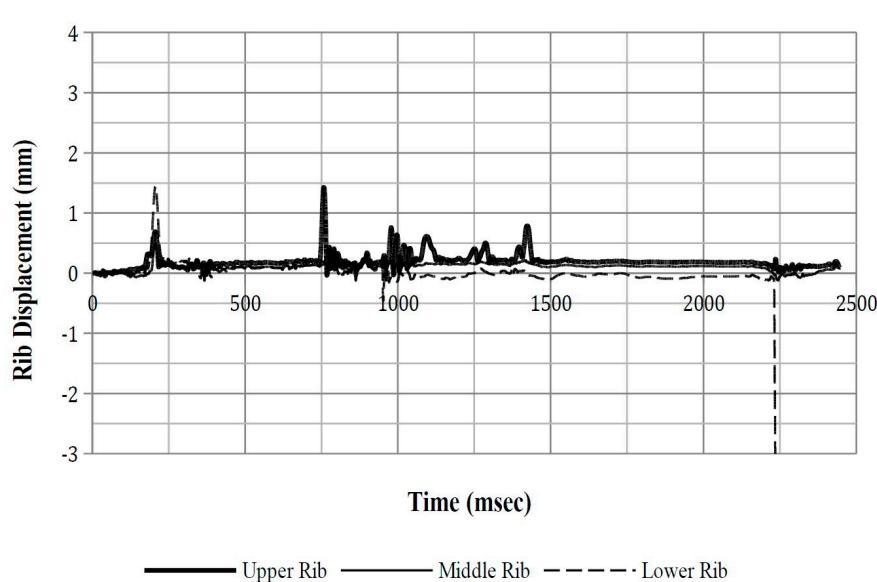
Upper, middle, and lower rib deflection time-history plots.

Figure A6. ATD Position 1 rib displacement.

Figure A7. ATD Position 2 rib displacement.

Figure A8. ATD Position 5 rib displacement.

Figure A9. ATD Position 8 rib displacement.

The maximum rib deflections are presented in Table 6 along with the corresponding time and probability of an AIS3+ thoracic injury. A time-history plot of rib deflection is provided in Appendix C.

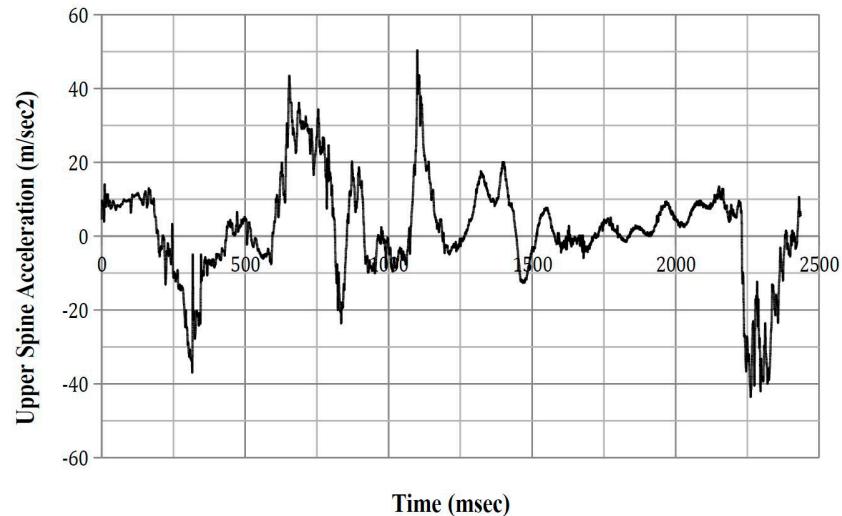
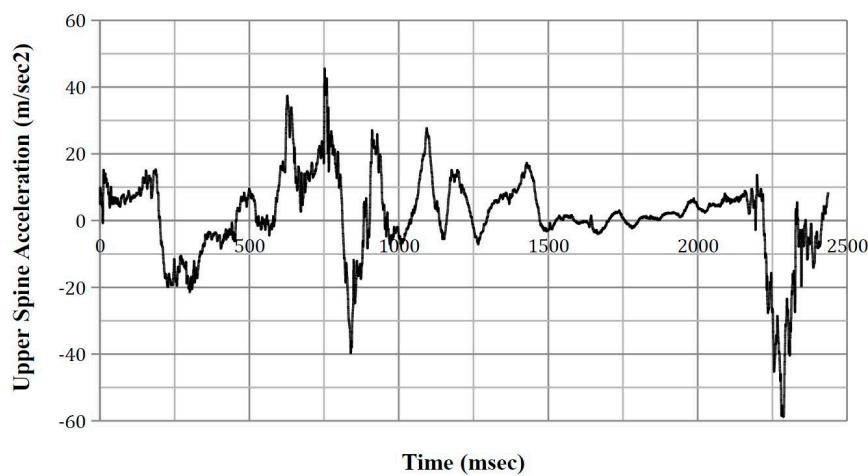
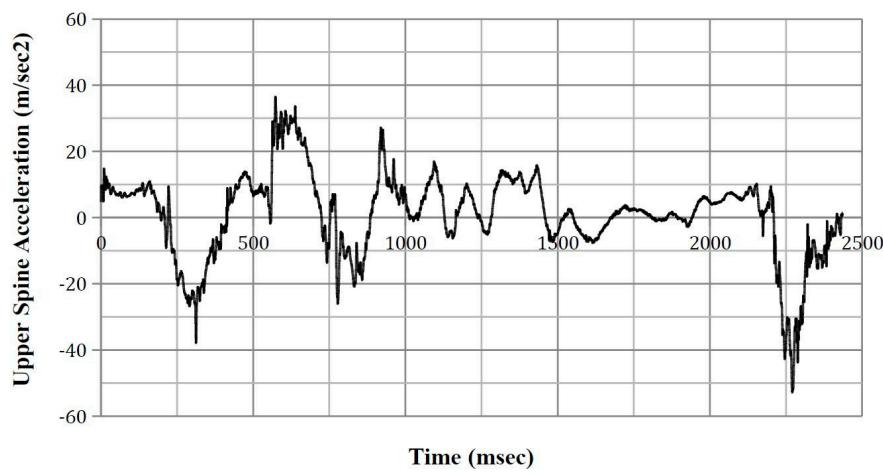
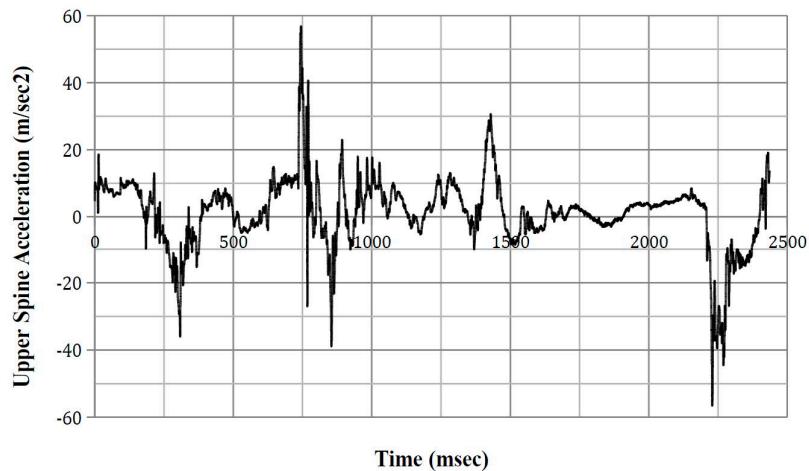
Upper spinal acceleration time-history plots.

Figure A10. ATD Position 1 upper spine acceleration.

Figure A11. ATD Position 2 upper spine acceleration.

Figure A12. ATD Position 5 upper spine acceleration.

Figure A13. ATD Position 8 upper spine acceleration.

The peak upper and lower spinal accelerations when the ATD contacted the left vehicle interior and impacted the centre console are presented in Tables 7 and 8, respectively. A time-history plot of the upper and lower spinal acceleration for each ATD position is presented in Appendix D and E, respectively.

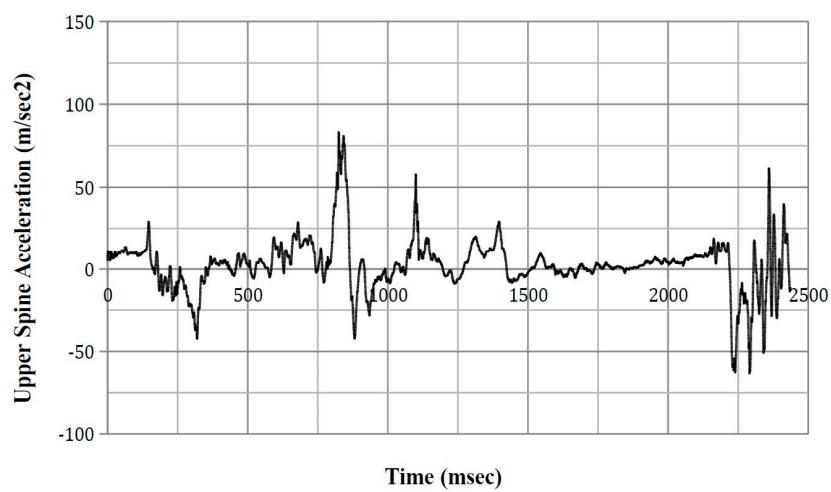
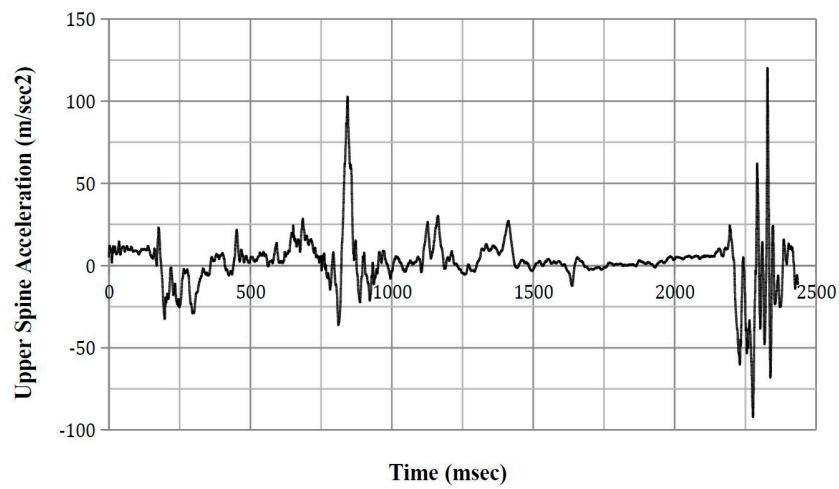
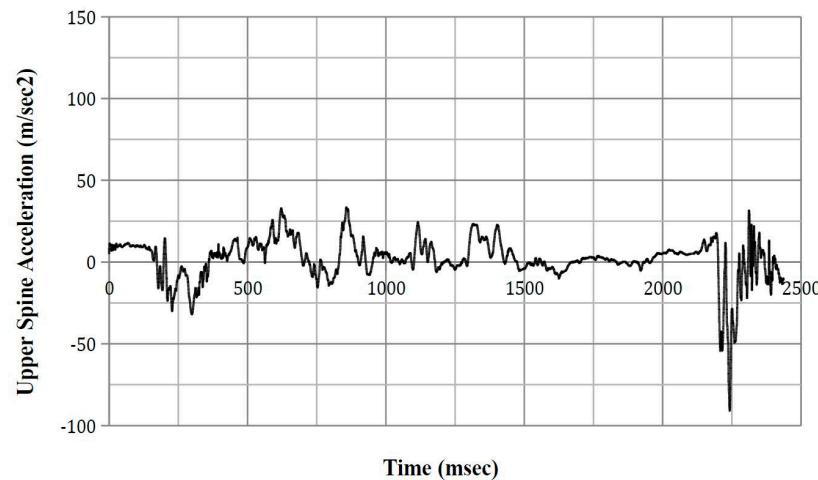
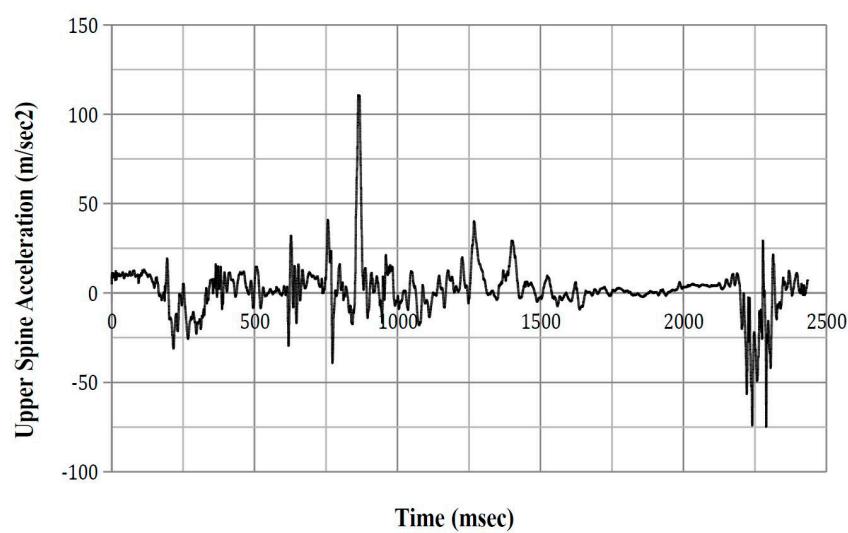
Lower spinal acceleration time-history plots.

Figure A14. ATD Position 1 lower spine acceleration.

Figure A15. ATD Position 2 lower spine acceleration.

Figure A16. ATD Position 5 lower spine acceleration.

Figure A17. ATD Position 8 lower spine acceleration.

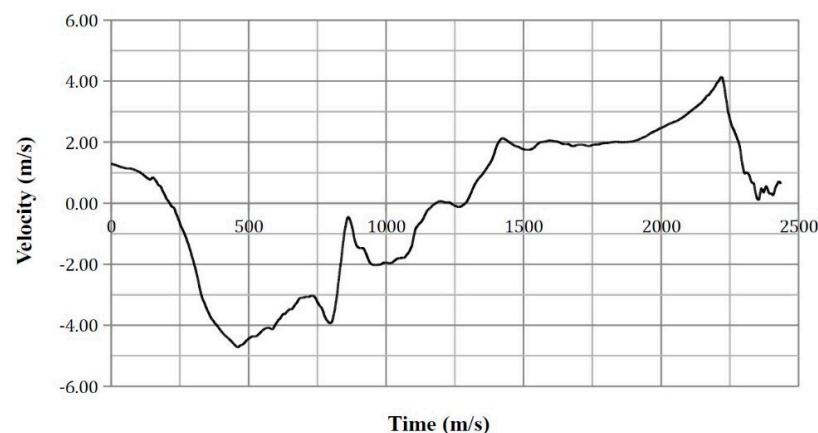
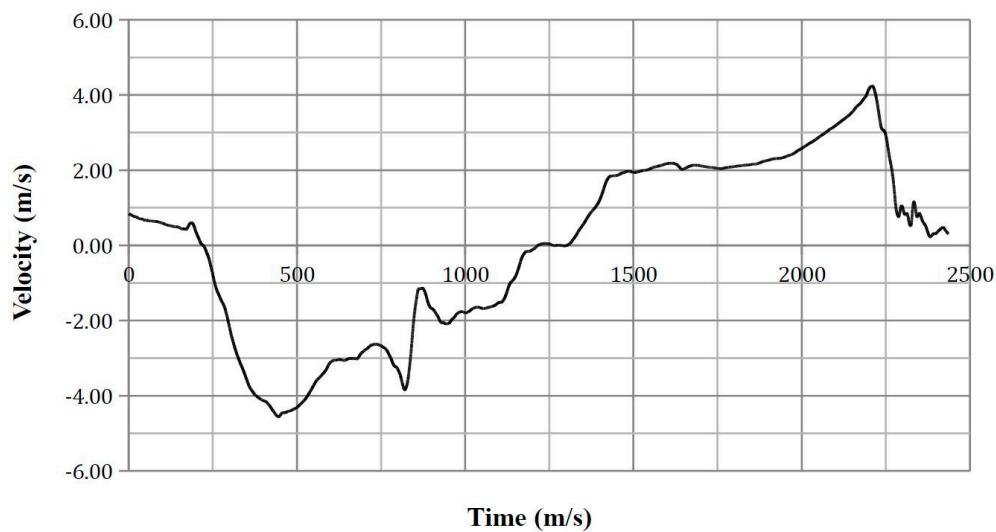
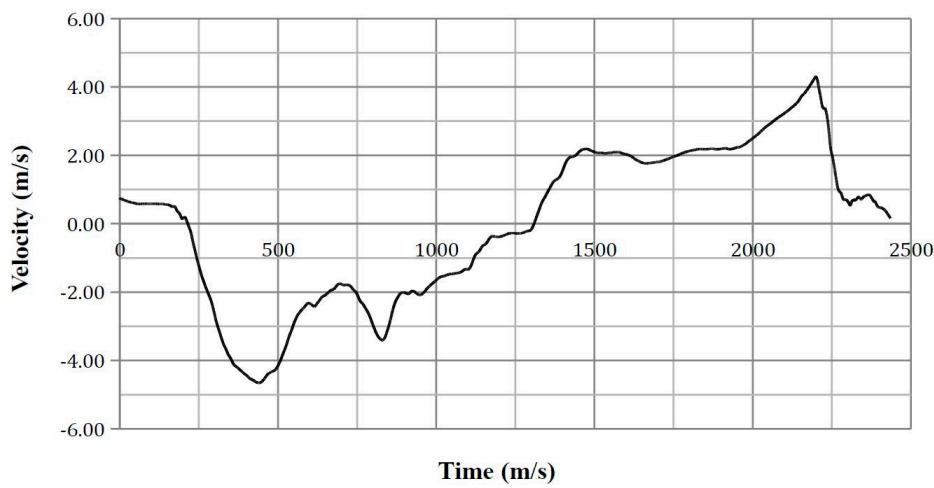
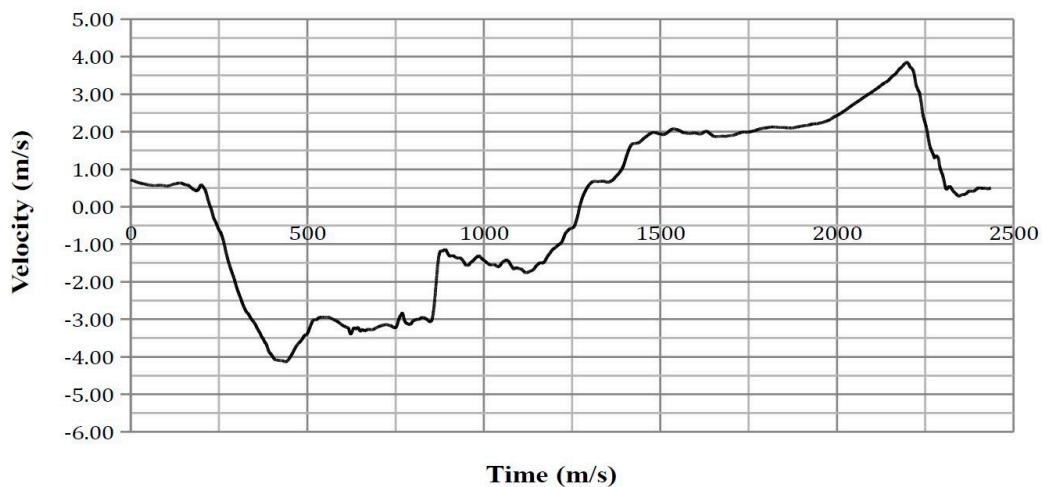
Y-axis velocity plots used in calculating ASA-10.

Figure A18. ATD Position 1 lower spine y-axis velocity.

Figure A19. ATD Position 2 lower spine y -axis velocity.

Figure A20. ATD Position 5 lower spine y -axis velocity.

Figure A21. ATD Position 8 lower spine y -axis velocity.

ASA-10 results are presented below (Table 9) with time-history plots presented in Appendix F.

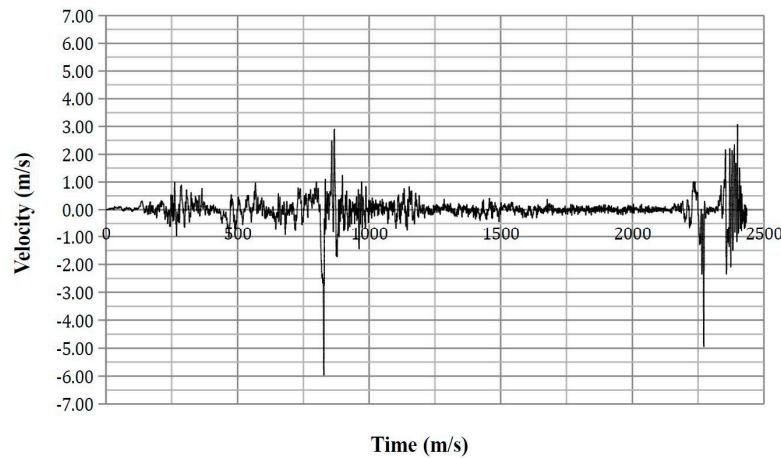
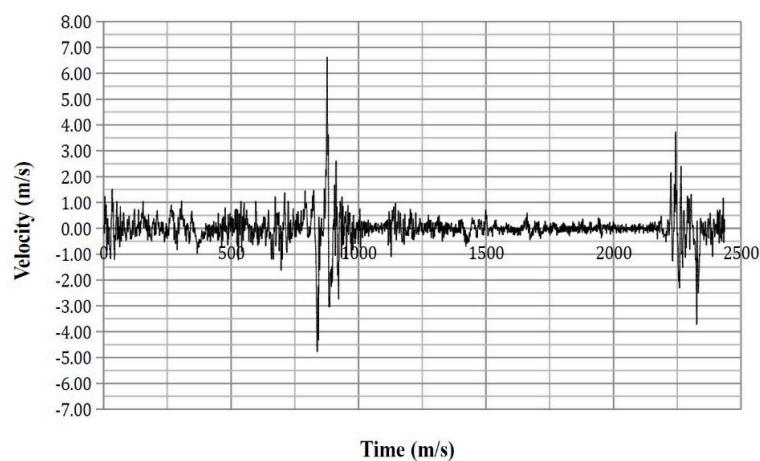
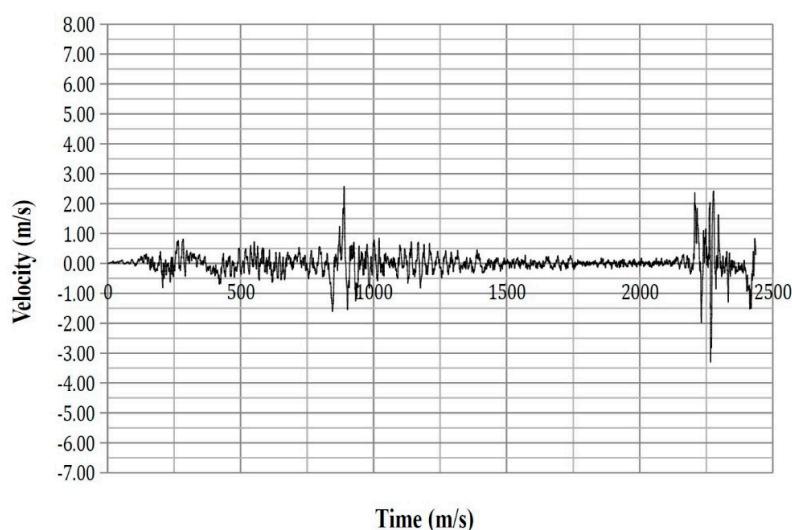
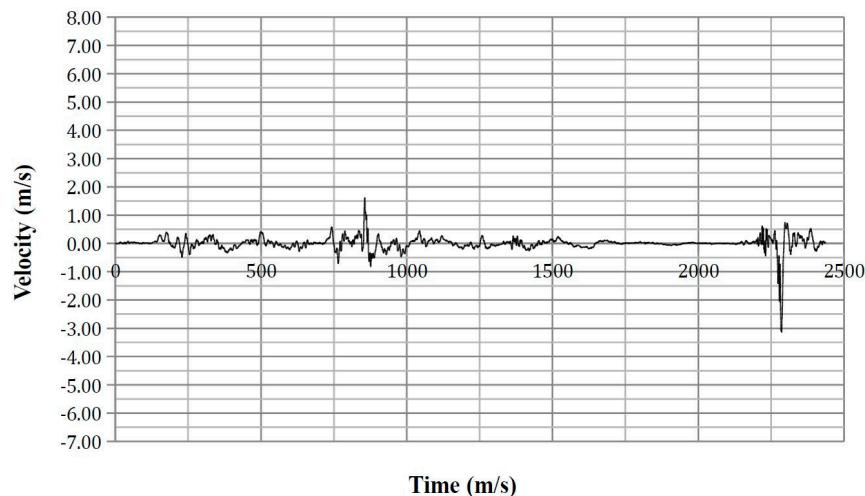
Lateral thoracic impact velocity time-history plots.

Figure A22. ATD Position 1 y -axis velocity for Node 380839.

Figure A23. ATD Position 2 y -axis velocity for Node 380823.

Figure A24. ATD Position 5 y -axis velocity for Node 380870.

Figure A25. ATD Position 8 *y*-axis velocity for Node 381218.

From the lateral thoracic impact graphs in Appendix G, it is noted that peak lateral thoracic impact velocities of up to 6 m/s were observed. However, this was due to the ATD head and left shoulder impacting the vehicle's roof rail interior and left door interior, respectively, and not the thorax impacting vehicle's interior.

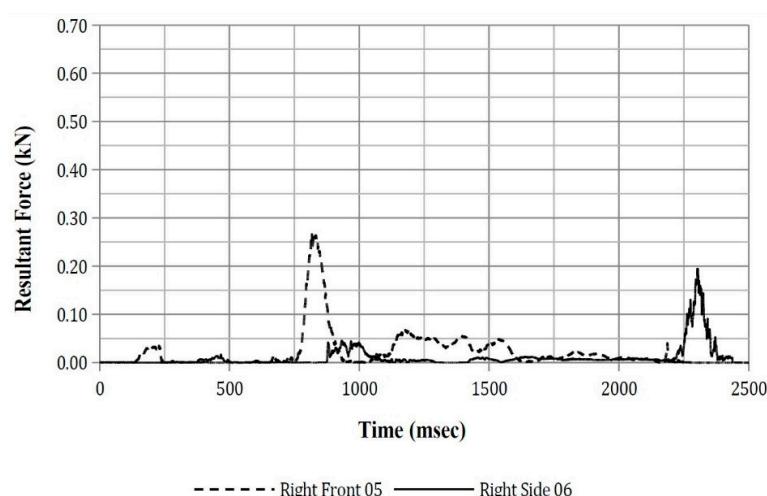
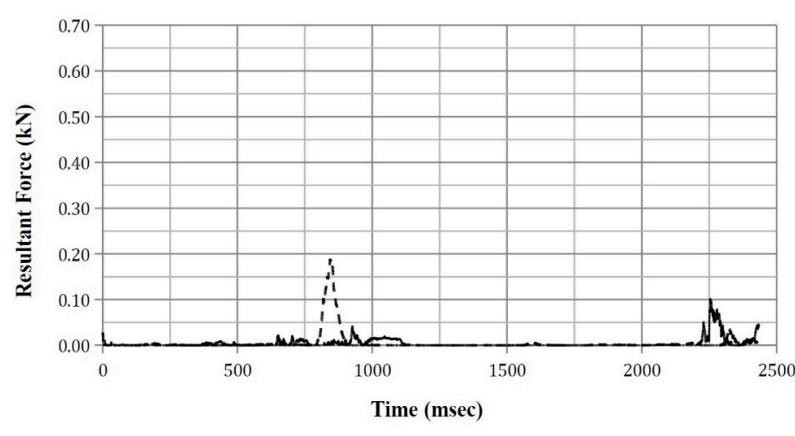
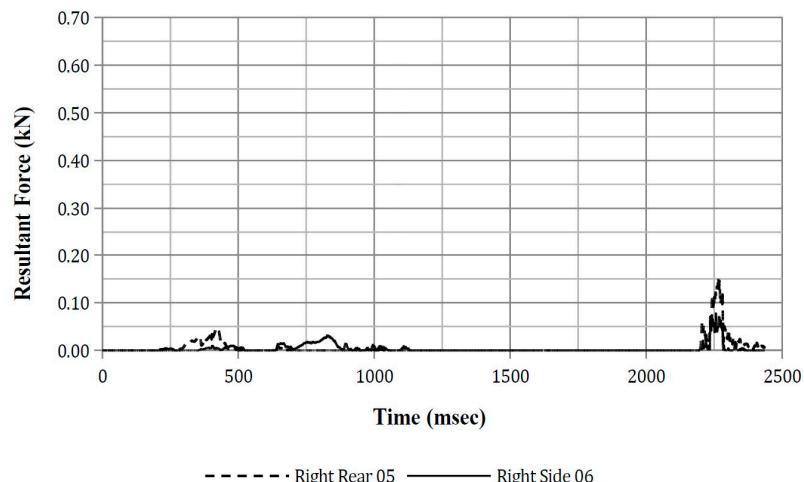
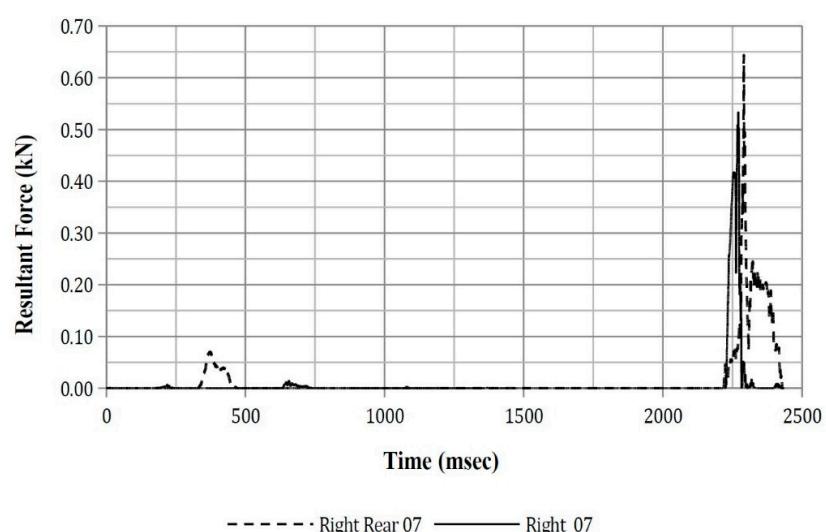
Maximum thoracic force time-history plots.

Figure A26. ATD Position 1 thorax resultant force.

Figure A27. ATD Position 2 thorax resultant force.

Figure A28. ATD Position 5 thorax resultant force.

Figure A29. ATD Position 8 thorax resultant force.
