Reconstruction of a Rollover Crash for Thoracic Injury Etiology Investigation

Tana Tan ^{*}, Mario Mongiardini, Raphael Grzebieta

Transport and Road Safety (TARS), University of New South Wales, Old Main Building (K15), Sydney, NSW 2052, Australia; mario.mongiardini@unsw.edu.au (M.M.); r.grzebieta@unsw.edu.au (R.G.); gmattos@friedmanresearch.com (G.M.)

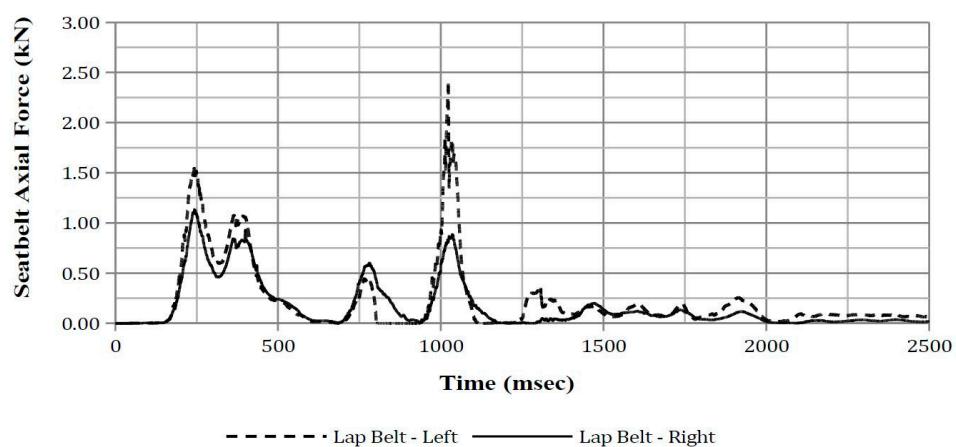
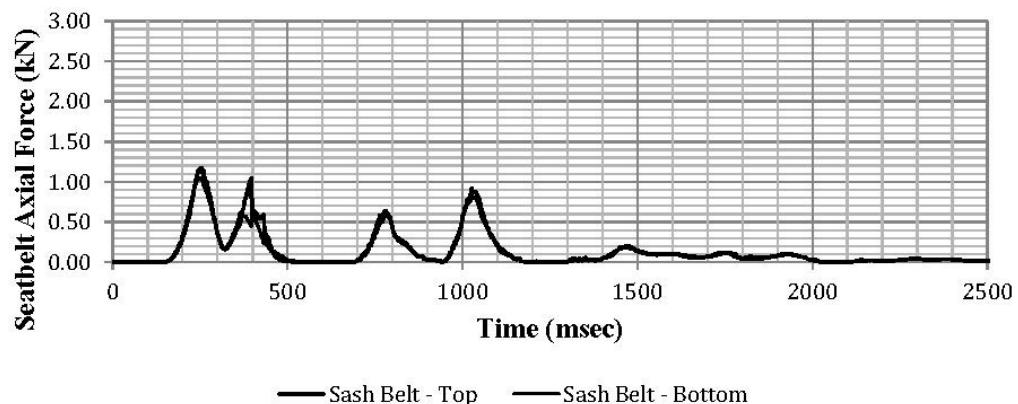
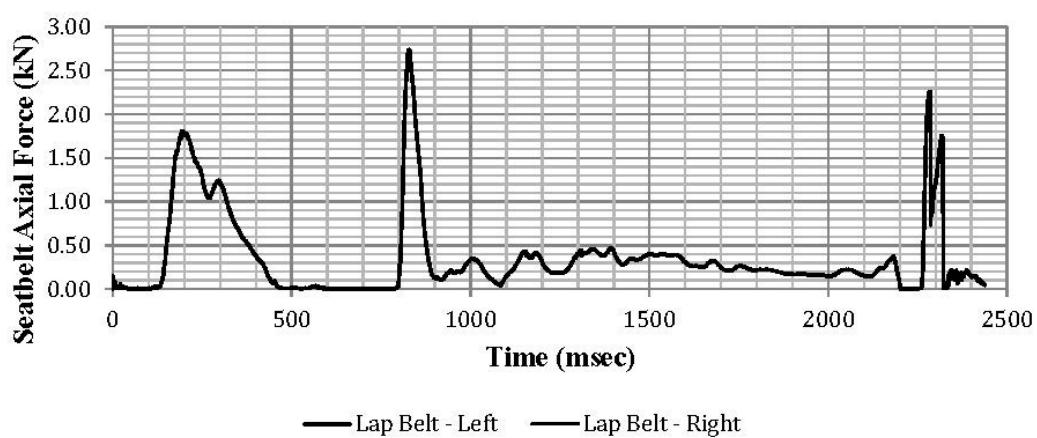
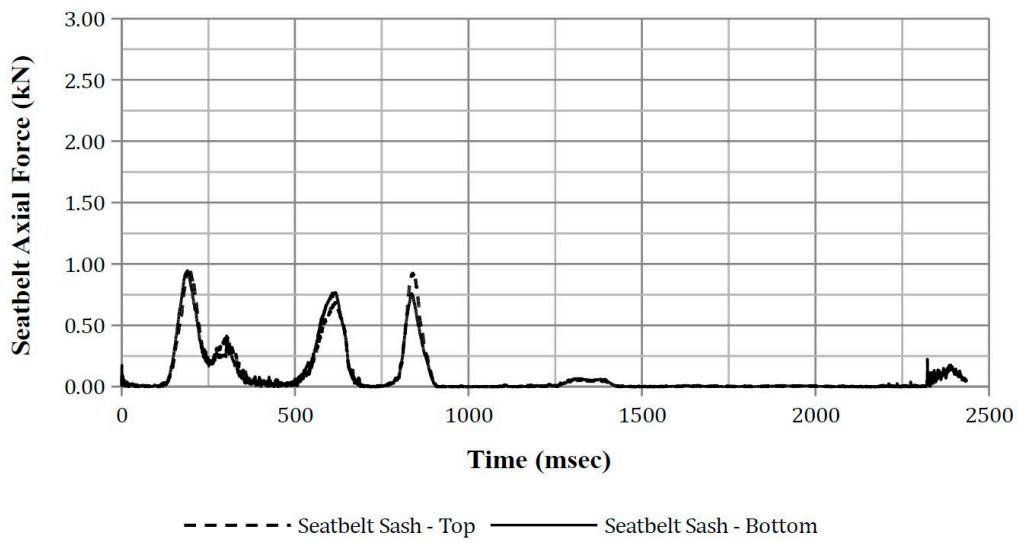
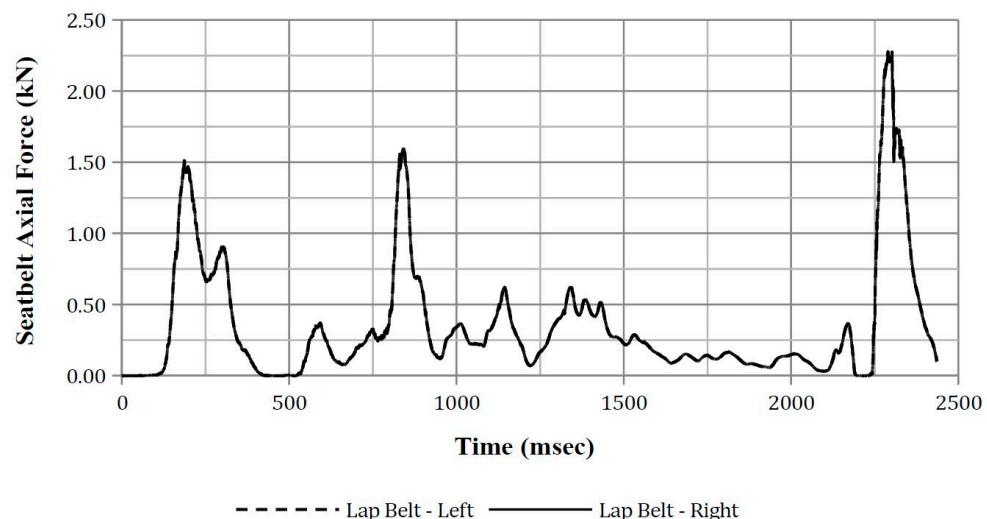
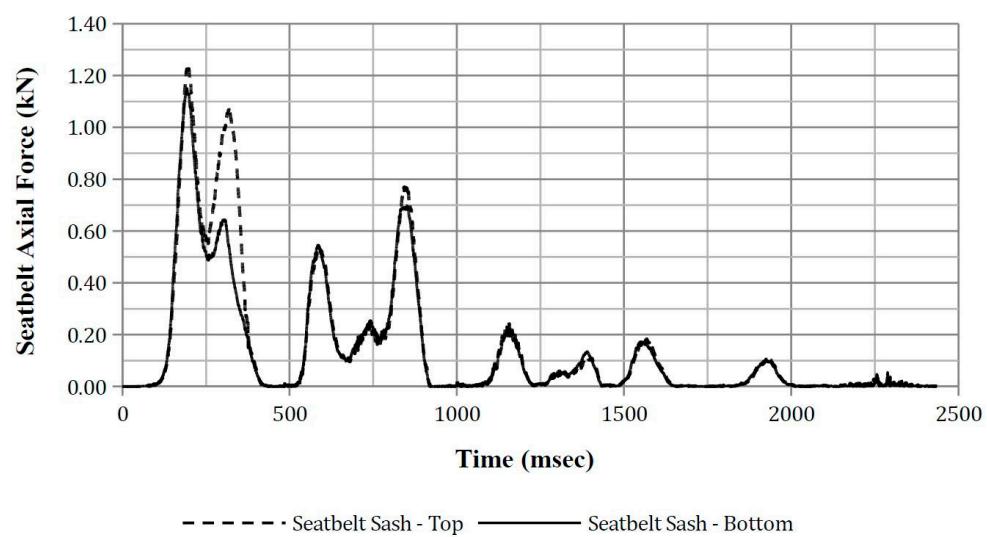
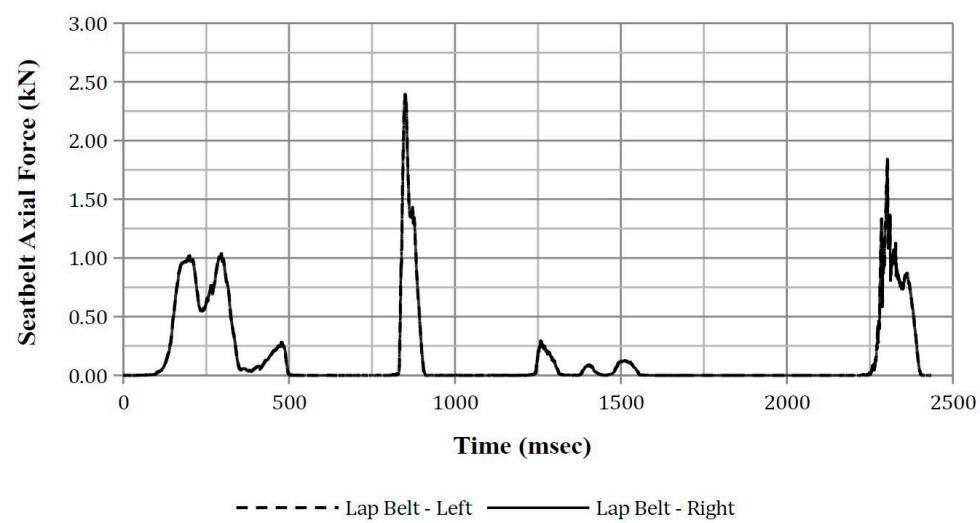
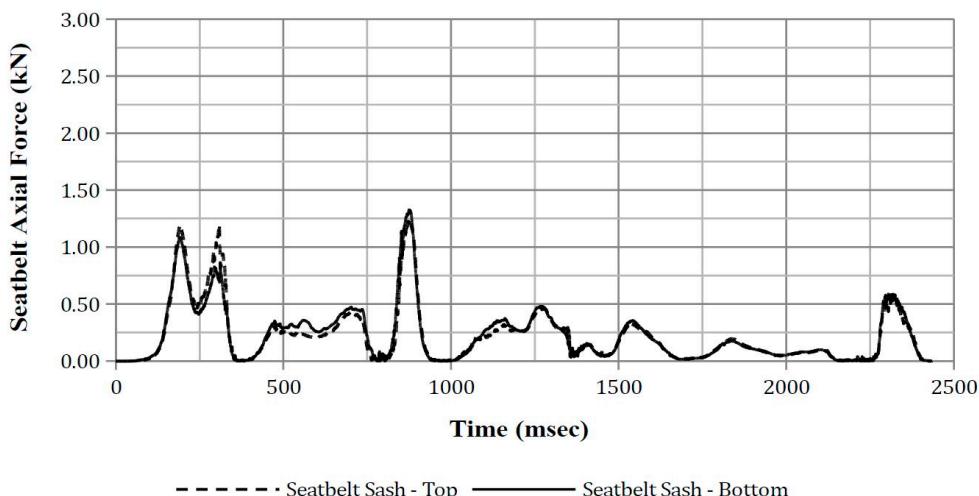
Seatbelt axial force for lap belt and sash time-history plots.

Figure A30. ATD Position 1 lap belt axial force.

Figure A31. ATD Position 1 sash belt axial force.

Figure A32. ATD Position 2 lap belt axial force.

Figure A33. ATD Position 2 sash belt axial force.

Figure A34. ATD Position 5 lap belt axial force.

Figure A35. ATD Position 5 sash belt axial force.

Figure A36. ATD Position 8 lap belt axial force.

Figure A37. ATD Position 8 sash belt axial force.

The maximum lap belt axial forces were observed to be between 2.28 and 2.74 kN and occurred during the second to third quarter-turn. The maximum observed axial force from this study are noted to be approximately three times higher than those measured in previous studies [56]. These observed higher axial belt forces is a reflection of the ATD pelvis moving upwards (i.e., away from the seat cushion) and towards the door and is restrained by the lap belt. It is noted that, when the ATD was in Position 5, the maximum lap belts axial force occurred during the fourth quarter-turn. This peak load was due to the lap belt being sufficiently taut, thus restraining the ATD as the right wheels impact the ground, which resulted in the ATD traversing and pivoting inboard.

The maximum sash belt axial forces for the ATD in Positions 1, 2, and 5 were observed to be between 0.95 and 1.23 kN. These peak forces occurred as the vehicle rotated just beyond ninety degrees and the ATD's thorax was partially restrained from moving anteriorly by the sash belt. The maximum sash belt axial force for the ATD in Position 8 was observed to be 1.33 kN and occurred while the vehicle was inverted and while the ATD's head was being pushed inboard and rearwards by the roof rail. This resulted in the thorax pivoting forwards and pressing against the locked seatbelt sash, thus resulting in the observed loads. This observed axial force is similar to the sash belt axial forces observed in previous studies [56].
