# **ADELAIDE IN-DEPTH ACCIDENT STUDY**

1975-1979

## **PART 7: ROAD AND TRAFFIC FACTORS**

**A.J. McLean  
W.J. Offler  
B.L. Sandow**

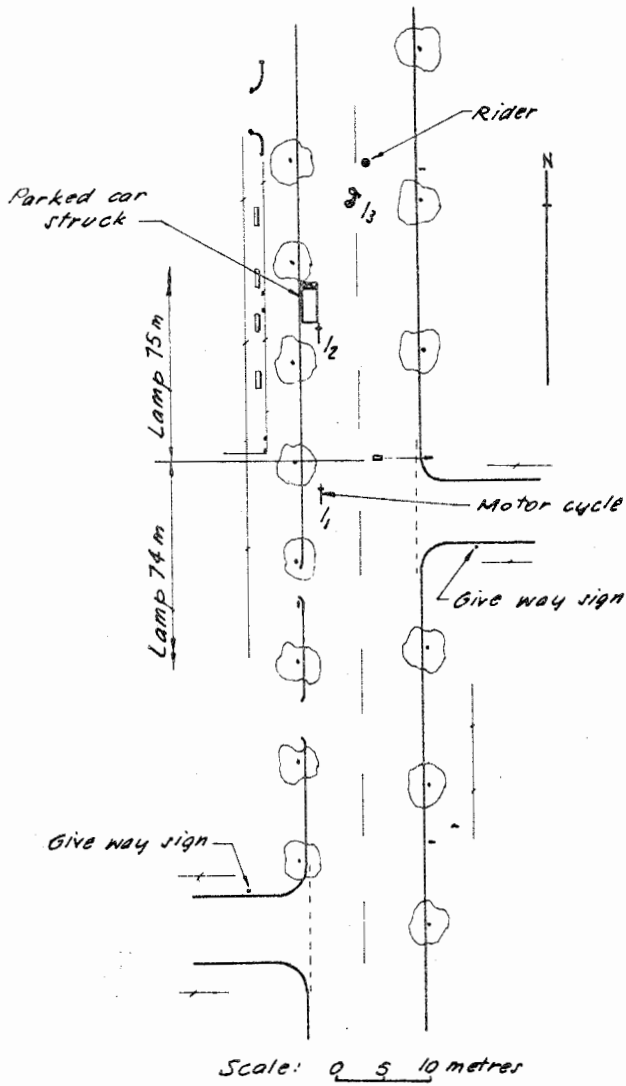
FIGURE 3.1: Accident 217.

The other five accidents in this group all happened on poorly-lit roads. While this would have made it more difficult for these drivers to see the parked vehicles, it is probable that alcohol intoxication was still the main causal factor, with one possible exception. Accident 217 occurred on an arterial road just past a signalised intersection. A motorcyclist, who had a heavy cold, sneezed as he was crossing the intersection. This is a considerable distraction when wearing a crash-helmet with the visor in place, and by the time the rider had recovered from it he realized that he was about to hit a parked car. The two lane exit from the intersection became one lane before the site of the accident. The rider had been in the kerb lane and this meant that he would have had to merge to his right to have avoided the parked car. He had a blood alcohol level of 0.11, which may have reduced his ability to react appropriately. Although sodium vapour lamps are installed on this section of road, as shown in Figure 3.1, the level of illumination is far from uniform due to the distance between the lamps and the blanketing effect of the foliage of the trees at the roadside. The resulting dark patches are accentuated at this location by the uniformly high intensity of the illumination of the adjoining signalised intersection.

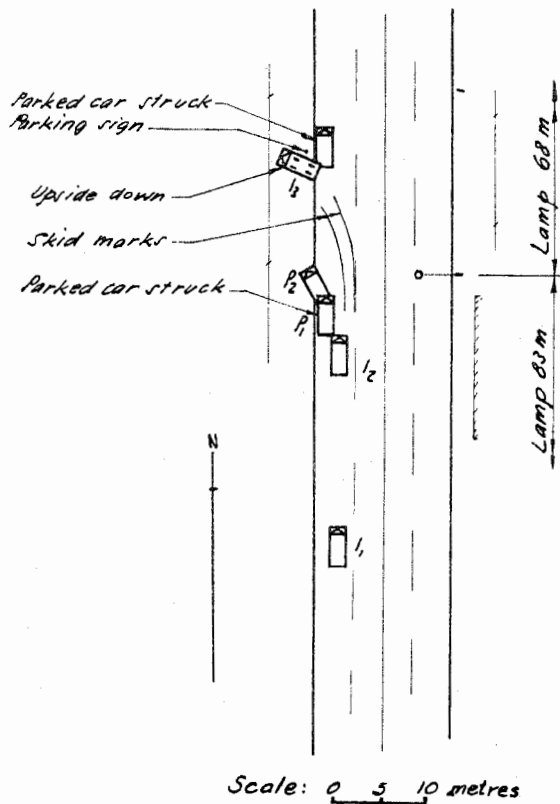
FIGURE 3.2: Accident 071.

One other of these alcohol-involved accidents occurred on an arterial road. In this accident (071, Figure 3.2) the mercury vapour lamps provided a non-uniform level of illumination. The driver of the car had a blood alcohol level of 0.21 and the very poor static visual acuity of 3:36 in both eyes, was not corrected by wearing glasses. His car hit the right rear corner of a parked car (Figure 3.3) and then yawed anti-clockwise and rolled onto the back of a second parked car (Figure 3.4). He reported that he had been talking with his passenger when he hit the first car, which he had not seen, and that he thought that alcohol had only contributed to a small degree, if at all, to his being involved in this crash. This case is listed in Table 3.1 under "Veered to the left" but the car may well have been proceeding straight ahead.

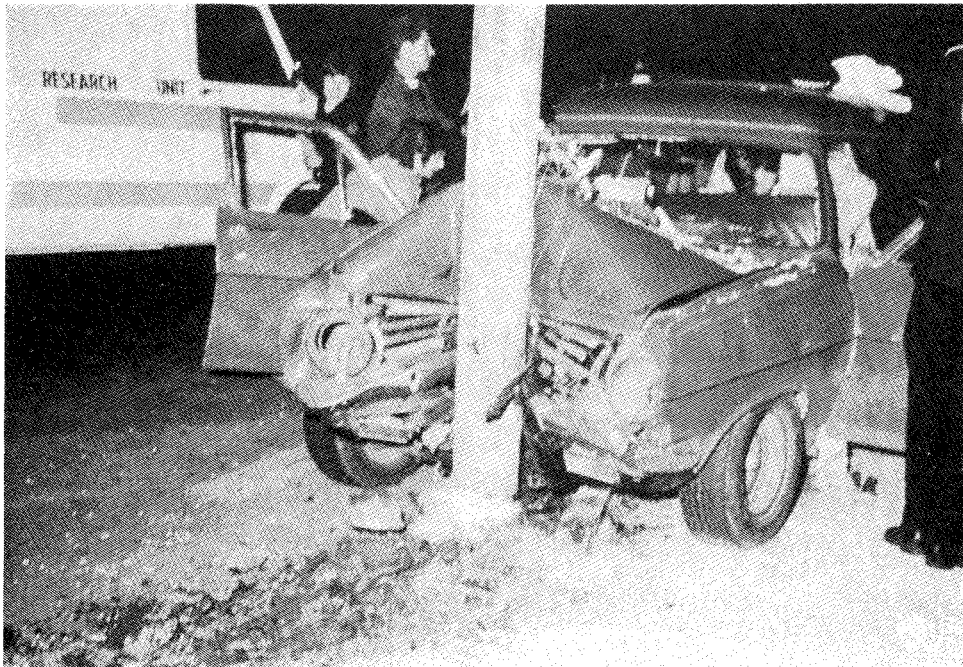
We believe that two of the intoxicated drivers may have fallen asleep. In Accident 051, a witness who was travelling in the other direction said that he saw an oncoming car pull over to the side of the road and then its lights went out. He assumed that it had parked but when he got closer he saw that it had crashed into a pole (Figures 3.12 to 3.15). The pole itself was not badly damaged (Figure 3.14) but this was not true for the car (Figure 3.15). The occupants, neither of whom were restrained, would not have survived had emergency care not been available within minutes of the crash. The driver had a broken neck and chest injuries which made breathing very difficult. The passenger also had severe chest injuries and facial and brain injuries.

FIGURE 3.12: Removal of critically injured driver from car following collision with utility pole : Accident 051.

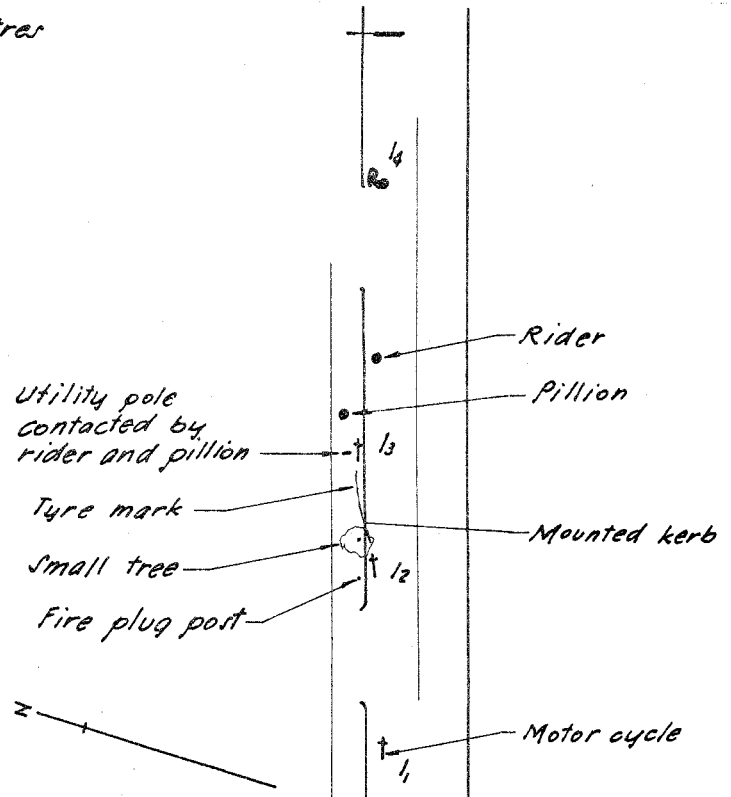
FIGURE 3.24: Accident 289.

The third accident of this type involved a motorcycle which ran up onto the footpath some distance after exiting from a right-hand right angle bend (Accident 289, Figures 3.22 and 3.24). The 16 year old rider and his pillion passenger both hit their heads on a Stobie pole which was narrowly missed by the motorcycle. Despite the fact that they were both wearing crash helmets they were both killed. The rider had a blood alcohol level of 0.14, and had been licensed for six months.

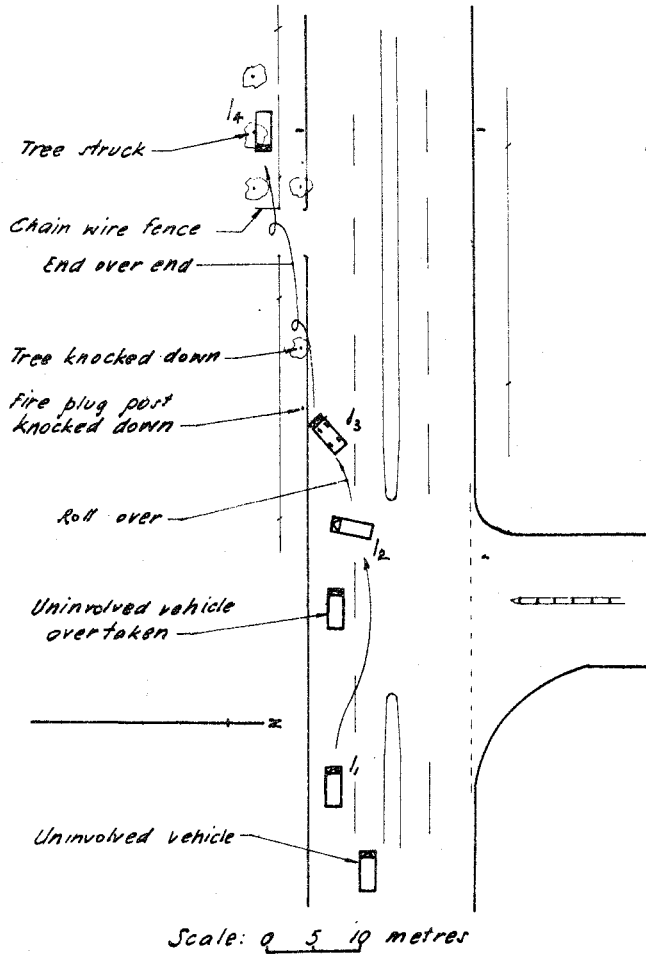
FIGURE 3.28: Accident 237.

One of the two accidents involving the loss of lateral stability (Table 3.1) seems to have happened largely because the driver was intoxicated (BAC 0.19). He passed one car on its left, then swerved across into the right lane to pass another car (Accident 237, Figure 3.28). On swerving back to the left lane his car yawed anti-clockwise and rolled over. It left the road, knocking down a hydrant marker post, a small tree and a chain wire fence before crashing into a large tree located on private property. The driver had no idea why the accident happened.

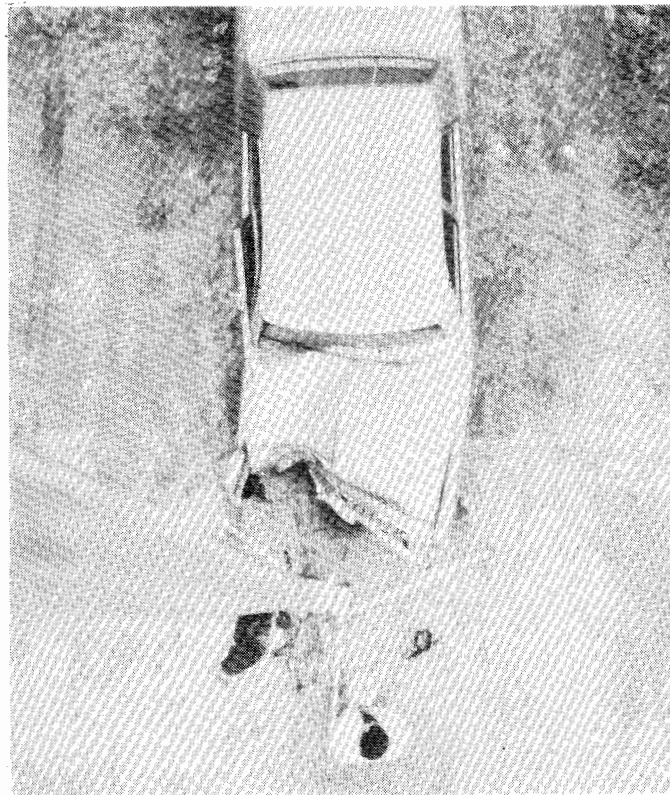
FIGURE 3.31: Damage resulting from collision with tree :  
Accident 057 (See also Figures 3.30 and 3.32).

FIGURE 3.32: See Figures 3.30 and 3.31.

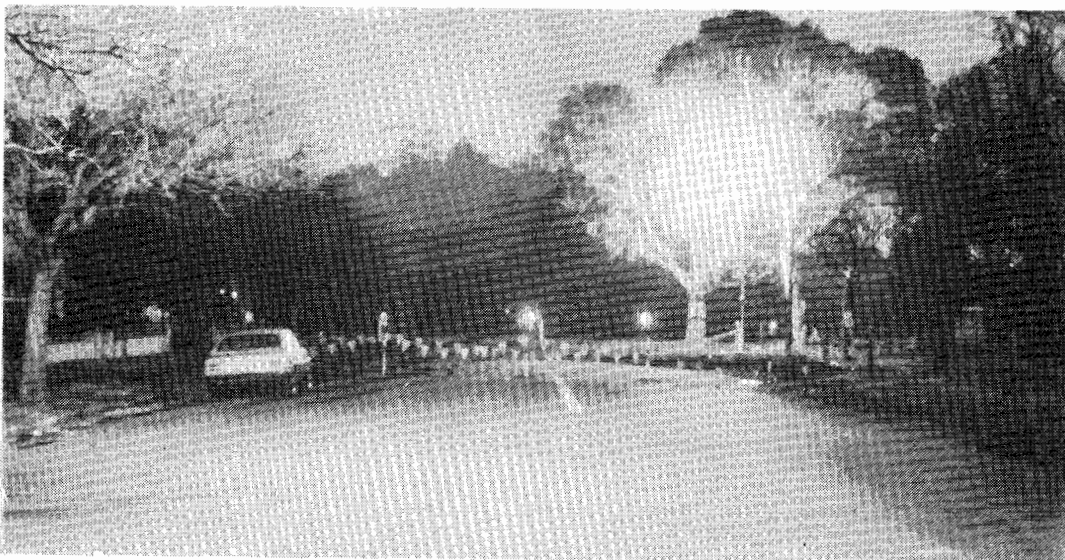
FIGURE 3.42: Roadworks warning barrier (see Figure 3.41).

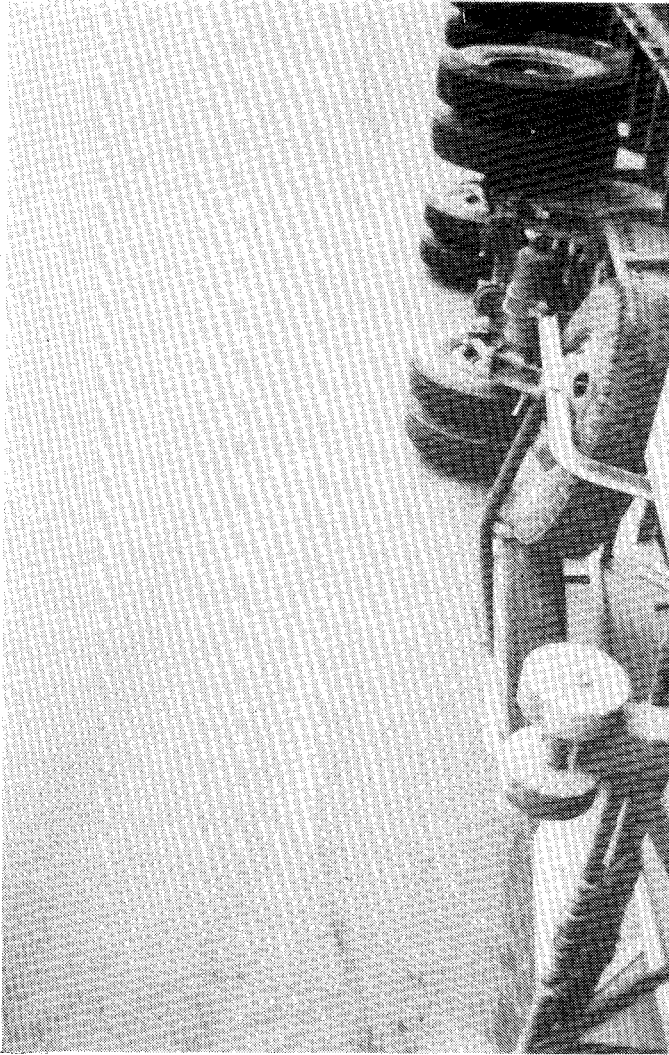
FIGURE 3.45: Capsized semi-trailer, showing scuff marks on road surface : Accident 013.

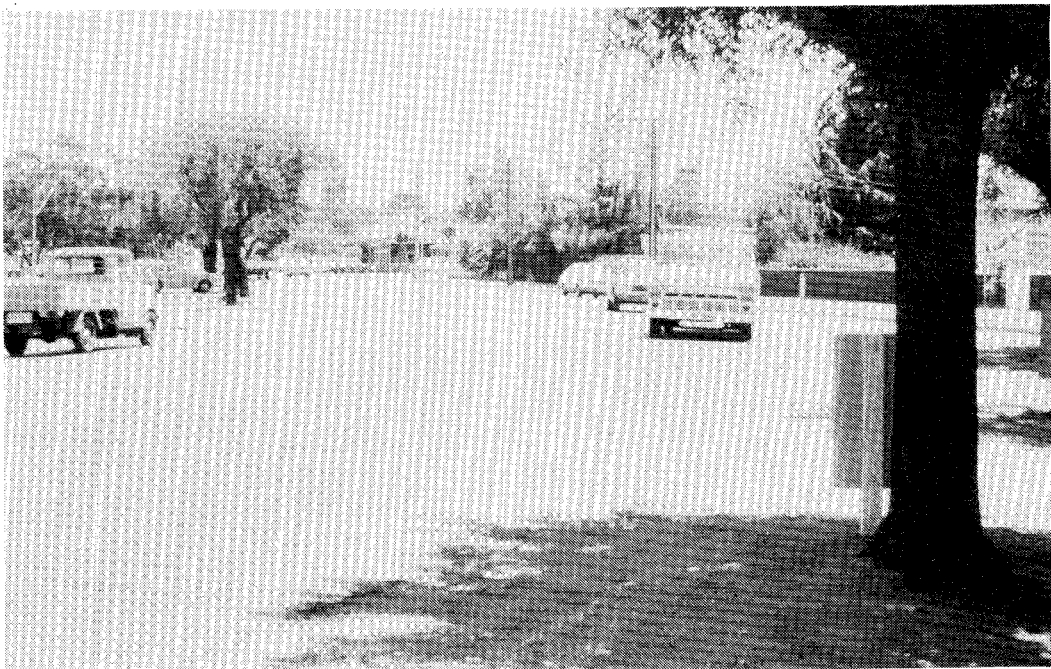
FIGURE 3.46: View back along the approach path for the semi-trailer in Accident 013 (see Figures 3.44 and 3.45)

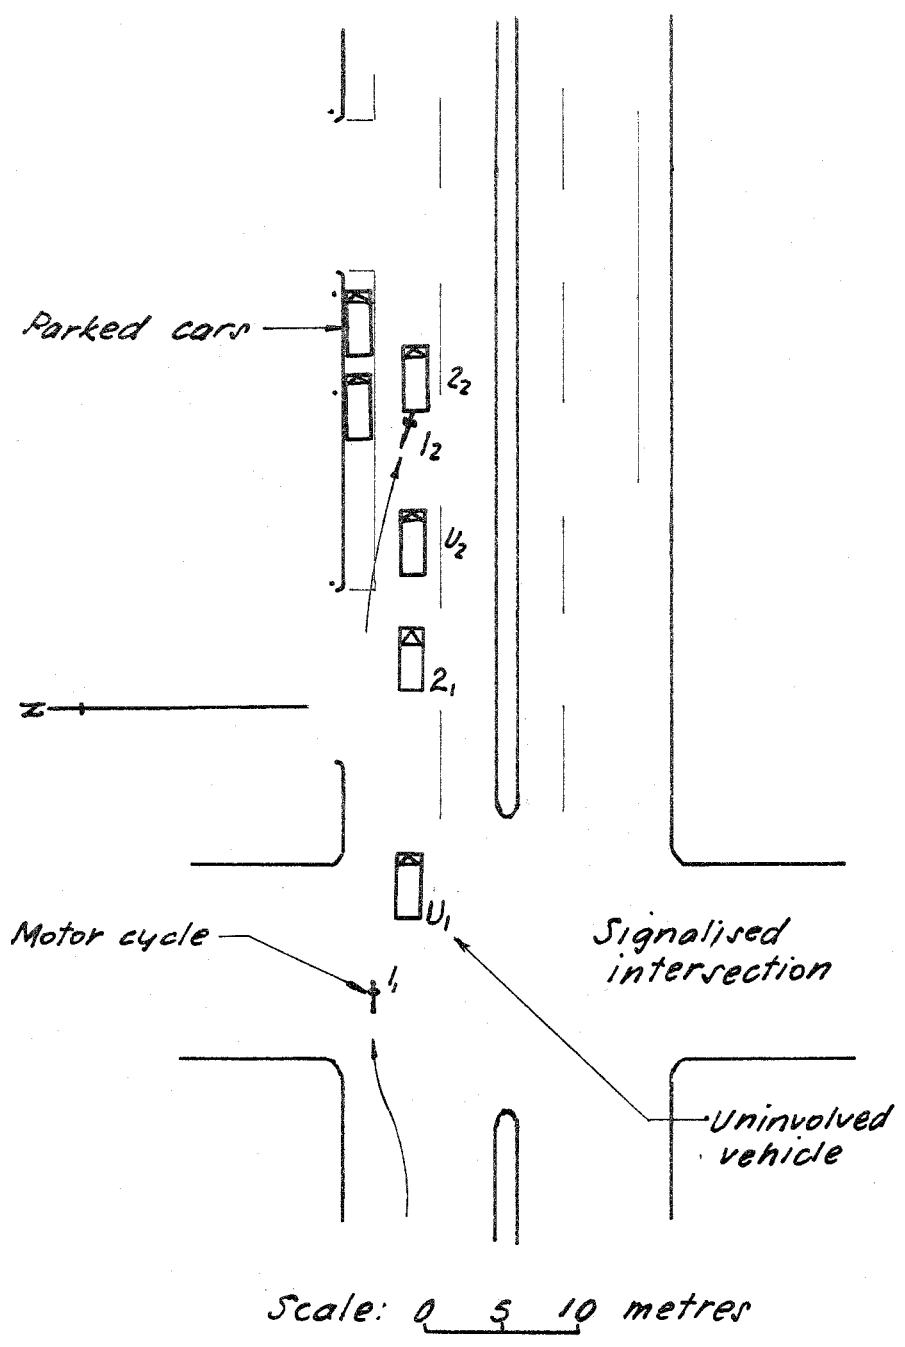
FIGURE 4.3: Accident 243.

A 20 year old motorcyclist who had a BAC of 0.12 swerved across to the left lane of three available lanes, to pass a car which he thought was slow to move off when the traffic signals changed to green (Accident 243, Figure 4.3). The left lane became a parking lane soon after the

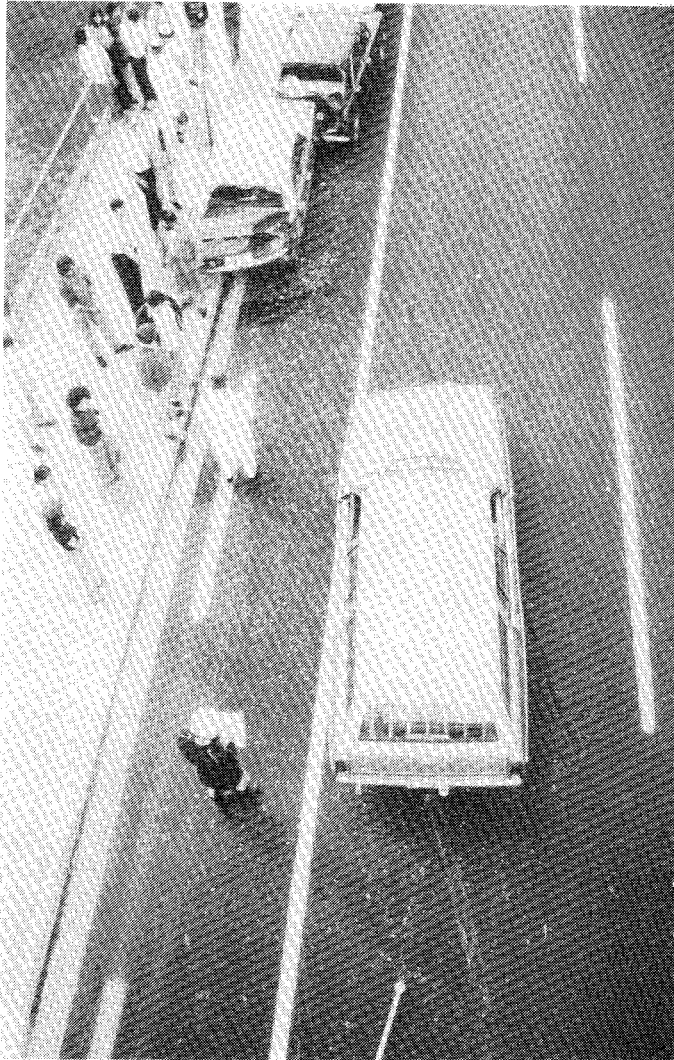
In Accident 021 a driver slowed down in the left hand lane of a four-lane divided road and then drove into a gap between two parked cars, intending to park at the kerb. The gap was smaller than she thought and so she stopped with her car at an angle, with the back still out in the traffic lane. She then saw a car coming up behind her in that lane and immediately thought that she was going to be hit, even though the other car was some distance away. The other driver had just turned around after missing a left turn at a nearby intersection. He said that he saw the car ahead of him slow down, the brake lights came on, and he then checked his rear vision mirror to see if the right hand lane was clear. When he looked back the car in front had stopped. He braked hard, but skidded into the back of it, pushing it into the row of parked cars (Figure 4.4).

FIGURE 4.4: Rest positions of cars after rear-end collision : Accident 021.

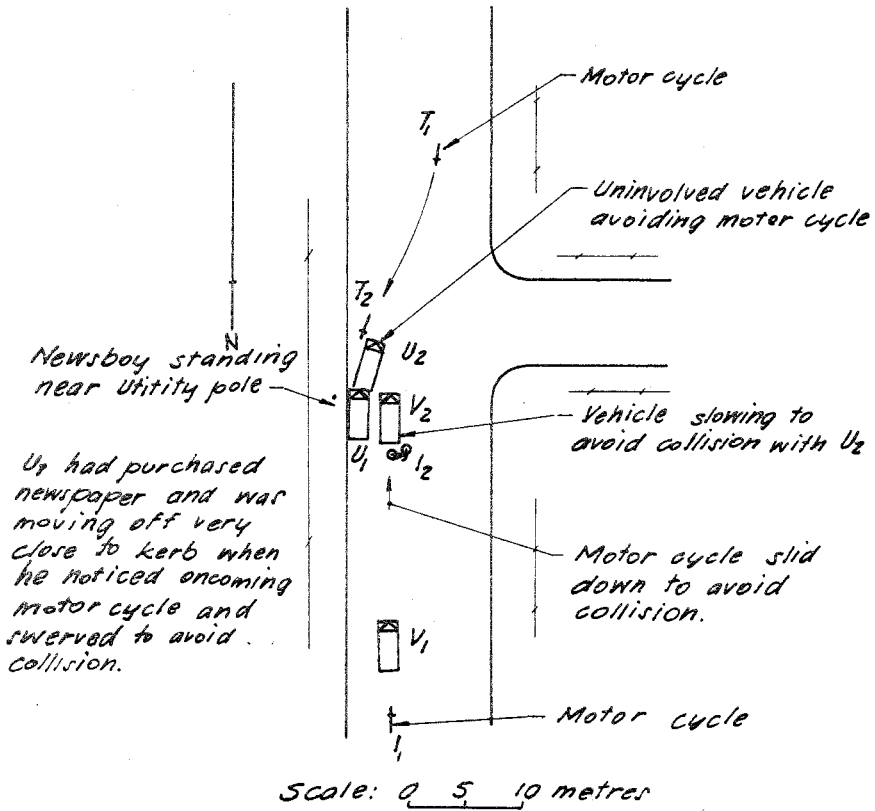
FIGURE 4.5:  
Accident 227.

A 21-year-old female motorcyclist bumped into the back of a car that braked unexpectedly when another car pulled away from the kerb at a sharp angle after the driver had bought a newspaper from a paper boy (Accident 227, Figure 4.5). The car that left the kerb had moved out to avoid an oncoming motorcycle that had swerved across in front of it, on the wrong side of the road, to get to the paper boy. The motorcyclist tried to brake as soon as she realized that the car ahead of her was stopping, but she used the wrong foot. Her confusion arose from the fact that she had recently been riding another motorcycle which had the footbrake pedal on the left hand side, whereas her machine had it on the right. By the time that she managed to apply the brake she had hit the back of the car and then fell to the roadway.

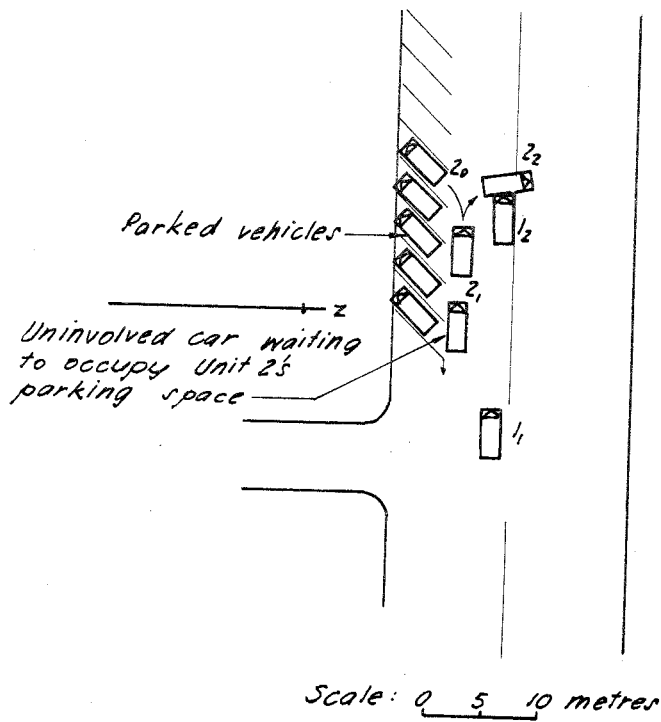
FIGURE 4.6: Accident 195.

Figure 4.6 shows the sequence of events in Accident 195, in which a 35-year-old male driver reversed out of an angle-parking space with another car stationary in the roadway behind him, waiting to move in to park. Having reversed out, the driver then tried to do a U-turn, thinking that the road was clear. As he turned he heard the sound of a car horn and, at almost the same instant, his car was hit on the side. Although he had not seen the through vehicle approaching this driver admitted that he was unable to turn his head to look to the rear when seated in a car and, not having an outside rear-vision mirror, he had had to rely on what he could see in the interior mirror. The driver of the through vehicle saw the two cars stationary ahead of him but did not expect the front one to attempt a U-turn. This driver said that he was travelling at 55 to 60 km/h, a speed which, while legal, could be considered to be excessive under the circumstances.

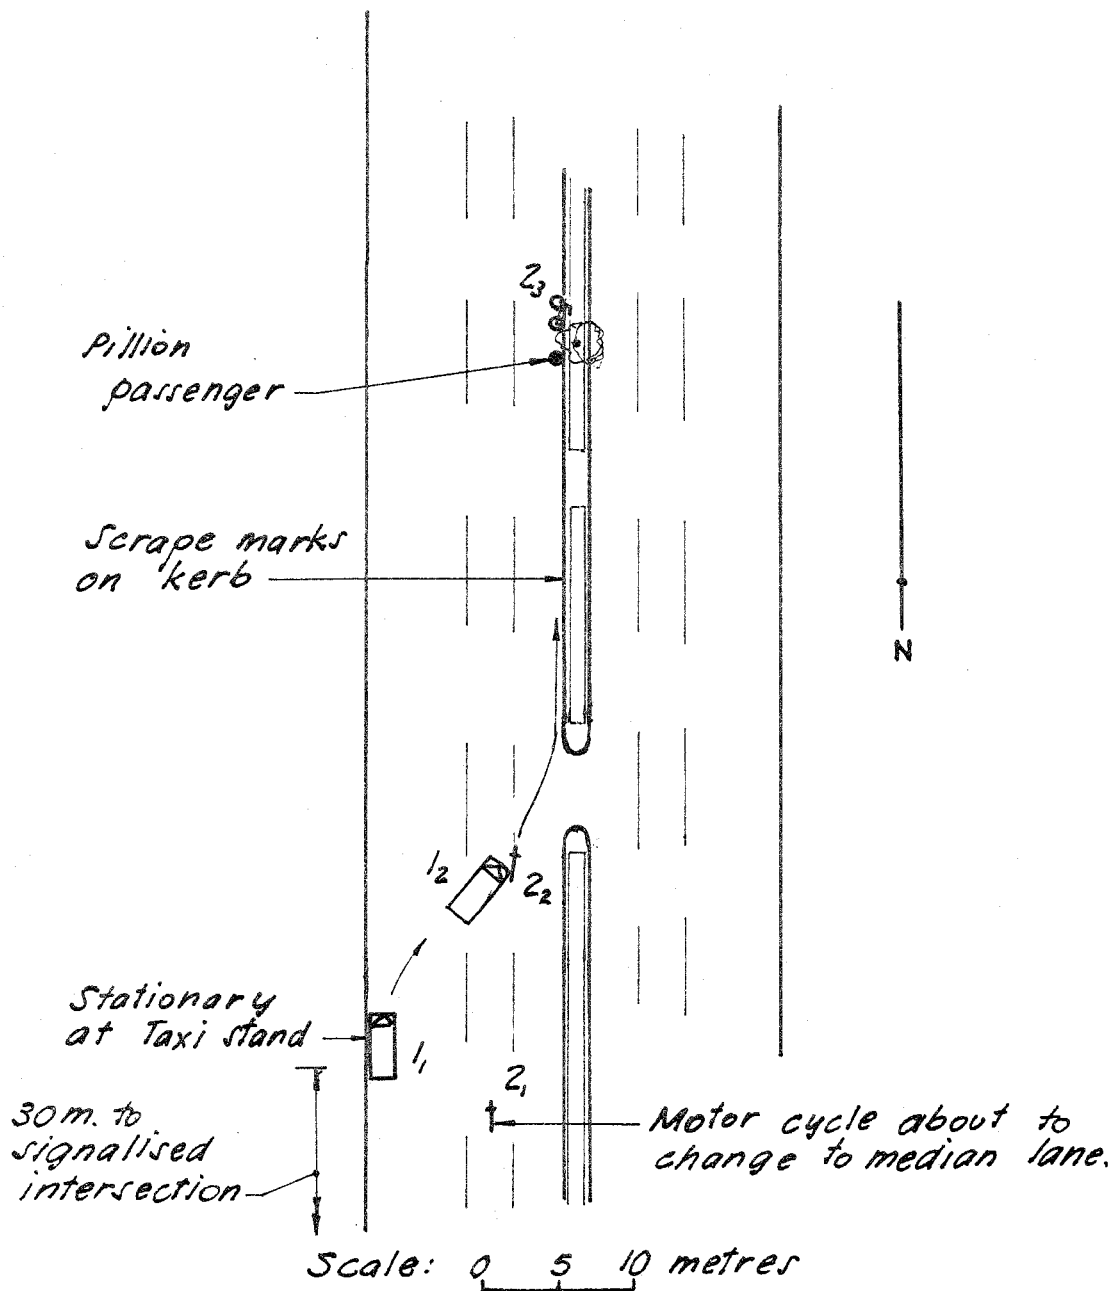
FIGURE 4.7 : Accident 281.

The third motorcycle accident in this category occurred in the central city area (Accident 281). A taxi driver had just taken on a fare. He turned and looked behind him and, noting that the traffic lights were red, moved off. Intending to move across to a gap in the median and perform a U-turn, he entered the second lane (Figure 4.7) and looked in his rear vision mirror to see if it was still clear for him to cross to the lane adjacent to the median. As he was doing this he heard a thump at the front of the car. On looking round, he saw a motorcycle veering across towards the median strip. The machine hit the kerb and ran along it for a short distance before sliding down. The rider of the motorcycle said that he had accelerated away from the intersection when the lights changed, and was checking that it was safe to move from the centre lane to the one adjacent to the median when he felt the motorcycle wobble. He was unable to correct this wobble before the wheels hit the median. His pillion passenger said that the front corner of the taxi hit her left leg. The headlight of the motorcycle was on at the time of the collision

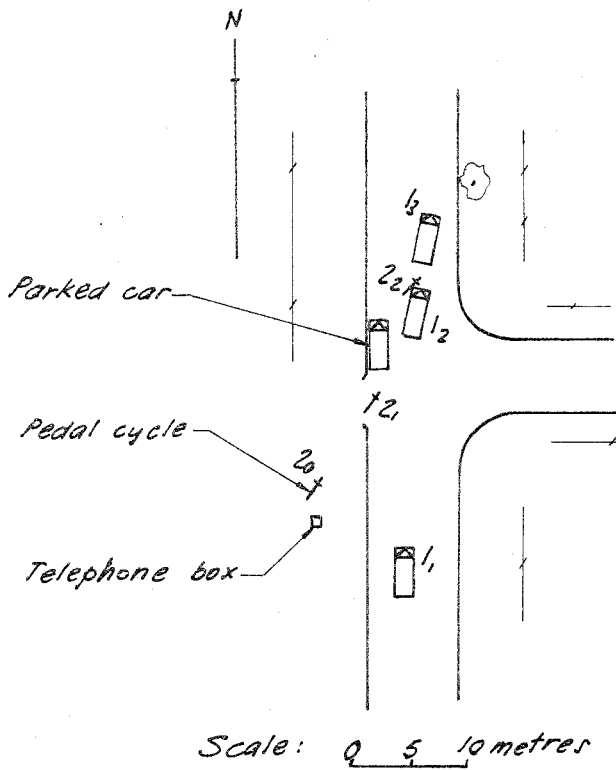
FIGURE 4.8: Accident 177.

In Accident 177 a ten-year-old cyclist rode out from behind a telephone callbox on the left hand side of the road. He swerved left around a parked car, and then suddenly turned right, just as a car was about to overtake (Figure 4.8). This accident occurred at a T-junction, as can be seen in the Figure, but it is classified here as a midblock collision because the presence of the intersection had no discernable influence on the actions of either the driver or the cyclist, who was crossing to a property on the right beyond the intersection.

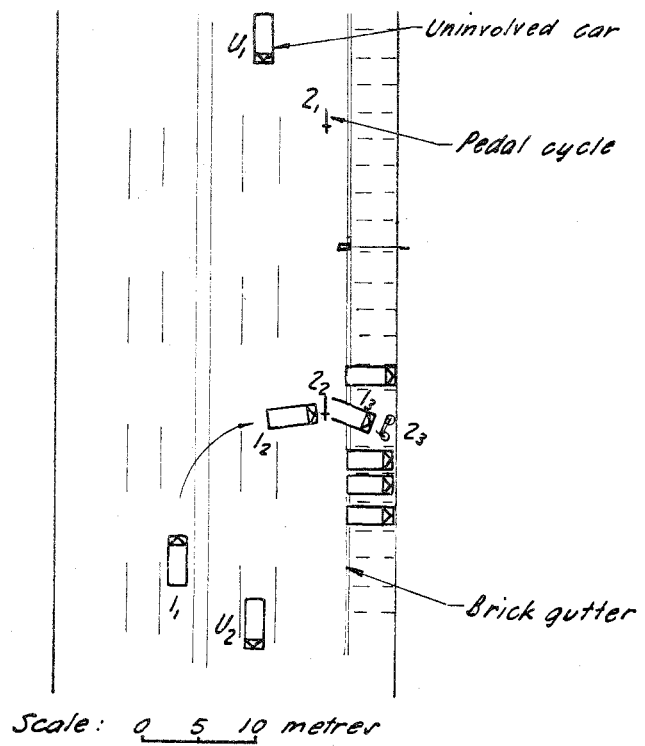
FIGURE 4.9: Accident 069.

The other collision involving a cyclist occurred in heavy rain at night (Accident 069). The car driver turned right, after waiting for an oncoming car to pass, to cross the road and enter a parking space (Figure 4.9). He slowed down to cross a brick-paved gutter, and was about

to accelerate into the parking space when a cyclist hit the left front side of the car and was thrown over the bonnet. The driver had not seen the cyclist at all before the impact. The street lighting on the approach path of the cyclist was good, with a sodium vapour lamp directly above, but the conspicuity of the rider was greatly diminished by the weather conditions. The cyclists had seen the car waiting in the centre of the road, and had anticipated the possibility that it might turn across in front of him, but when it did so he found that he could not stop because the brakes on his bicycle were ineffective, because of water on the wheel rims.

The quality of the illumination provided by the street lighting was reasonably good at the locations of the night accidents (069 and 078) and yet the turning driver was not aware of the presence of the approaching vehicle in either case (partly because of other factors noted above). As both locations were close to signalised inter-sections further investigation of the lighting requirements of such sections of road may be worthwhile. Consideration might also be given to restricting turning movements of the type described here within, say, 100 metres of a signalised inter-section.

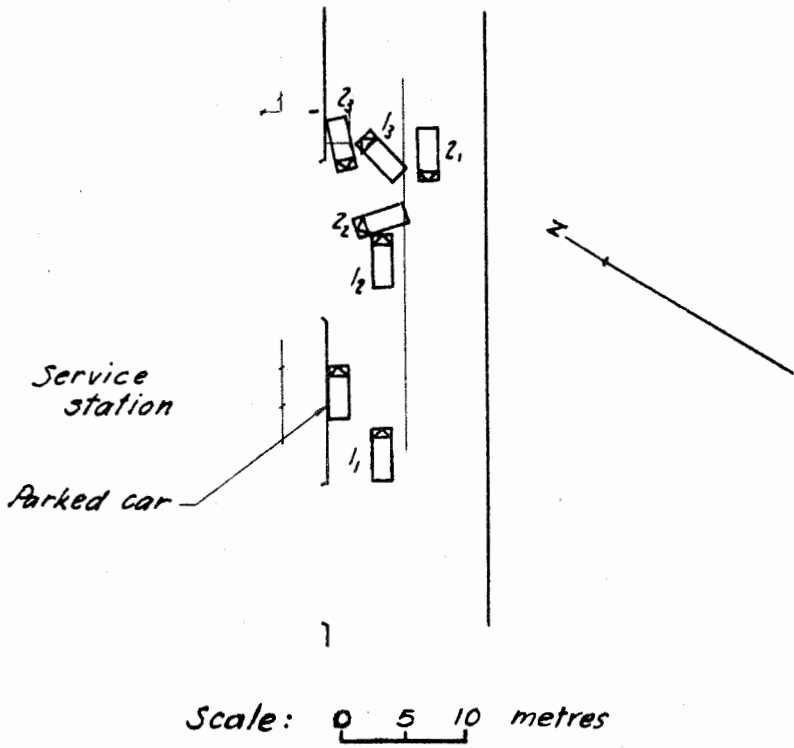
FIGURE 4.10: Accident 012.

A driver who was concerned that her car was low on petrol decided to turn right into a service station to see if it had an after-hours self-service pump. She saw a car coming towards her, but thought that she had ample time to complete the turn. As she turned, however, her car hesitated, then picked up, then hesitated again. Before it reached the driveway entrance it was hit on the left side by the oncoming car (Accident 012, Figures 4.10 and

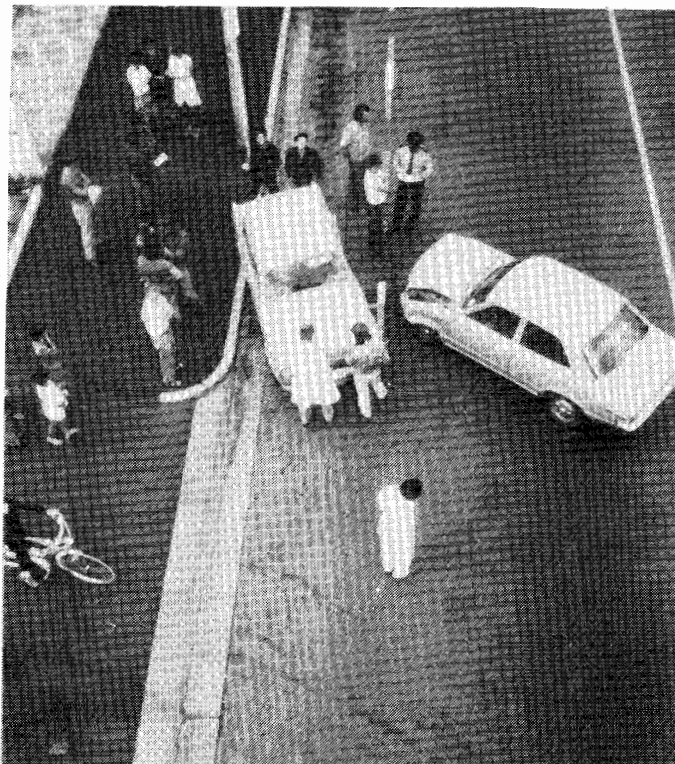
FIGURE 4.11: Cars in final position of collision sequence shown in Figure 4.10.

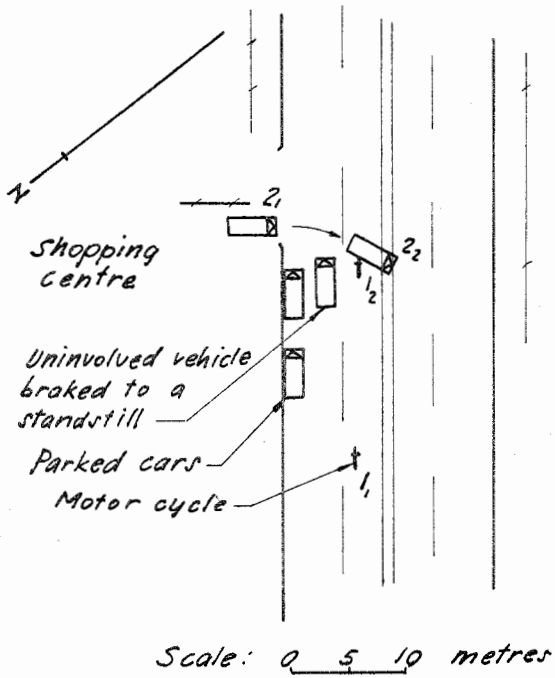
FIGURE 4.12: Accident 092.

In Accident 092 a 19-year-old motorcyclist, who was travelling in the centre lane, noticed the brake lights go on on a car ahead of him that was in the kerb lane. He assumed that there was some hazard ahead of that vehicle, but was still taken by surprise when another car suddenly appeared from his left in front of it. He tried to swerve to his left to go around the back of this car as it moved across in front of him but still collided with the right rear corner (Figure 4.12).

Turning movements out from off-road parking areas can be as hazardous as movements into them. Both Accident 092 and 257 could have been prevented by preventing traffic from turning right when entering the roadway. This could be achieved by a raised median or, possibly less effectively, by a regulatory sign prohibiting right hand turns. A lower (than 60 km/h) speed limit in shopping and business districts might help to reduce the frequency of this type of collision. This practice is used in some States in the U.S.A. (eg: North Carolina, where the built-up area speed limit of 35 mph is reduced to 25 mph in business districts).

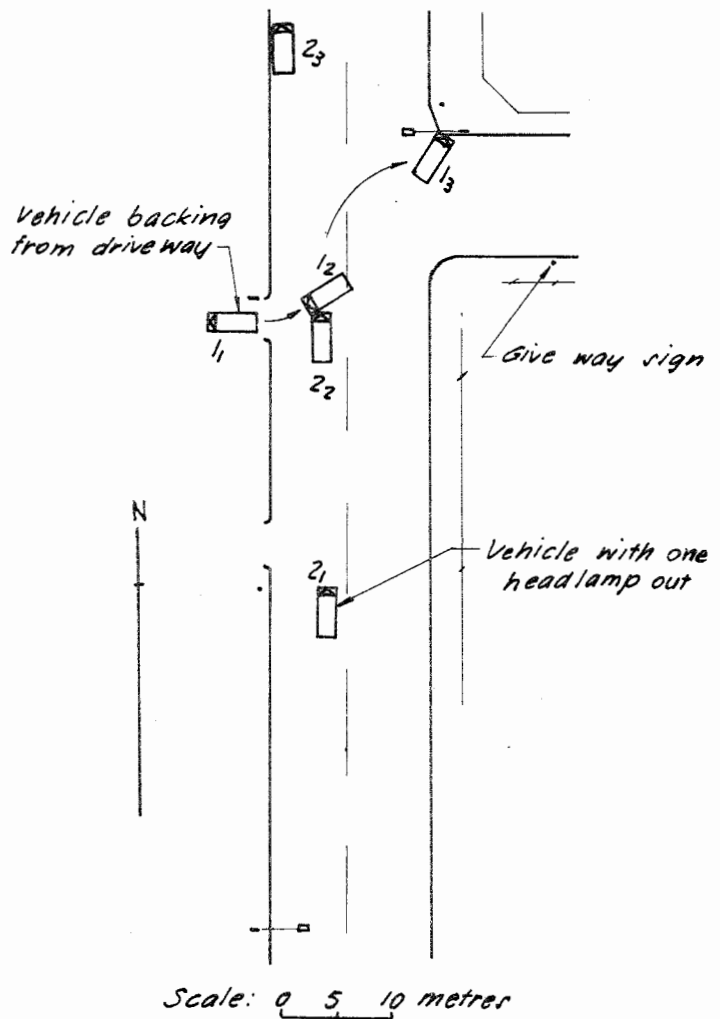
FIGURE 4.13: Accident 188.

off (Accident 188, Figure 4.13). He said that he stopped before backing onto the road and checked for traffic approaching from his left. Seeing none, he continued reversing. He had just reached the centre-line of the road when his passenger shouted that a car was about to hit them. Their car was struck on the front of the left side and was pushed backwards and rotated clockwise through 180 degrees. They claimed that the striking car did not have its headlights on.

The collision involving a car reversing onto the roadway occurred midway between two widely-spaced sodium vapour lamps. These lamps were 70 metres apart and located alternately four metres away from the centreline of a 14 metre wide two-way two lane road. The high BAC level of the driver in the striking car and the fact that only one headlight was operating were the major causal factors in this accident but the non-uniform artificial lighting would have made more difficult the task of detecting the presence of the other car.

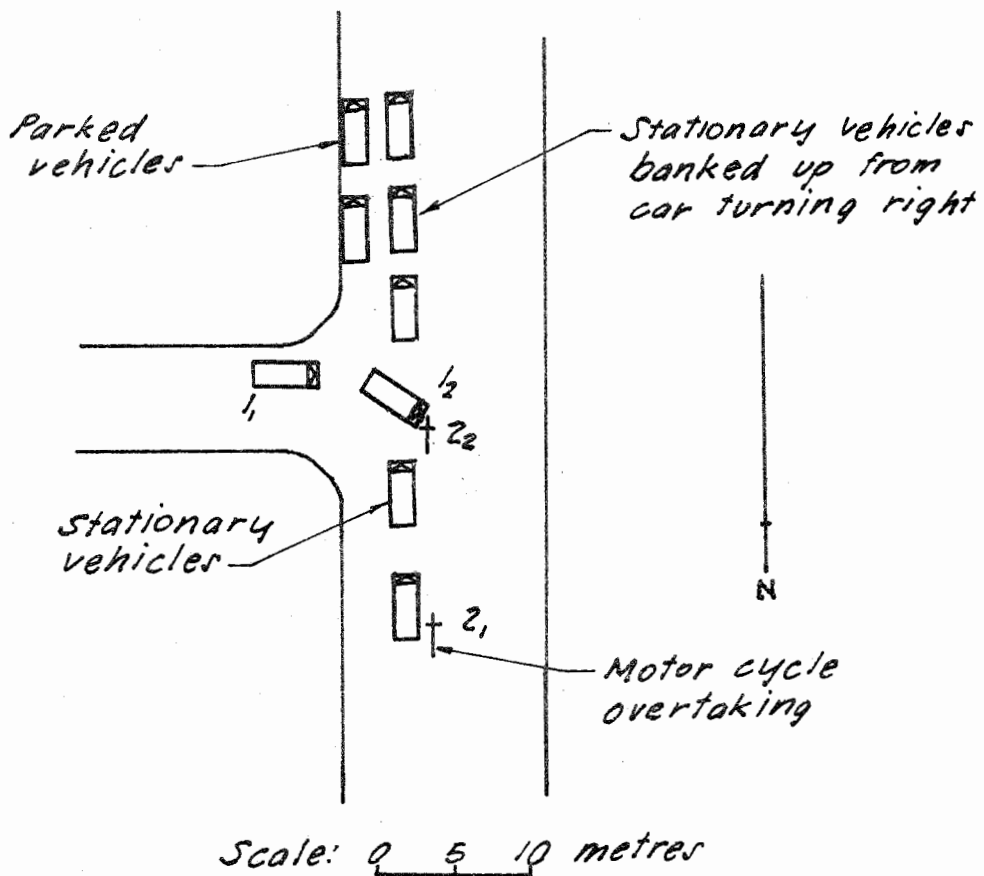
FIGURE 5.1: Accident 279.

In the two car/motorcycle collisions the motorcycle was passing stationary (or parked) cars as it approached the junction on the through road. The stationary cars in Accident 279 were a major factor in the causation of the collision (Figure 5.1). They were banked up behind a vehicle that was waiting to turn right at a T-junction further down the road and one of the drivers had left a gap for a car to move out from the stem of a T-junction on his left. He waved the waiting car through the gap without first checking that it was safe for it to do so and it collided with a motorcycle that was passing the stationary line of cars. The parked cars in the other accident (278) were a partial, but possibly minor, obstruction to vision, as was a row of trees planted close to the edge of the footpath. The driver of the car stopped and then, thinking the way to be clear, started to turn right into the through road. When she saw the motorcycle approaching she stopped but her car was across its path. It is likely that the motorcyclist was travelling at a speed in excess of the speed limit, on the basis of the length of the braking skid mark. The 85 percentile speed for through traffic in this direction was 71 km/h.

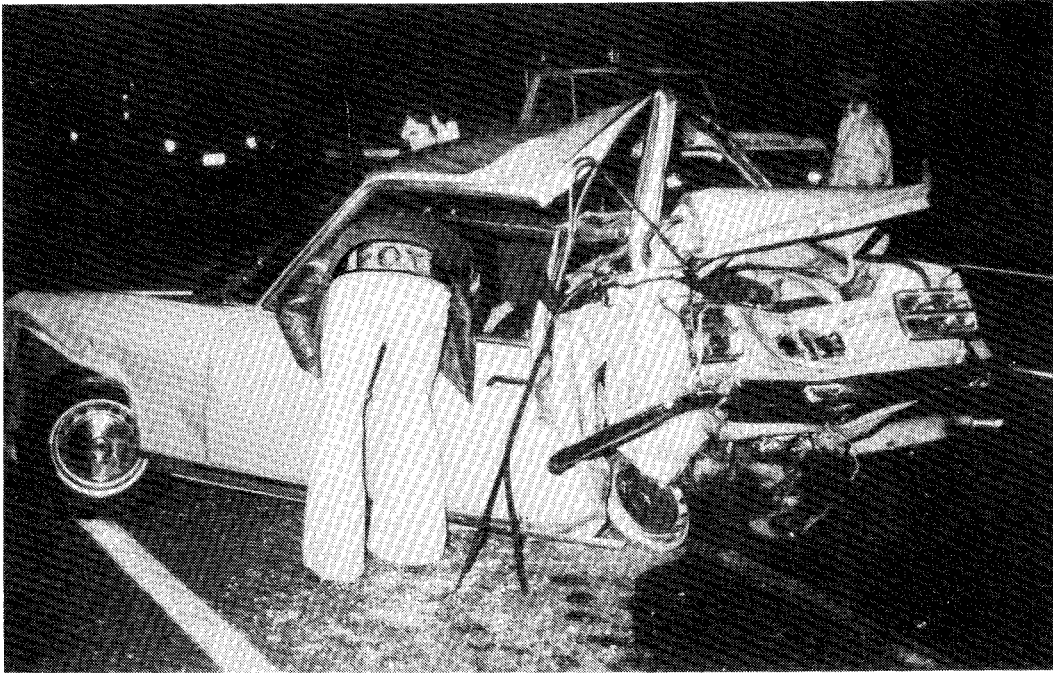
stationary in a queue of three that were waiting to turn right into the stem of a T-junction (Figures 5.2 and 5.3). The collision happened at night on a road that was illuminated by sodium vapour lamps except at intersections or junctions, where mercury vapour lamps were used. This resulted in an apparently lower level of illumination at the junction (in this accident, on the approach to the junction). While this may not affect the performance of a sober driver to any meaningful degree it may make it more difficult for an intoxicated driver to realize that the vehicle in the traffic lane ahead of him is stationary (see Perrine, 1973) and so this characteristic of the street lighting may have contributed to the causation of this accident.

FIGURE 5.2: Car struck when stationary waiting to turn right.  
(Unit 2 in Figure 5.3.)

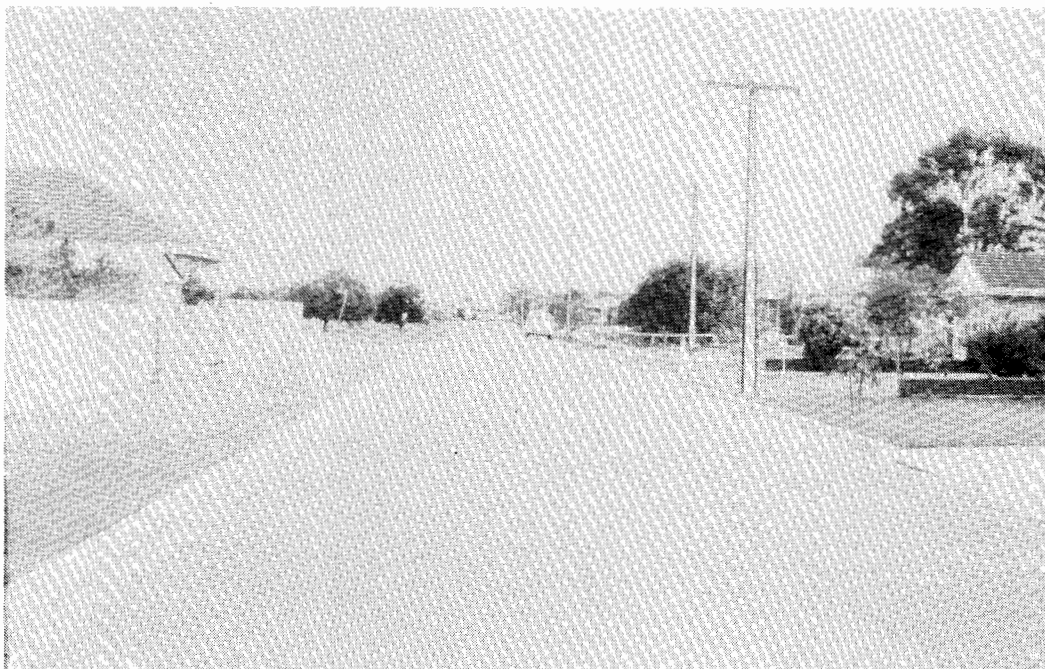
The most common obstruction to vision across the included corner was a boundary fence, hedge or garden shrubs (Figure 5.4 to 5.7). At some locations the corner was clear back to the house or other building but this was less common than obstructions located on or near the property boundary. Trees or shrubs on the footpath, or even in the carriageway, and utility poles were additional obstructions to vision at seven intersections (eg: Figures 5.5 and 5.6) and parked cars at the one intersection at which there were two accidents.

FIGURE 5.4: Approach path for vehicle on the left in Accident 207 (see also Figure 5.15)

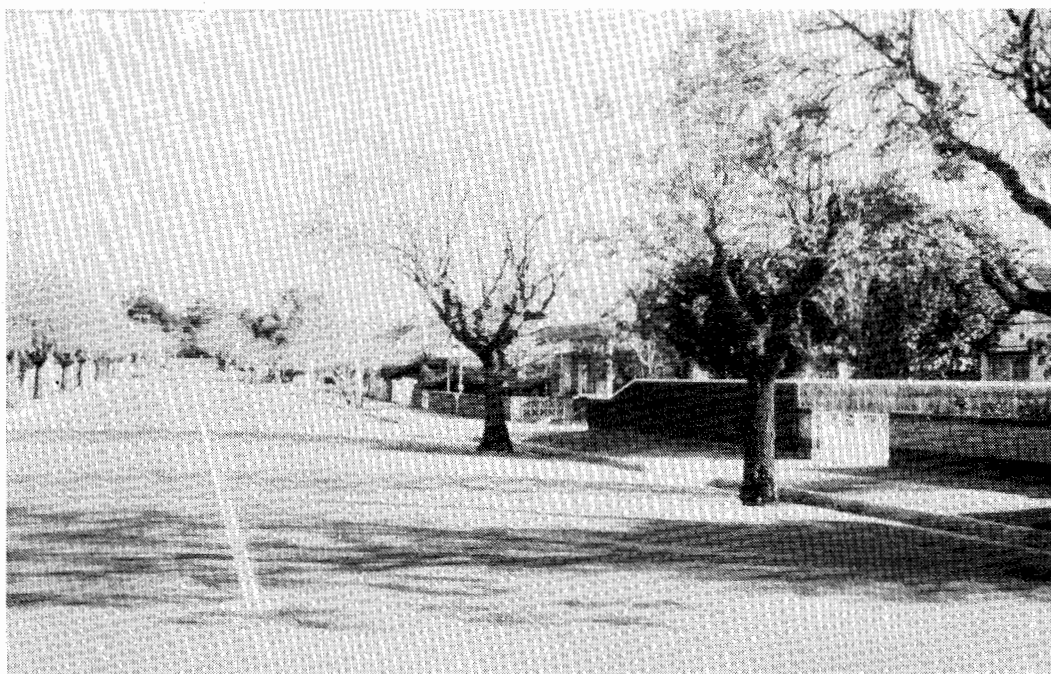
FIGURE 5.5: Approach path for vehicle on the left in Accident 009. Accident occurred at night.

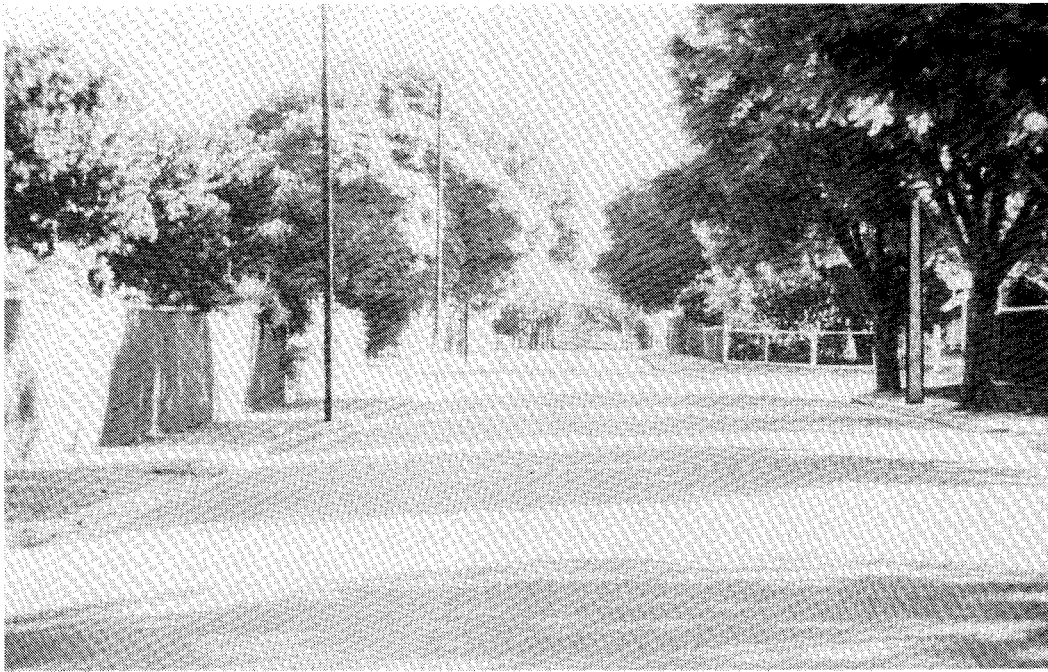
FIGURE 5.6: Approach path for vehicle on the left in Accident 033 (see also Figures 5.8 and 5.9). Accident occurred at night.

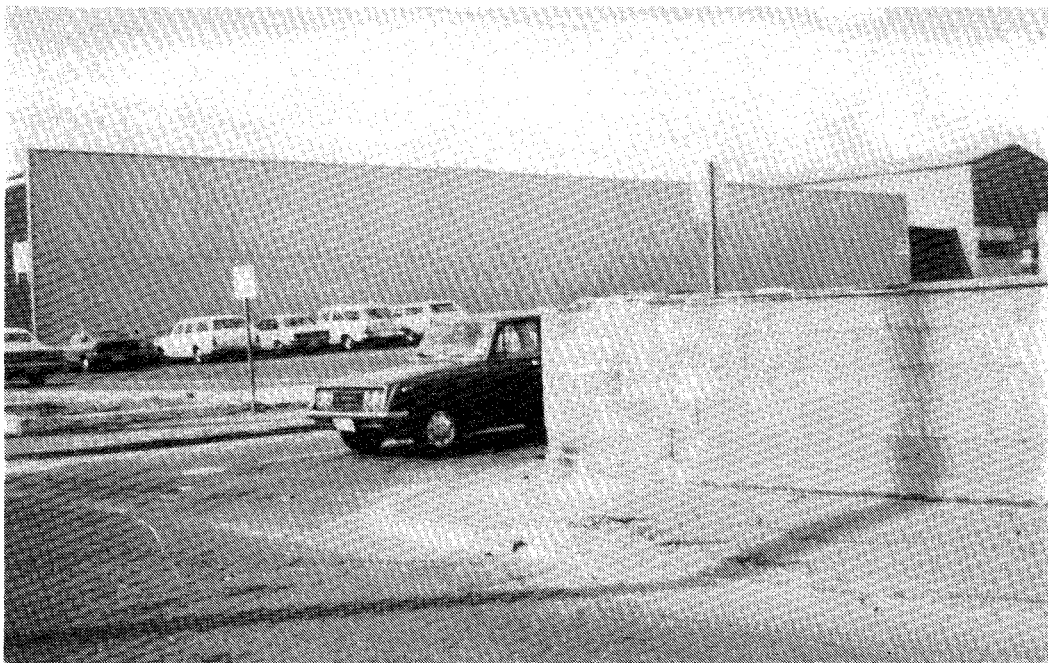
FIGURE 5.7: Severely restricted sight distance in Accident 017.
