# **ADELAIDE IN-DEPTH ACCIDENT STUDY**

1975-1979

## **PART 7: ROAD AND TRAFFIC FACTORS**

**A.J. McLean  
W.J. Offler  
B.L. Sandow**

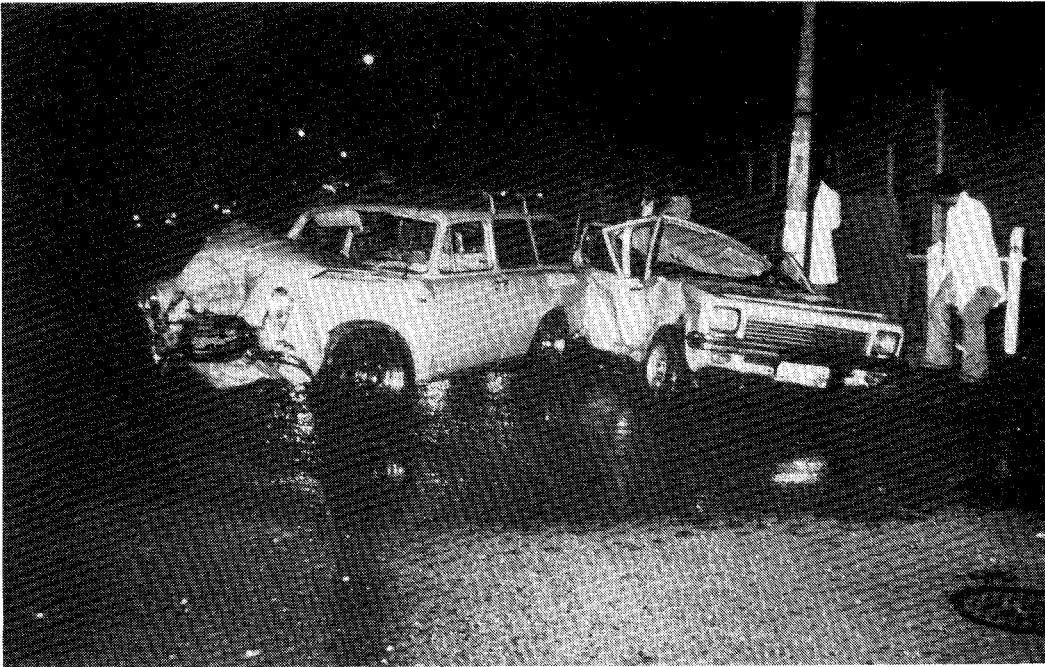
FIGURE 5.8: Final position of cars in Accident 033. Road has been hosed down to remove spilt petrol (see also Figures 5.6 and 5.9).

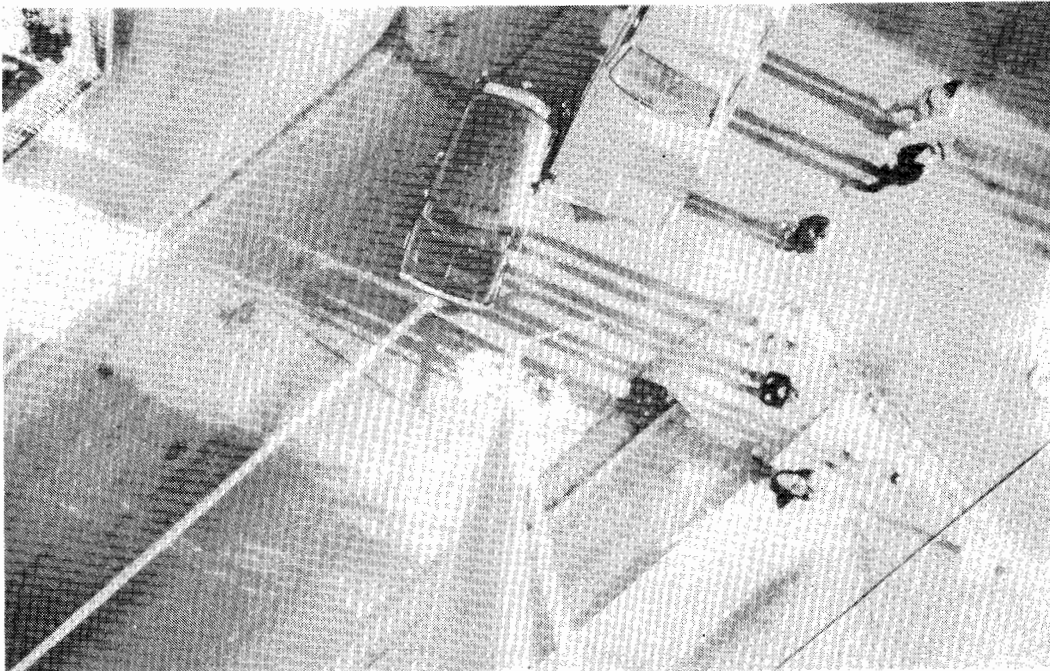
Neither of the cars left the carriageway as a consequence of the initial collision in 10 of these 35 accidents (see, for example, Figure 5.11). In seven accidents a car came to rest on the footpath but without another collision (Figure 5.10). There was at least one subsequent collision in 18 accidents, including collisions with other cars, and four cars rolled over following the initial impact (eg: Figure 5.15). Subsequent collisions between the original cars are not included here.

FIGURE 5.11: Final positions of cars in Accident 048. The larger car has rotated anti-clockwise through 100 degrees.

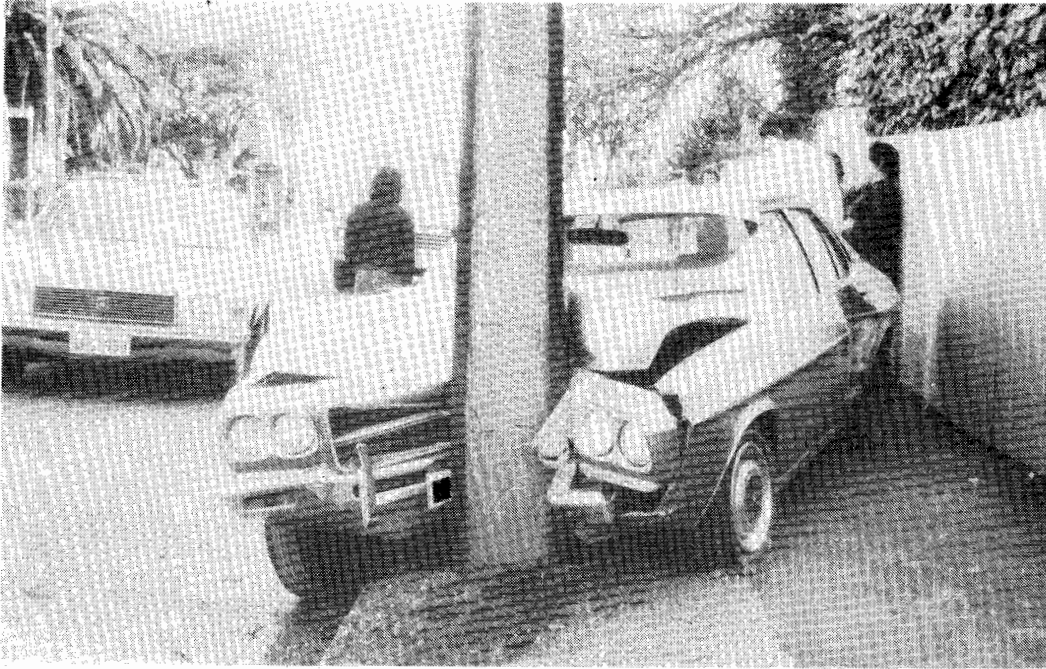
FIGURE 5.14: Subsequent collision with utility pole (Accident 090).

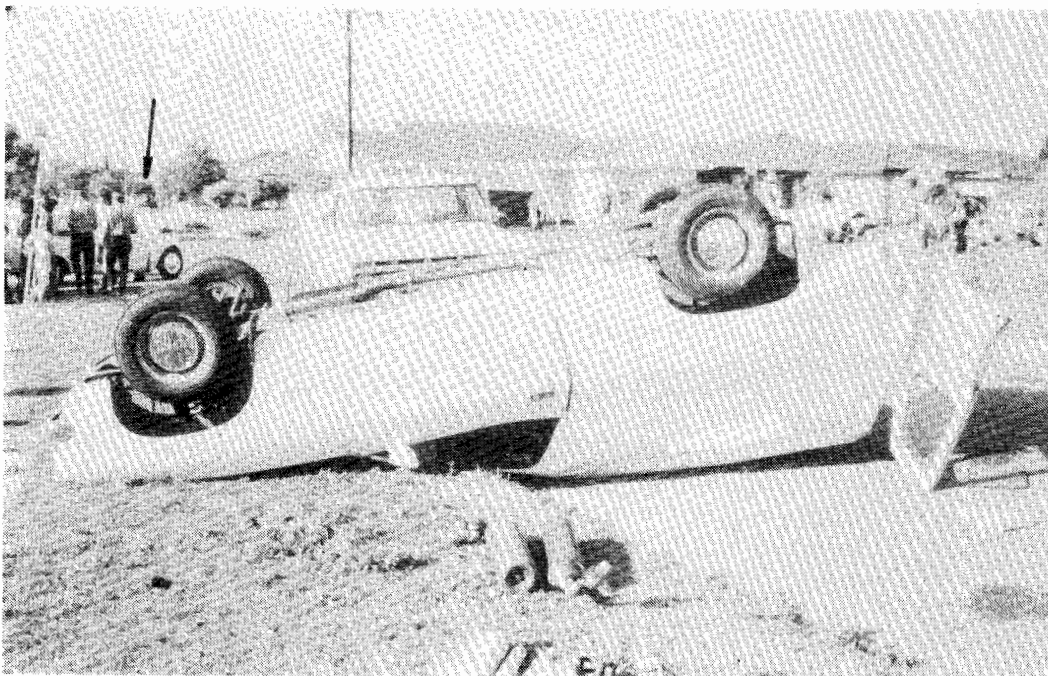
FIGURE 5.15: Rollover following collision with car (arrowed) at uncontrolled intersection : Accident 207.

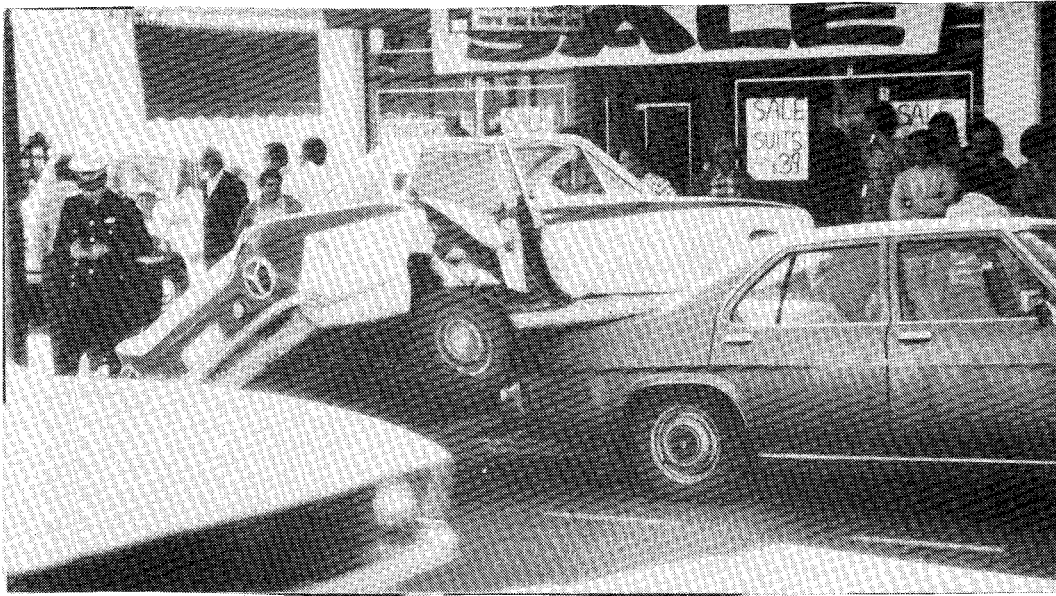
FIGURE 5.16: Final position of car following a collision at an uncontrolled intersection : Accident 149.

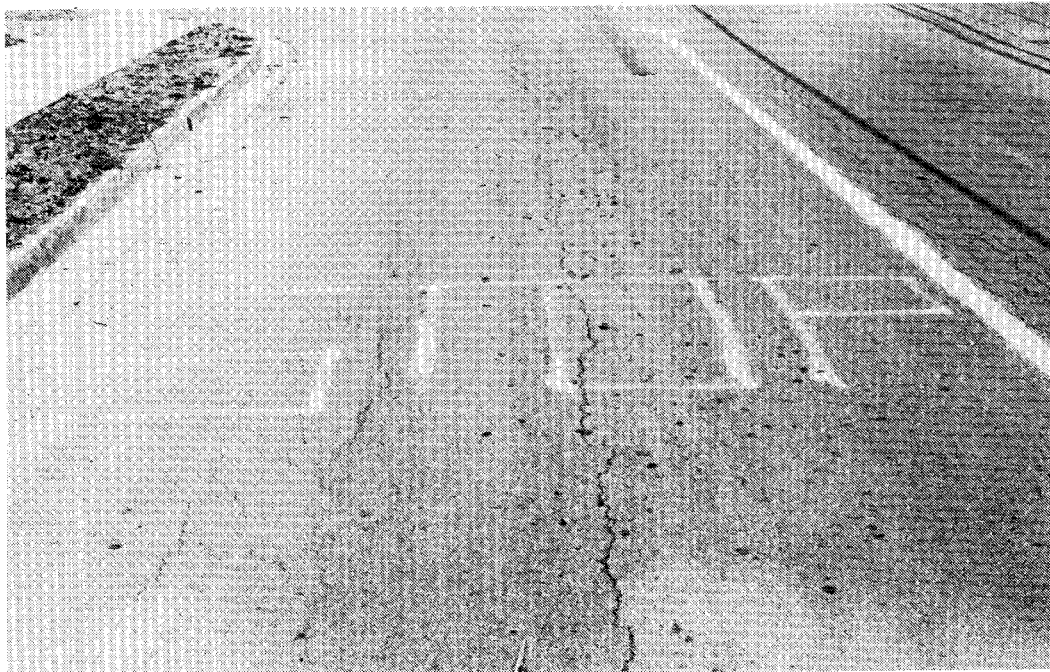
FIGURE 5.17: Local residents' attempt to prevent accidents at an uncontrolled intersection : Accident 104.

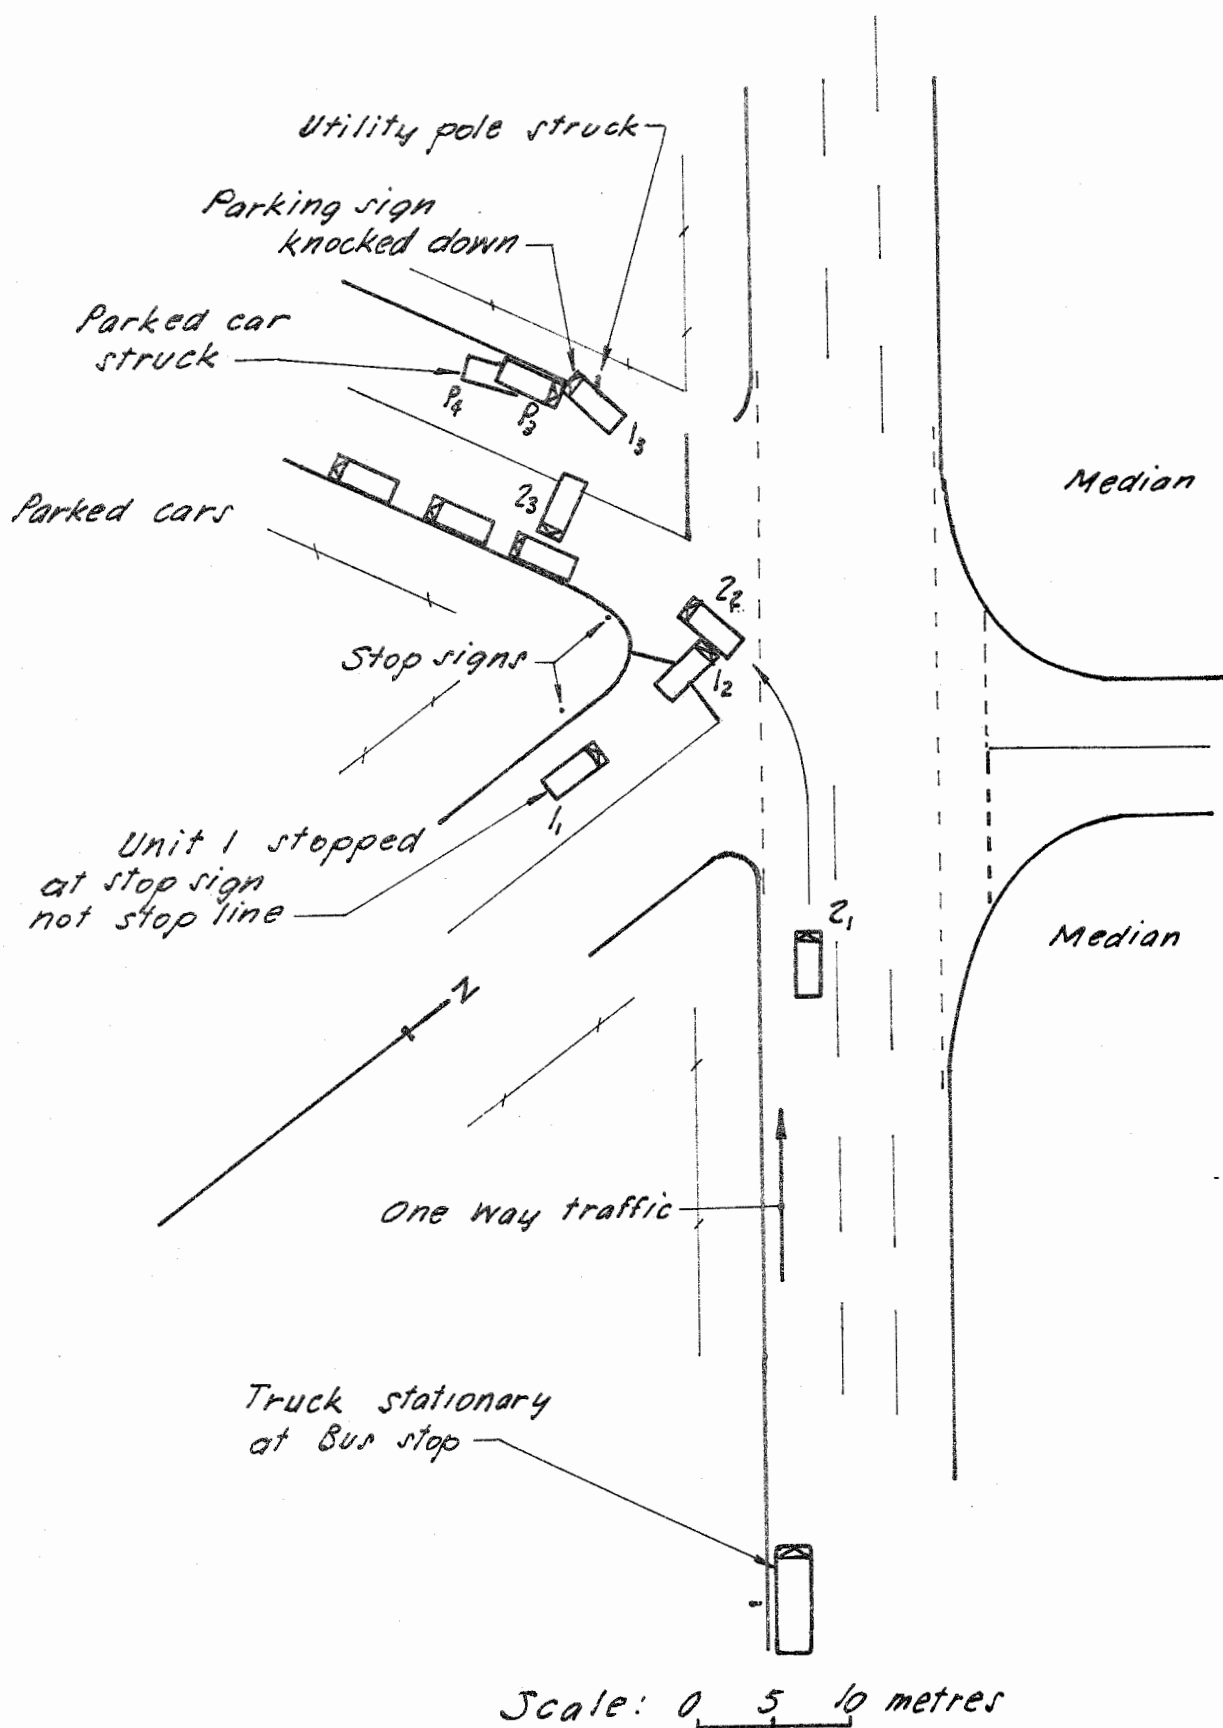
FIGURE 6.12: Accident 171.

One of these three collisions occurred at a relatively complex intersection (Accident 171, Figure 6.12). A car travelling along a divided road turned left at an intersection, only to collide with another car which moved off from a STOP sign on a third road at that intersection. The driver of the first car saw the second one stationary at the STOP sign, which is located a short distance back from the STOP line, and assumed that it would wait there until she had passed across in front of it. The other driver, not having driven that way before, was being given directions by her passenger and she moved off from the STOP sign without realizing that there was a car coming on her right. She could not explain why she had not seen this car, and wondered whether it might have been travelling rather fast. The driver of the first car said that a truck parked in a bus zone may have been a significant obstruction to vision, even though it was some distance back from the intersection.

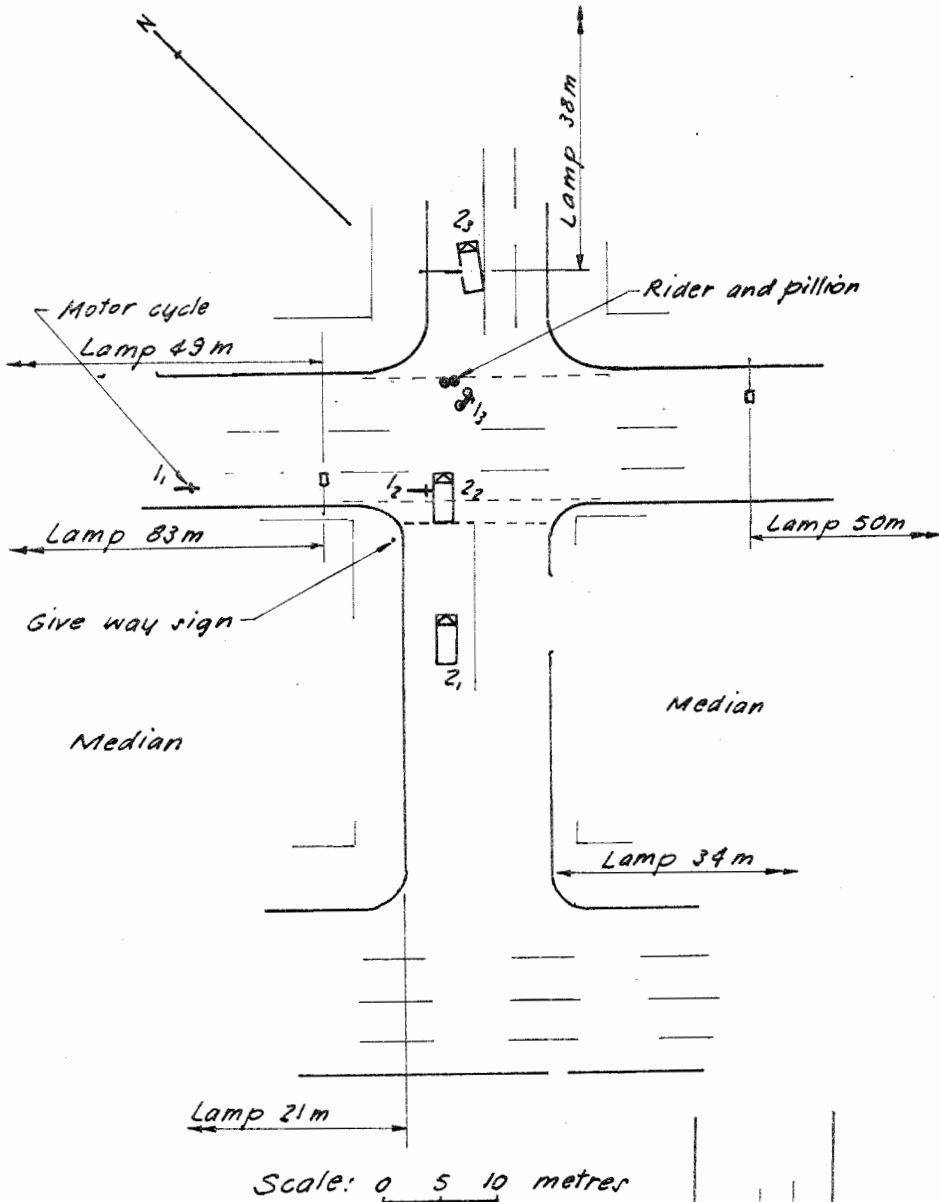
FIGURE 6.13:  
Accident 042.

The other two accidents in this group of three occurred at intersections on a road which has a very wide median reserve. The first of these, Accident 042, involved a car which was moving from a crossover in the median to a side road (Figure 6.13). The driver said that he stopped at the GIVE WAY sign, looked to his left and, not seeing any vehicles approaching, continued on. He was mid-way across the lane

closest to the median when his car was hit by a motorcycle. The rider and pillion passenger on the motorcycle were both severely injured and unable to recall the events immediately before the crash. The rider did say that he remembered travelling at about 75 km/h along that road as he approached this intersection. He had a blood alcohol level of 0.15, but this was unlikely to have been significant in the causation of this accident. The rest position of the motorcycle suggested that the car was going faster than would be expected had it stopped at the GIVE WAY sign.

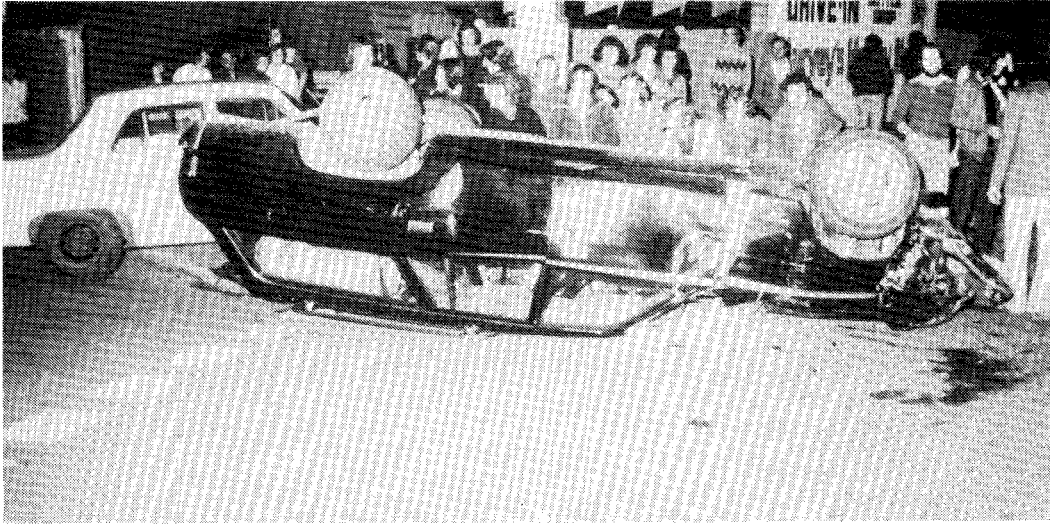
FIGURE 6.15: Final position of cars after collision at roundabout (Accident 186).

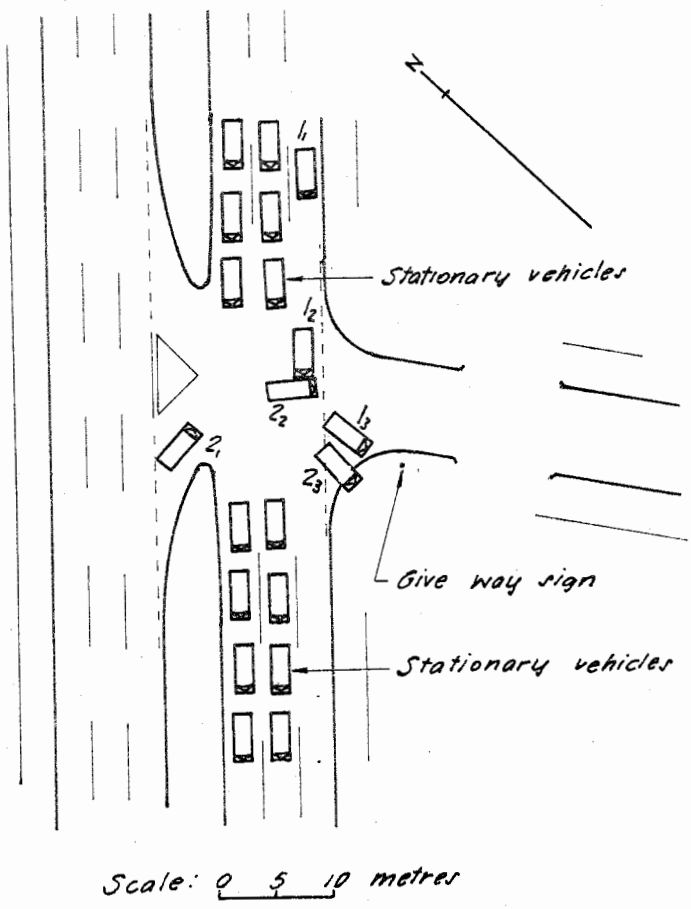
FIGURE 6.18: Accident 156.

Accident 156 is an example of a two car collision which occurred in this way (Figure 6.18). The driver who was moving through in the left lane may have been distracted a little by talking with his passenger, but the turning driver said, perhaps too generously, that the accident was all his own fault.

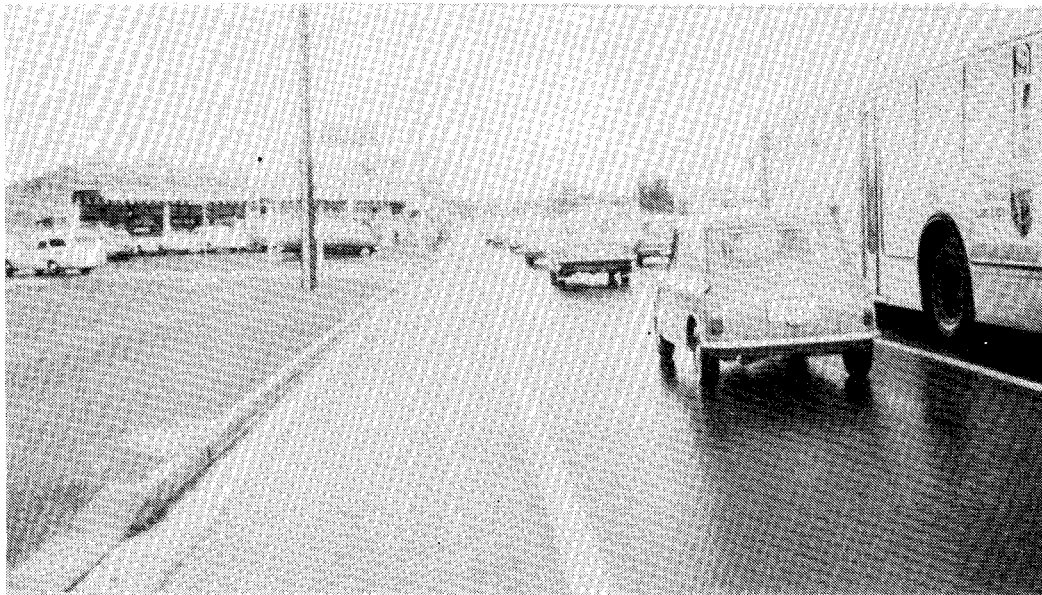
The remaining collision of this type that involved a motorcycle differed mainly in that the rider recognized that passing on the left under such circumstances was potentially hazardous. He told us that he had had several near misses there before and should have known better (Accident 249, Figure 6.19 and 6.20). Again, a driver in one of the stationary cars had waved the turning car through.

FIGURE 6.19: Approach path of motorcyclist in Accident 249.  
(see Figure 6.20).

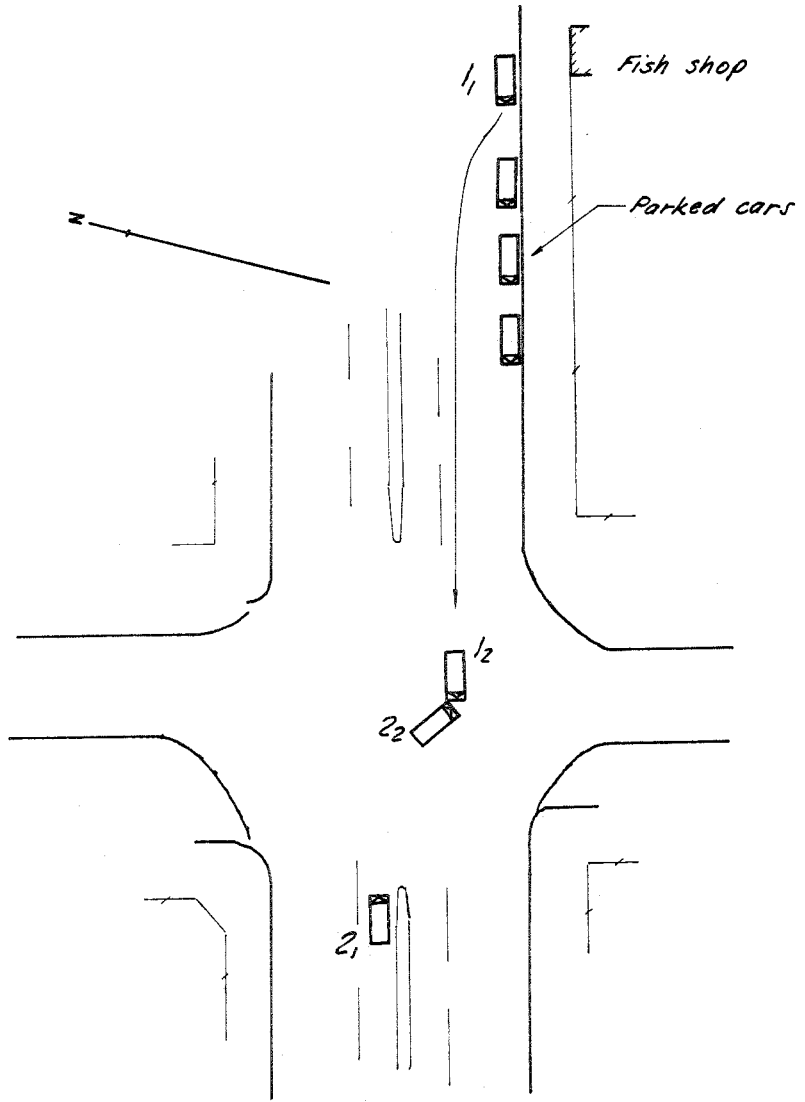
FIGURE 6.23:  
Accident 146.

In Accident 146 the turning driver said that he checked for oncoming traffic and, seeing none, then checked for traffic coming out from the side street (Figure 6.23). He started to turn only to collide with a car that had just pulled out from a row of cars parked at the kerb. The driver of the other car did not notice the turning vehicle until it started to move across her path. This accident happened just before mid-day.

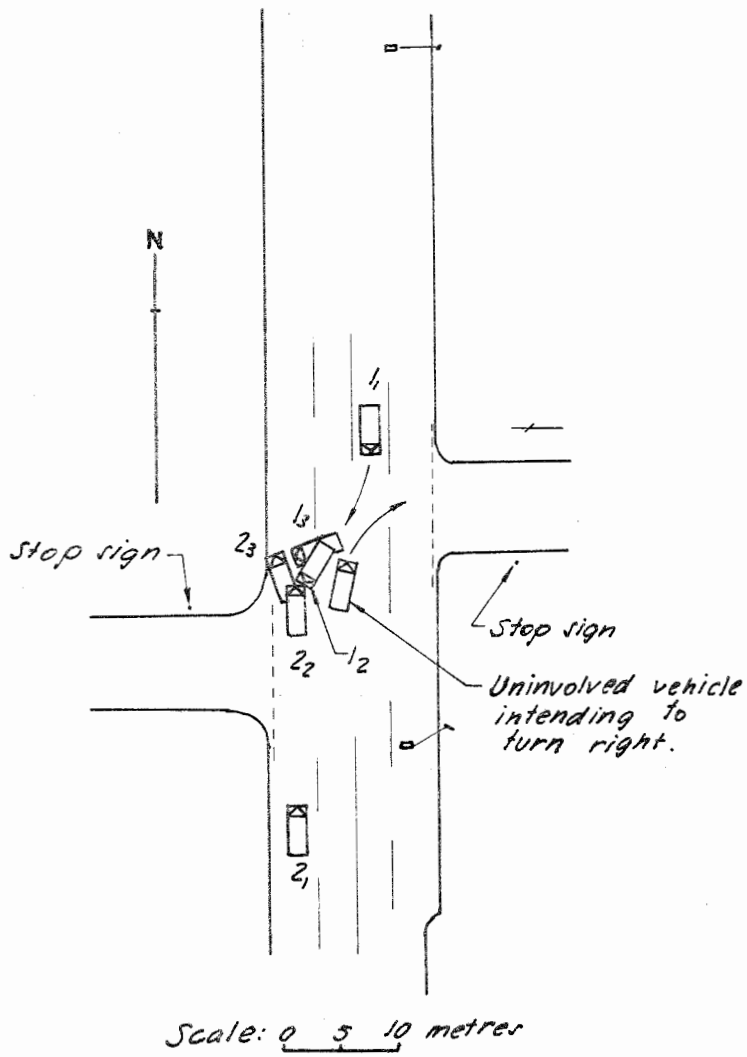
FIGURE 6.24: Accident 040.

The most complex sequence of vehicle movements in any accident in this study took place in Accident 040 (Figure 6.24). A 67-year-old female driver thought that she had right of way when driving out from a service station. Consequently she expected a car approaching from her right to give way to her, even though she misjudged its speed and distance from her. The driver of the other car was able to avoid a collision at this stage, but not later. The first-mentioned car crossed to the far side of the road where it was struck on the rear left side by a car which approached from the left. This spun the struck car around; it headed back across the road, colliding with a fourth car and then crashing into the car that it had narrowly missed in the initial manoeuvre. It finally struck a fifth car that was stationary at a STOP sign.

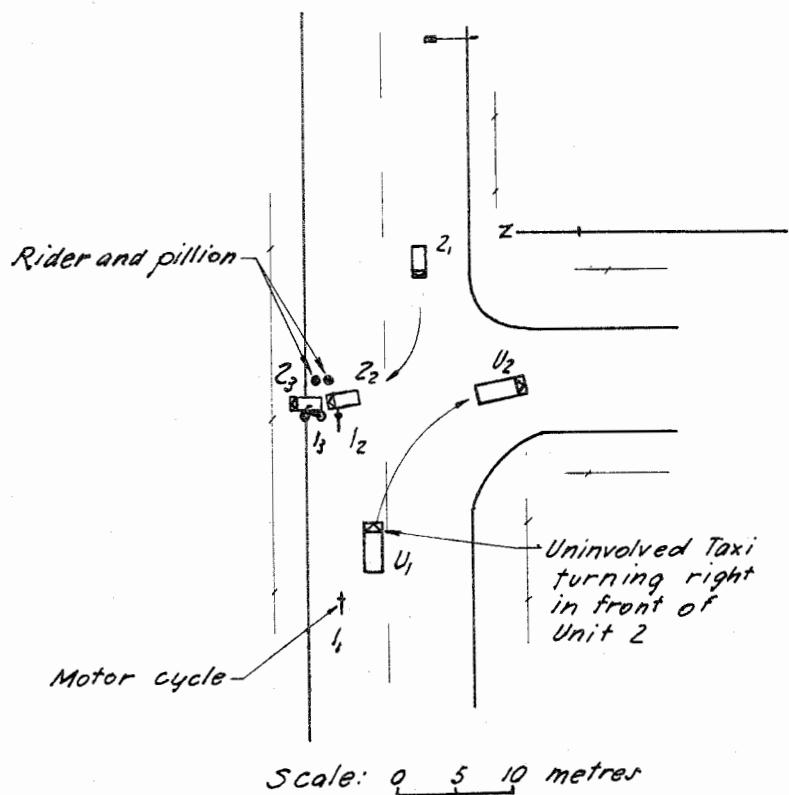
FIGURE 6.25: Accident 288.

The third collision in this group occurred at night at a location where there were two T-junctions with an arterial road (Accident 288, Figure 6.25). A 17-year-old male attempted to turn right into a side street by passing to the right of a car that was stationary facing him, waiting to turn right. The stationary car prevented the driver from seeing a third car approaching in the kerb lane, where the collision occurred. In this accident, as in the others described in Sections 6.6 to 6.8, the fact that the T-junctions were controlled by signs appears to have had no relevance to the causation of the accident.

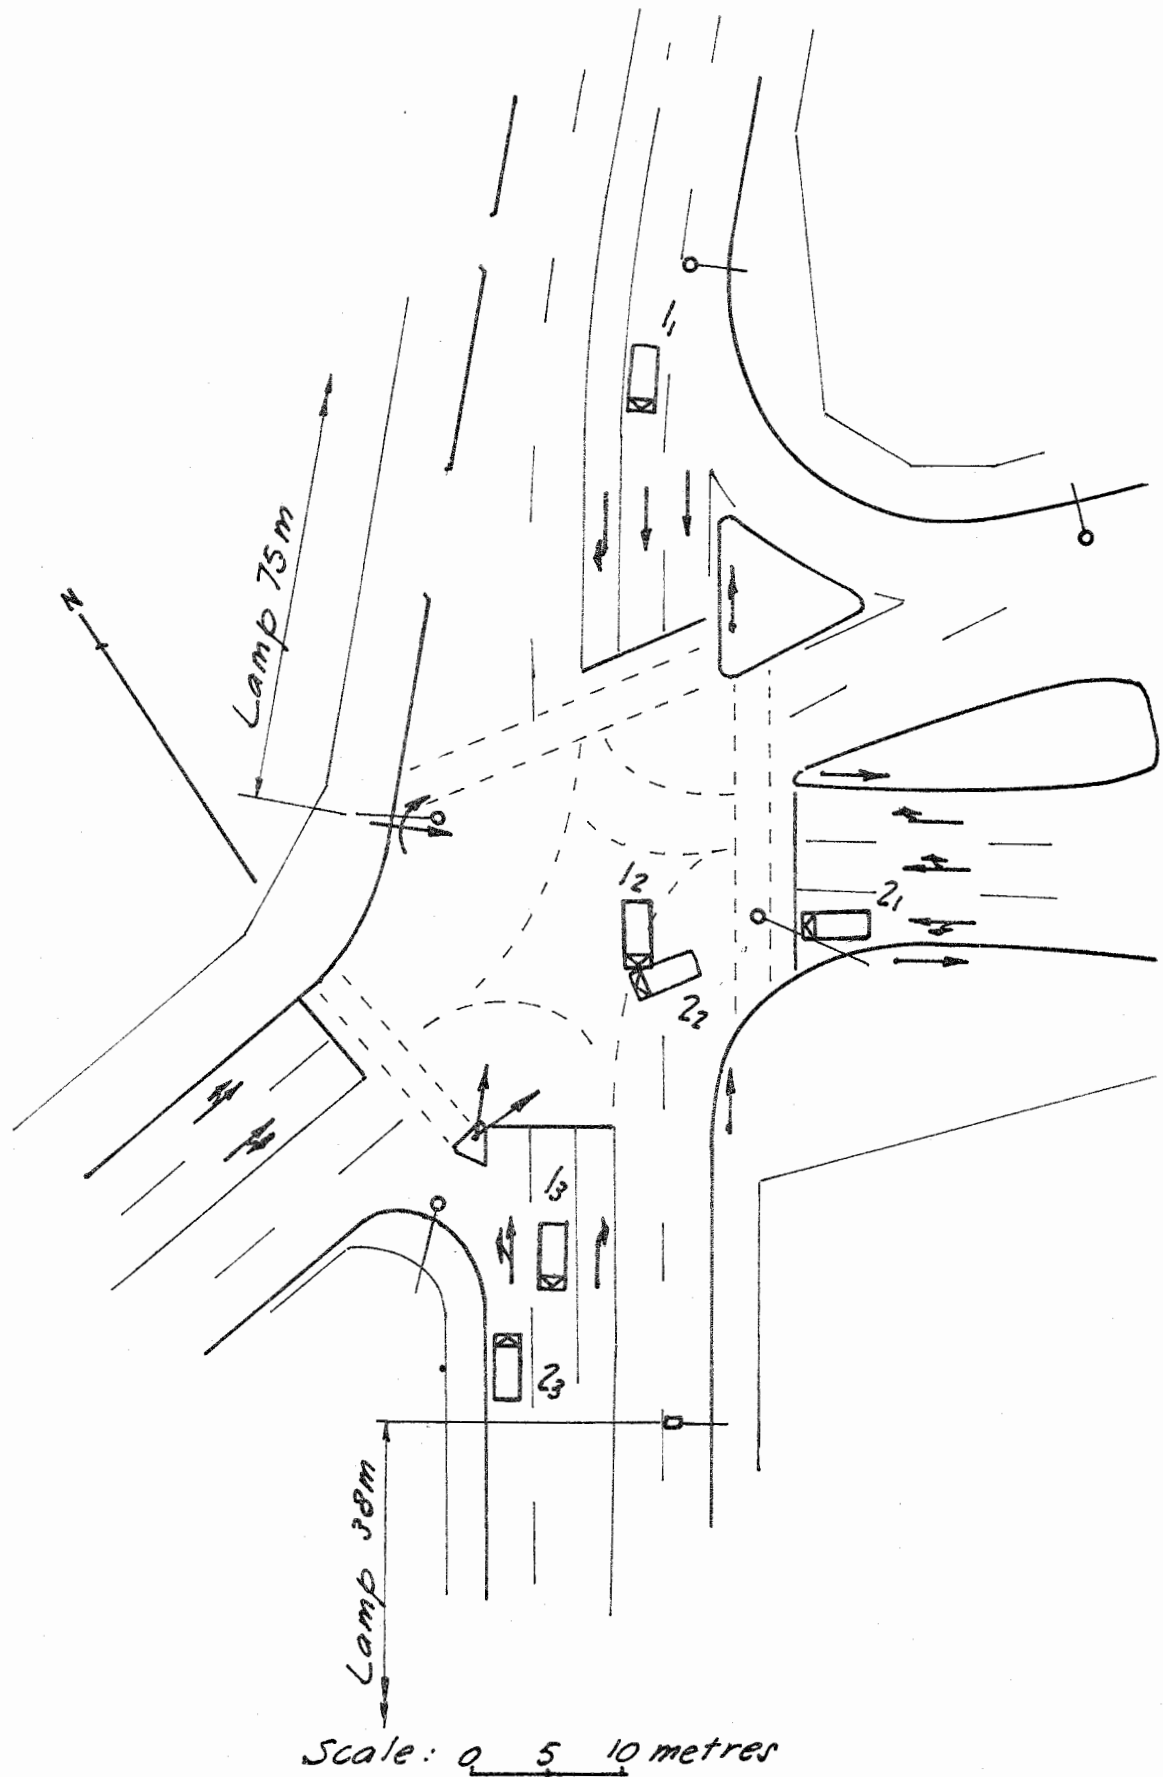
FIGURE 7.1: Accident 230

In the fourth of this group of five accidents (230, Figure 7.1) one of the drivers was not familiar with the area and said that he failed to see the red light because he was dazzled by the lights of an oncoming car. This effect was accentuated by the dirty windscreen on his car. We believe that this may have been a partial explanation for his failure to see the red light. Taken together with the distraction of a conversation with his passenger and drinking beer from a glass which seems, from our inspection of the car, to have been held in his right hand, there is little reason to be concerned about the conspicuity of the traffic signals. The accident history of this intersection suggests that the configuration of this accident (the approach paths of the

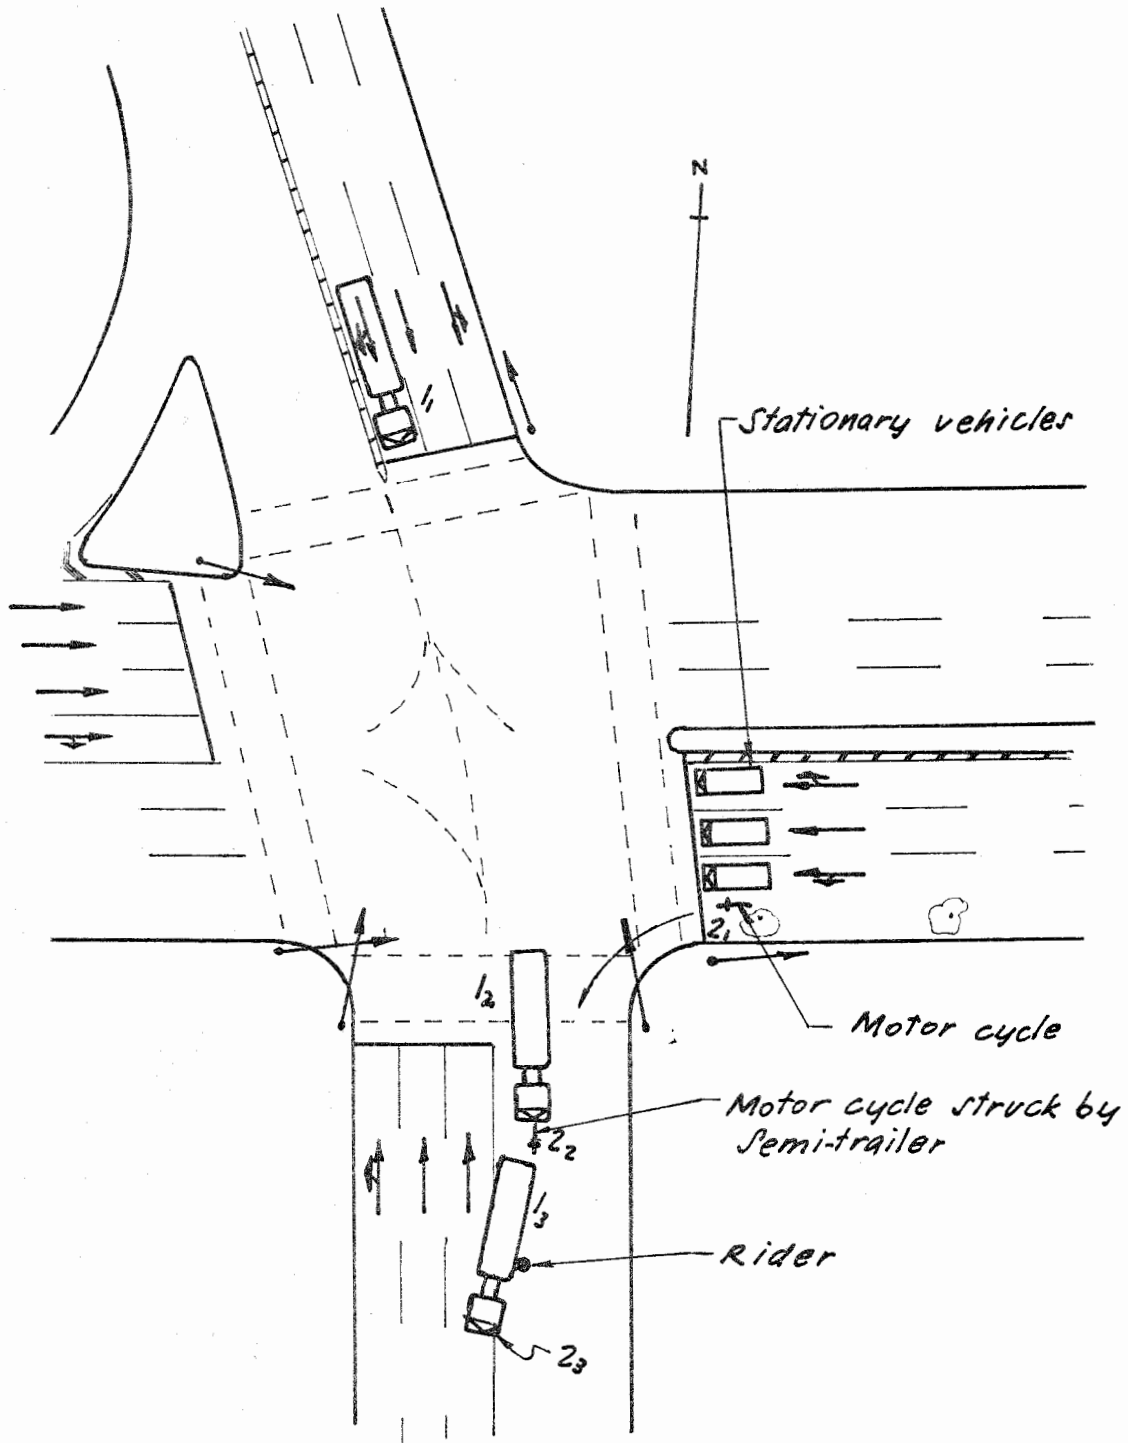
FIGURE 7.4: Accident 127.

Figure 7.4 shows the road layout and vehicle movements in Accident 127 in which a motorcyclist who turned left from the kerb lane when the signal changed to green was run down from the rear by a semi-trailer that was late in crossing the intersection. The rider, on turning left, had swung across to the centre lane, of two, intending to make a right hand turn into a side street, but was run down from behind by a semi-trailer which had failed to clear the intersection during the preceding intergreen period. The semi-trailer was probably about five to ten metres away from the far side of the intersection when the motorcyclist reacted to the green light and accelerated off into the street on his left. The rider had not looked to his right and did not see the truck before the impact. He sustained extremely severe leg injuries and now has a major permanent physical disability.

The two options available to the driver of a heavy vehicle on seeing the signal change from green to yellow as he approaches an intersection are to stop or to continue on at a steady speed (assuming negligible acceleration in the circumstances of Accident 127). Allowing one second for the driver to recognize that the light has changed, to decide to stop, and to start braking and taking a deceleration of 0.3 g for a semi-trailer when braking under normal circumstances then at a speed of, say, 50 km/h the driver must be at least 47 metres back from the stop line if he is to be able to stop without encroaching on the intersection. But if he decides to continue on at this speed, even if the yellow light has just come on when he is 47 metres back, he will not reach the far side of the intersection before the end of the intergreen period. He will, in fact, still have about five metres to go to reach this point, and fifteen metres, or just over one second, to go before he is fully clear of the intersection. So, over about five metres of his approach to the intersection, if the light changes to yellow, he can neither stop in time nor get to the far side of the intersection. This "booby-trap" distance is 15 metres if he is to fully clear the intersection. The same outcome can be shown to apply to all approach speeds in the range of 40 to 55 km/h. At speeds above and below this range this difficulty is accentuated. Therefore an all-red period of 3.5 seconds (an intergreen period of 6.5 seconds) would seem to be a more reasonable setting at this intersection than the actual all-red period of 2.5 seconds.

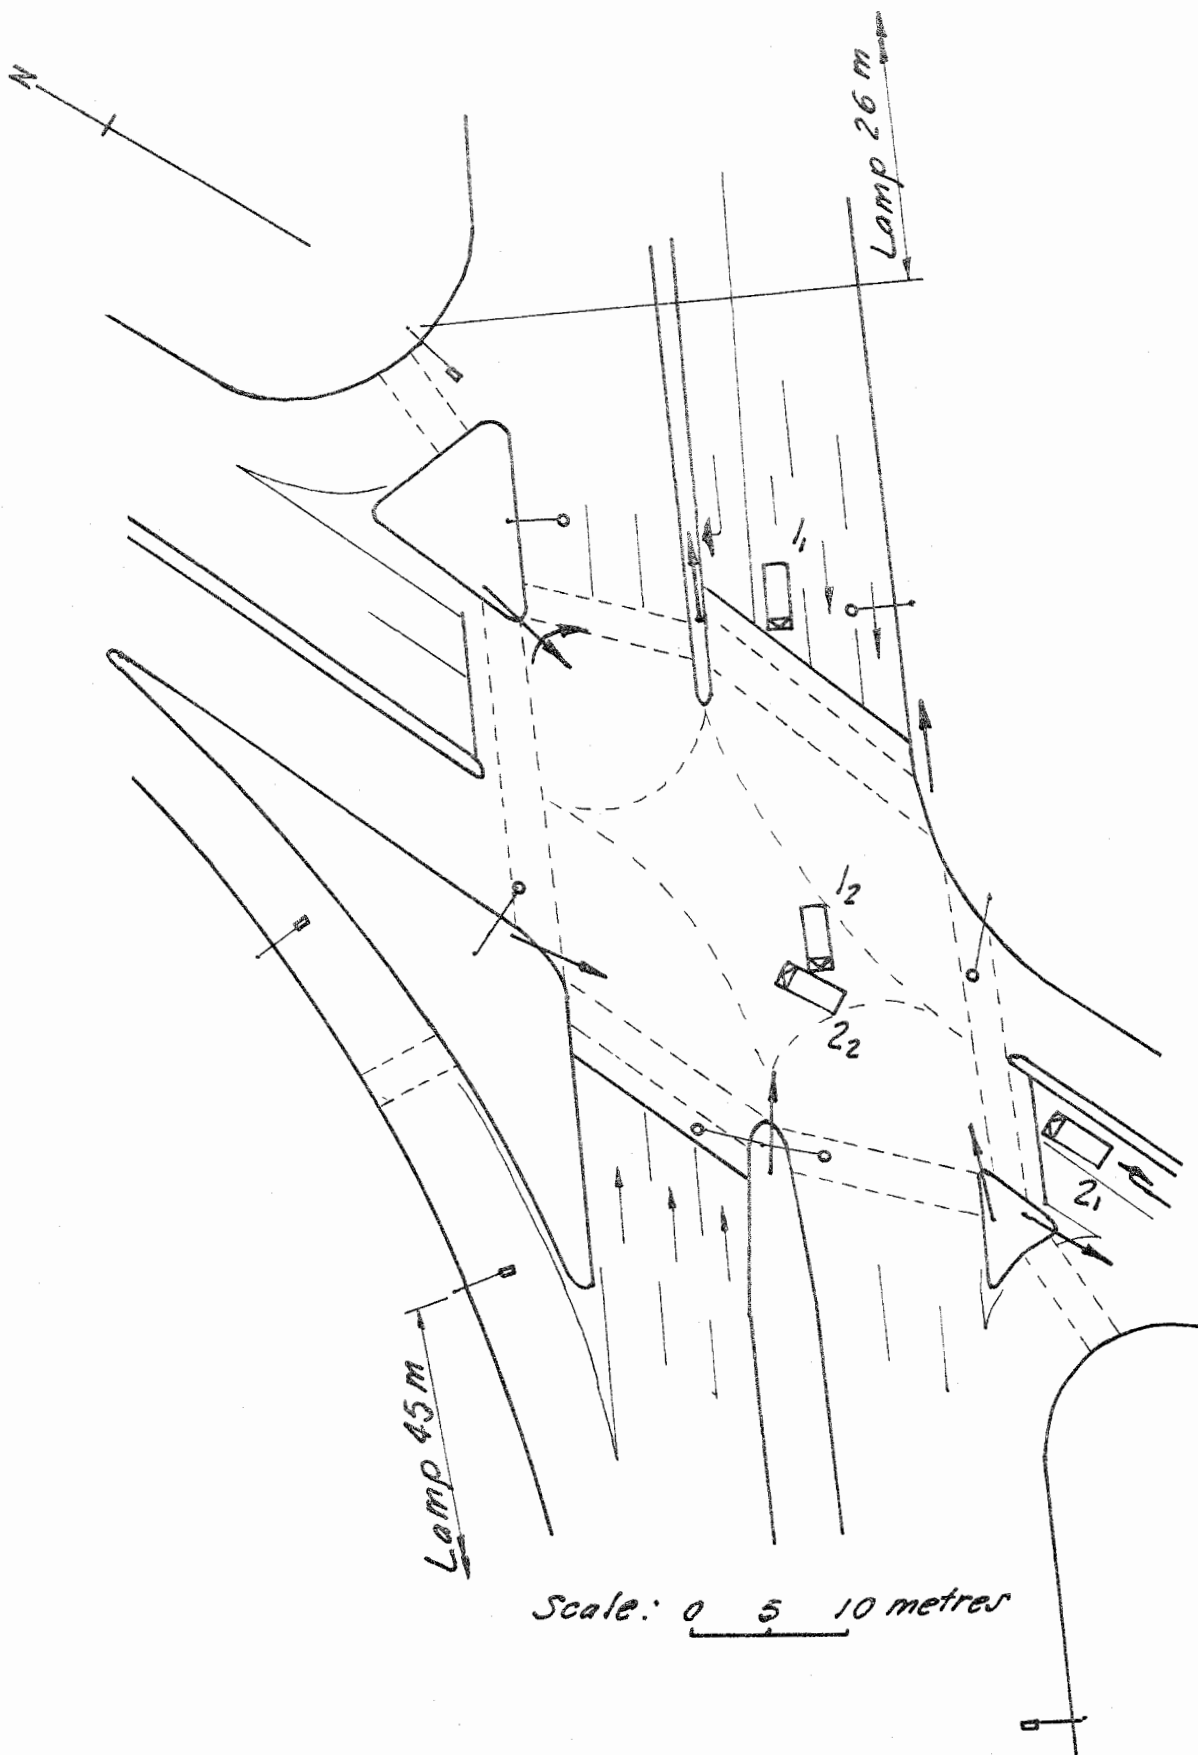
FIGURE 7.5: Accident 004.

Alcohol intoxication appears to have been a significant factor in the failure of two drivers to respond appropriately to the signal changing to red. In one of these accidents (004, Figure 7.5) the driver saw the light change to yellow, then red, but decided to continue on across the intersection. When a car appeared from the road on his left he braked but was unable to avoid colliding with it. The other driver, who was intending to turn right, did not realize that a collision was likely until the last moment. He then tried to accelerate out of the way. The driver who ran the light was breathalyzed by the police and was found to have a blood alcohol level of 0.10. (He was charged with exceeding the legal limit of 0.08). The other driver was found to have a blood alcohol level of 0.07, from a blood sample taken at the hospital.

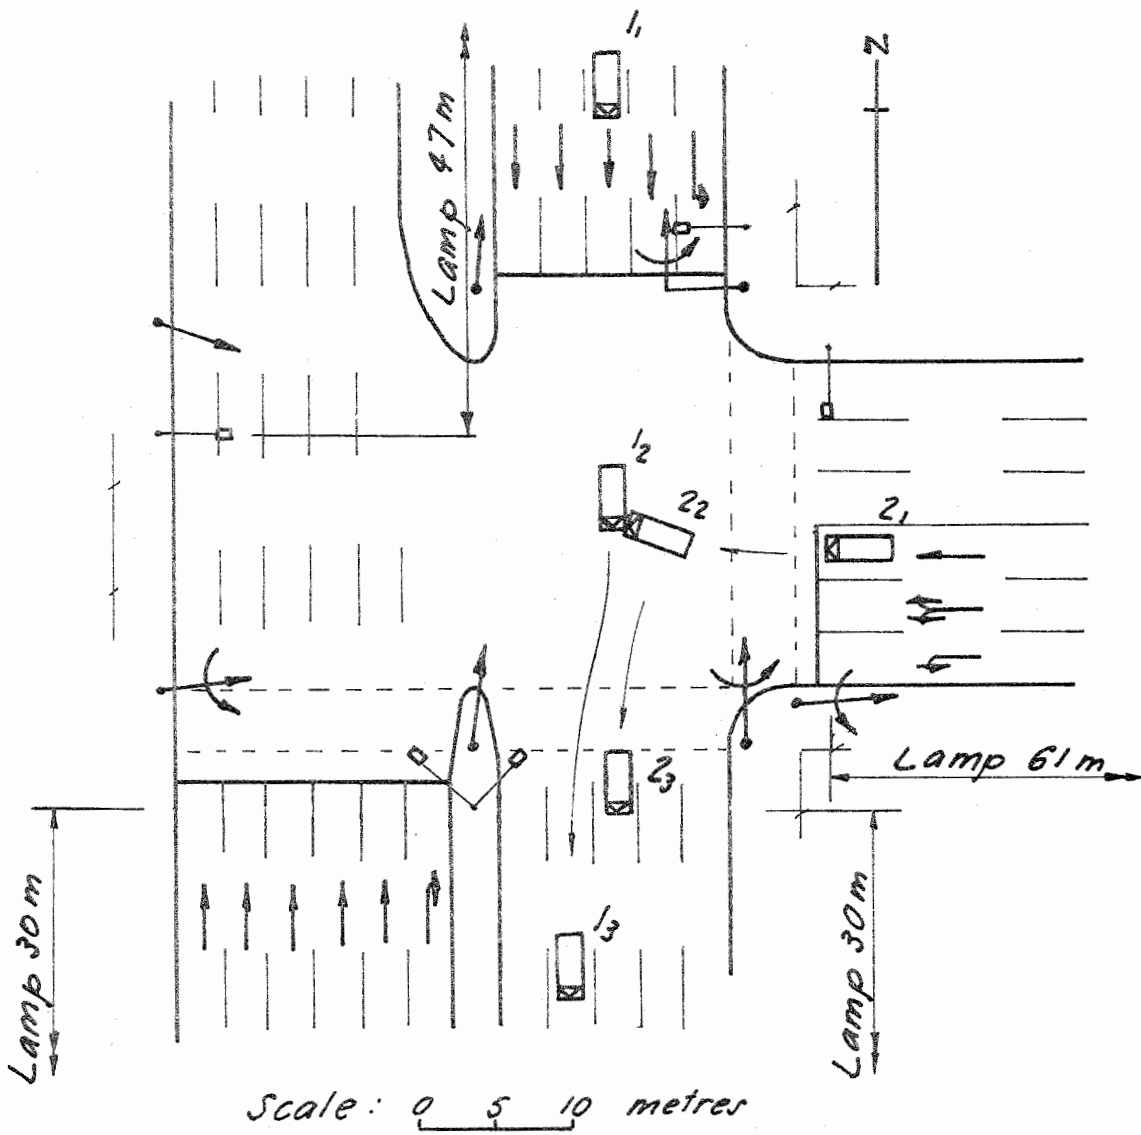
FIGURE 7.6: Accident 024

The third accident of this type also occurred at a T-junction (Accident 024, Figure 7.6). Both drivers were sober and we suspect that the one who ran the red light, which had been red for almost a minute, may have been paying more attention to his passengers whom he had picked up only a minute or two before than to his driving. It is possible that he mistook a green left turn arrow for a regular green signal light but this seems to be unlikely. This car was travelling in the third lane of five on a 10 lane divided road. The two green arrows are located to the left of the carriageway and there are four red signals also illuminated during that phase; two primary signals, one on the median and one cantilevered out over the kerb lane and two secondary signals on the far side of the intersection. The other driver was looking to his left as he entered the intersection from the stem of the "T", since traffic had been turning right across in front of him during the previous phase of the signals and he was making sure that no-one was running the lights from that direction.

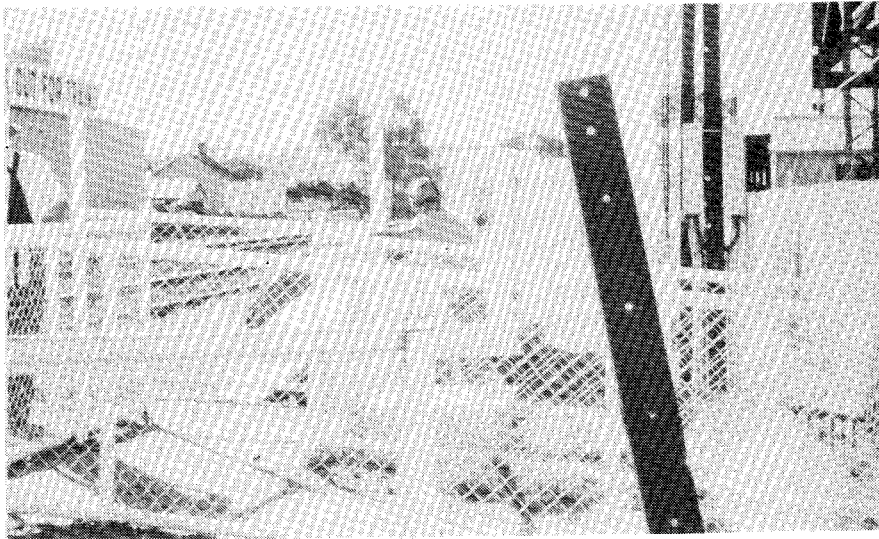
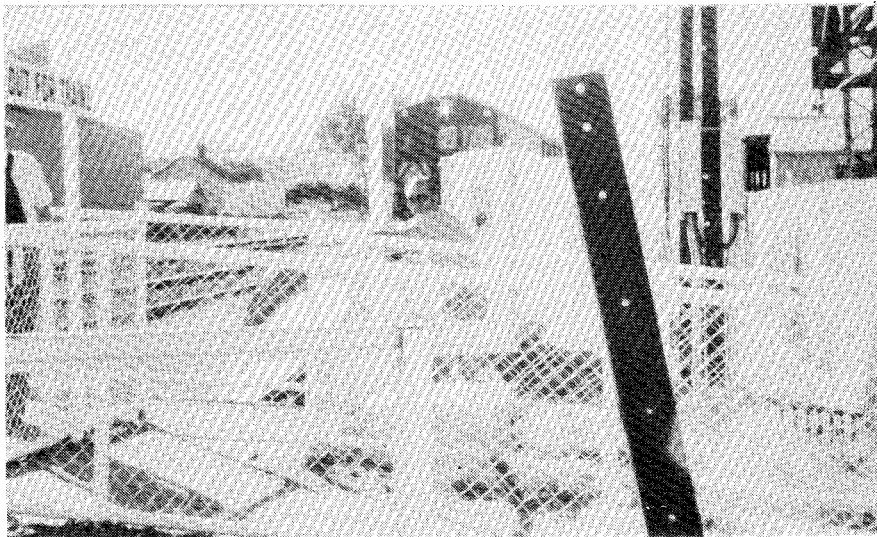
We do not know whether it occurred to the driver of the car to look to his right to check whether a second train was approaching, but even if he did he could be excused for not seeing it. Two large controlboxes are located in such a way alongside the railway line as to almost completely obscure from view an approaching train (Figures 7.8 and 7.9).

FIGURE 7.8: Approaching train hidden from driver by control boxes, Accident 264 (see Figure 7.9).
