# **ADELAIDE IN-DEPTH ACCIDENT STUDY**

1975-1979

## **PART 7: ROAD AND TRAFFIC FACTORS**

**A.J. McLean  
W.J. Offler  
B.L. Sandow**

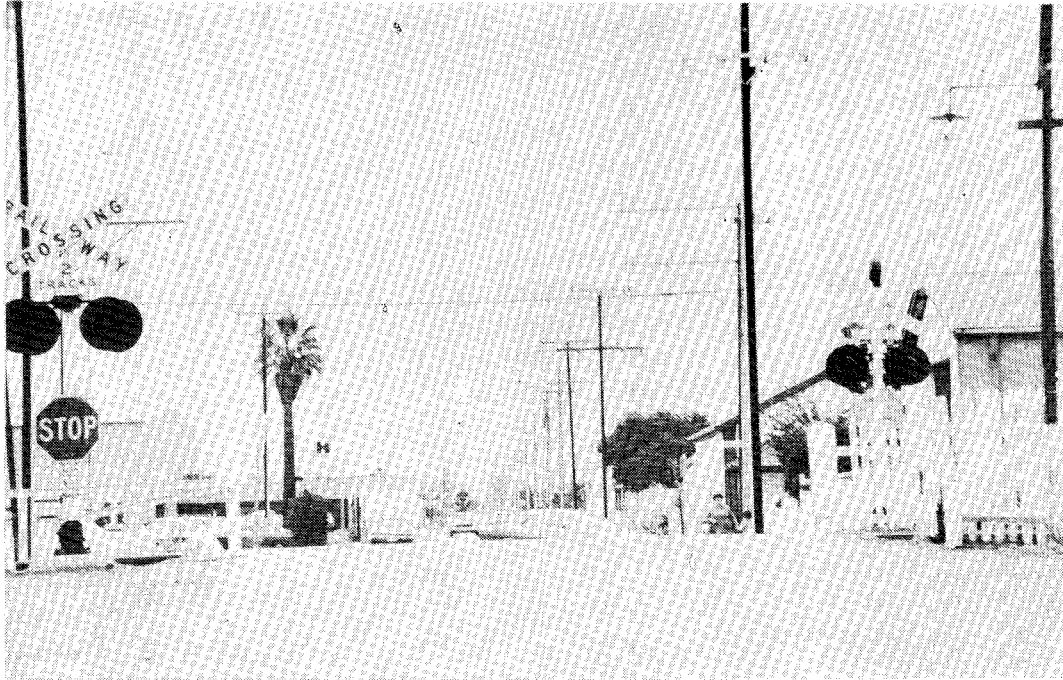
A small sign does warn motorists that there are two tracks at this level crossing but it does not note the consequent importance of ensuring that the warning bells have stopped before moving forwards after a train has passed. In any event, the message on this sign is likely to be of little value because the sign is located on the near side of the intersection where neither it nor the flashing lights on that side can be seen by the driver of a car stopped at the STOP line (Figure 7.10).

FIGURE 7.10: Location of warning signs and flashing lights at the level crossing (Accident 264).

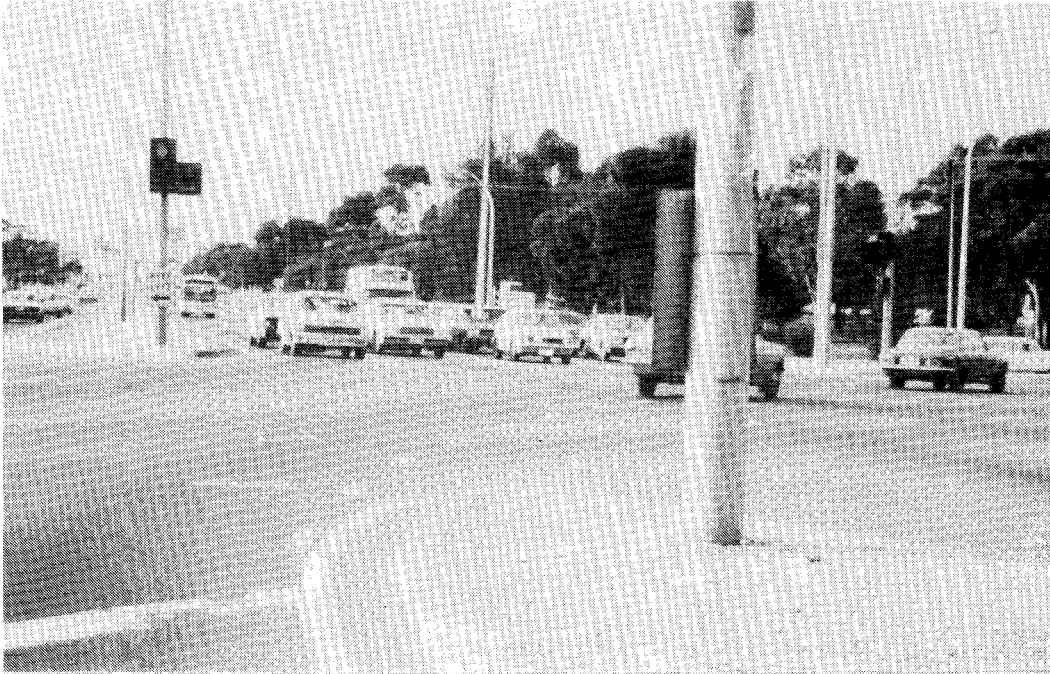
Two accidents in which the through vehicle entered the intersection without slowing down just as the signal changed to green have been described in the previous Section (Accidents 150 and 206). The third accident of this type involved a cyclist who was turning right across four through lanes (Accident 107). Although turning with a green arrow, the cyclist failed to clear the intersection during the intergreen period and was hit by an oncoming car which entered the intersection from the kerb lane. There were stationary vehicles in the other three lanes (Figures 7.12 to 7.14).

FIGURE 7.12: Cyclist's view of path across intersection (Accident 107).

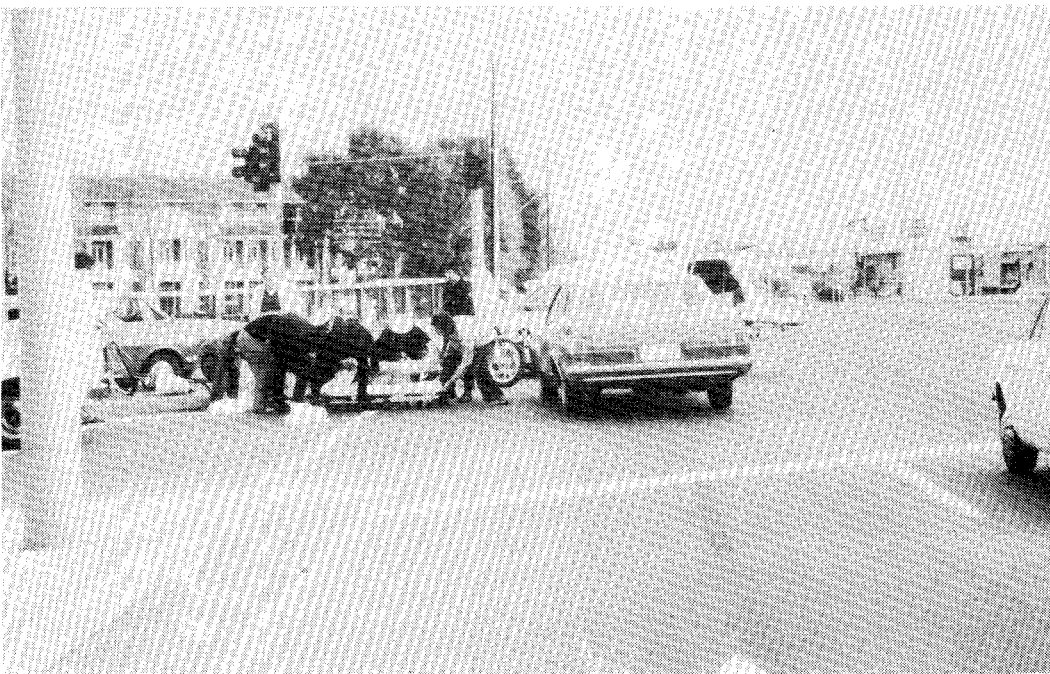
FIGURE 7.13: Driver's view of approach to the intersection, and final position of car (see Figure 7.12).

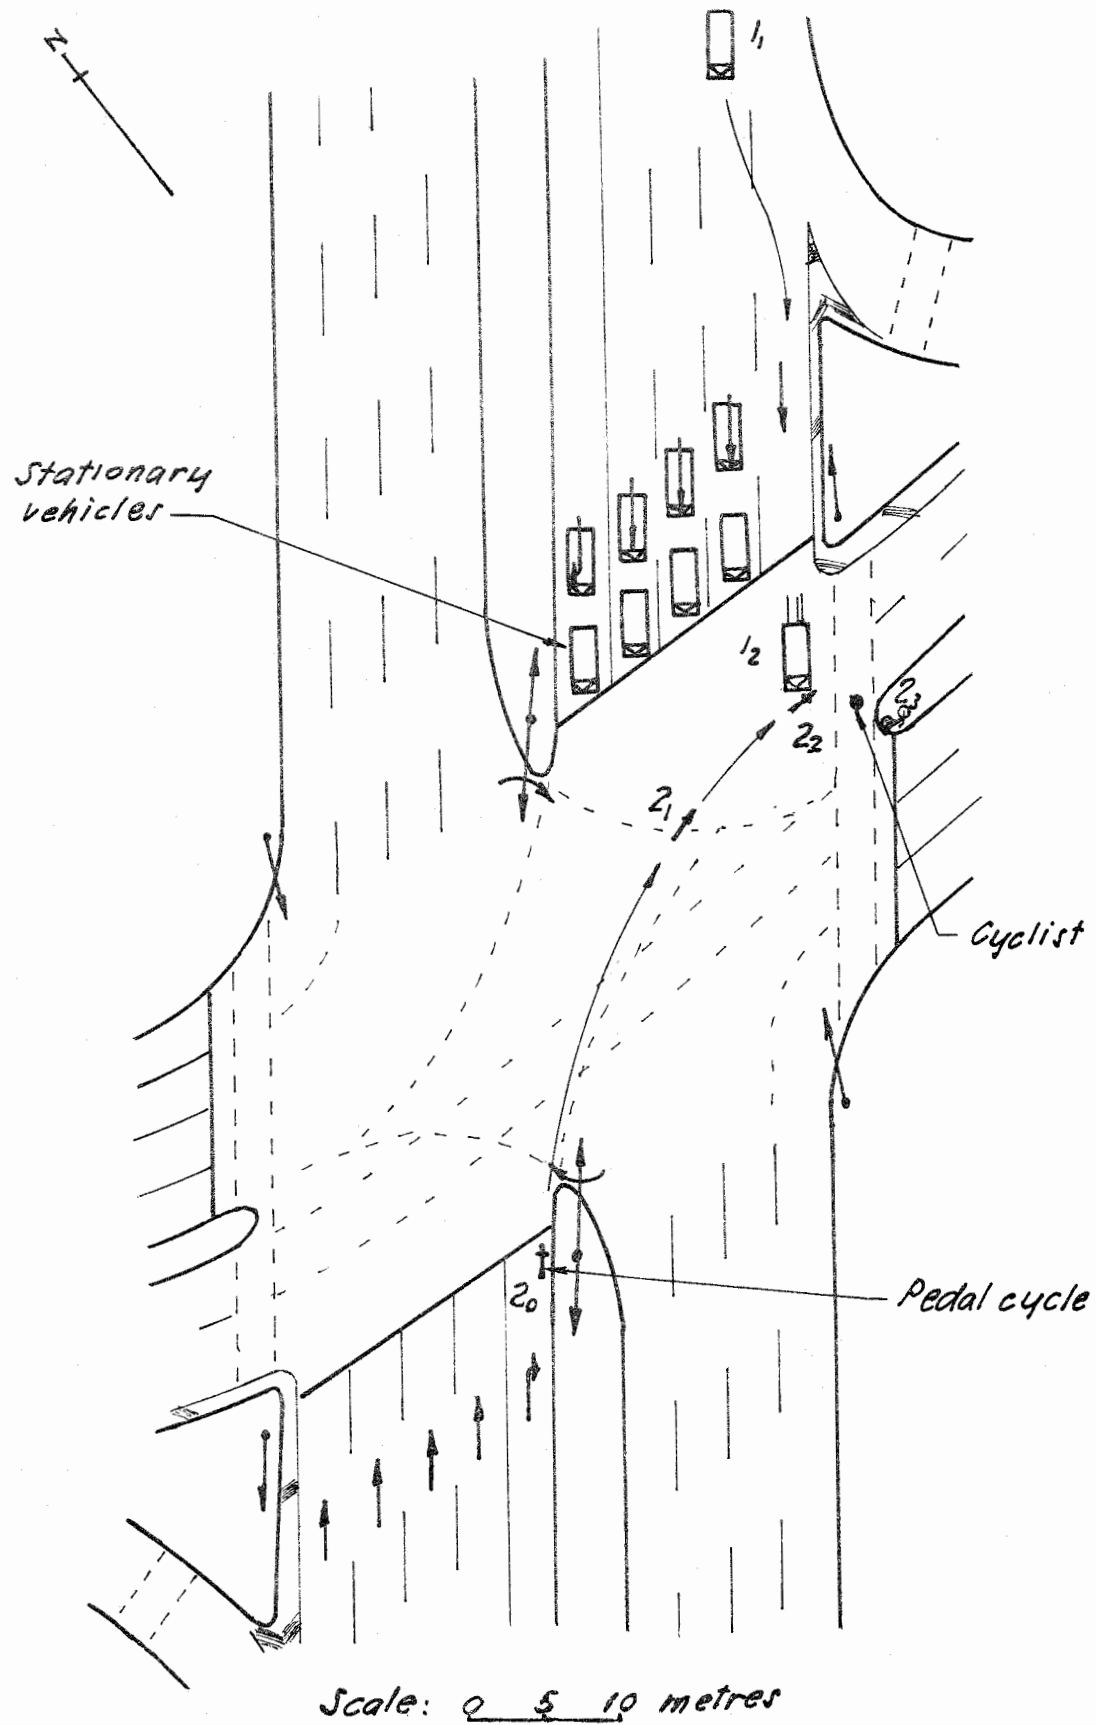
FIGURE 7.14: Accident 107.

The cyclist in Accident 107 had an additional problem with which to contend. The distance that a turning vehicle has to cover from the stop line to clear the intersection is 45 metres. This cyclist had covered 37 metres from the stop line when struck by the car which had entered the intersection rapidly from the kerb lane. The intergreen period here is four seconds, with a three second yellow. This means that a vehicle which starts a right turn as the arrow signal changes from green to yellow must average 40 km/h to clear the intersection before oncoming traffic gets a green light. This is obviously an unrealistic requirement for a pedal cyclist.

An all-red period of only one second may have been selected for this turning movement on the assumption that the oncoming vehicles have a clear view of any turning vehicles. This is not so, as this accident demonstrates. Increasing the period to four seconds would make the intersection safer, but even then a cyclist starting to turn as the light changes to yellow would have to average 23 km/h.

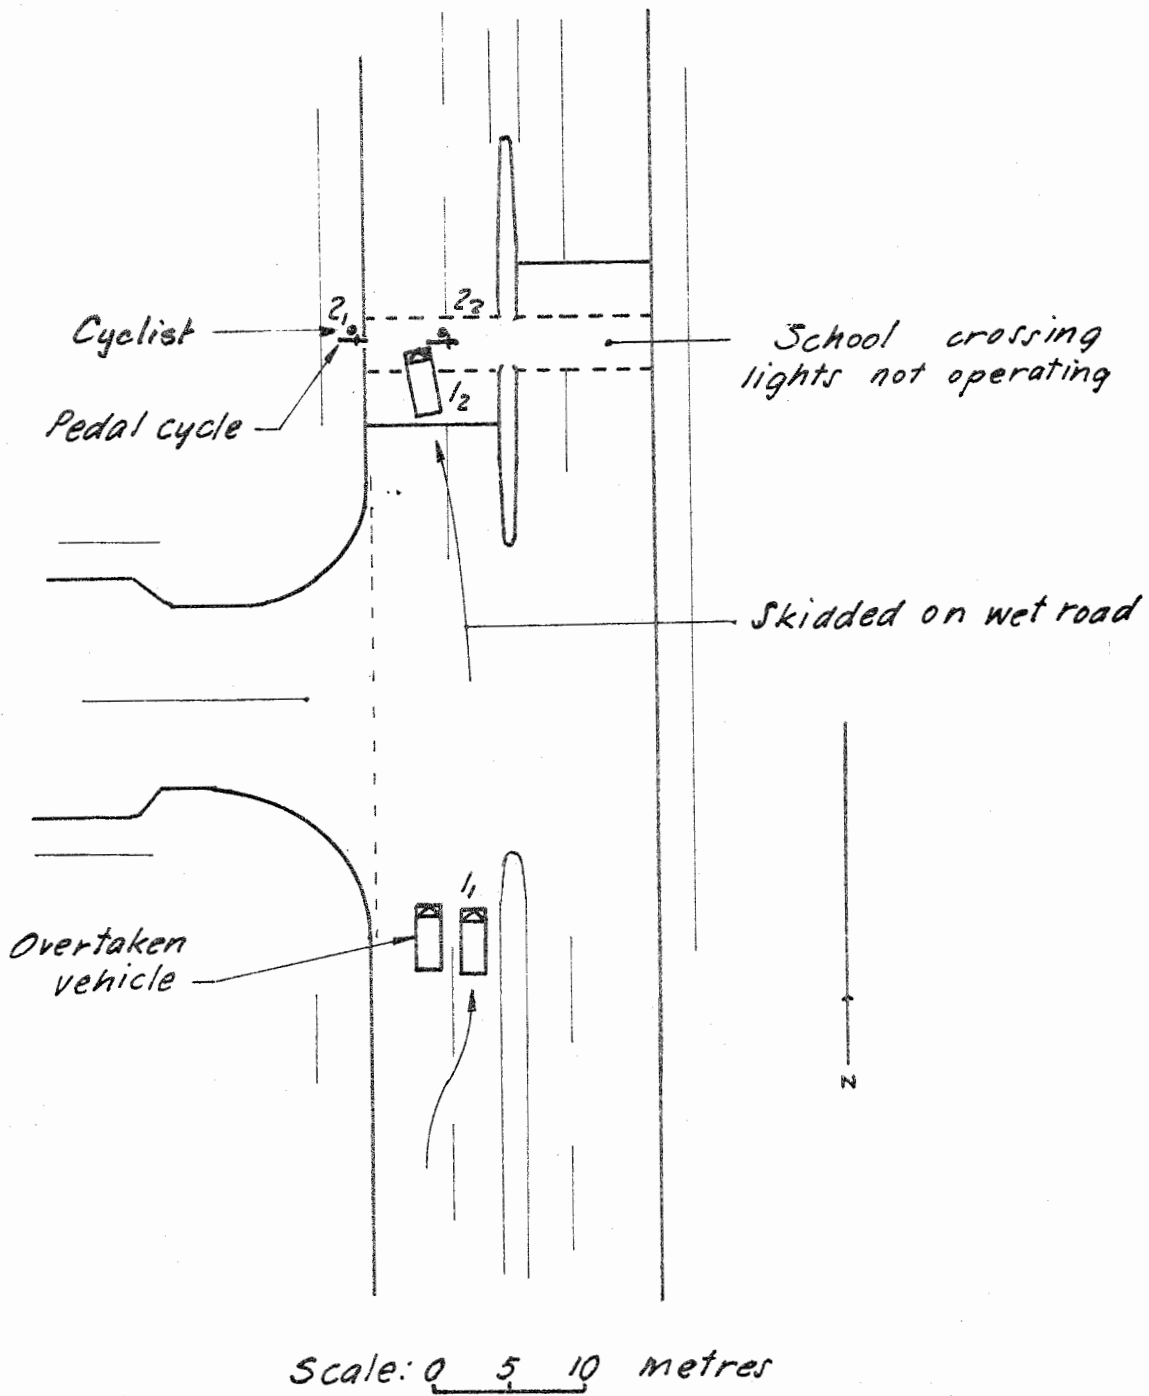
FIGURE 7.15: Accident 087.

087) happened soon after the flashing lights had been switched off on a weekday afternoon (and so the crossing had no legal significance). It involved a collision between a car and a 33-year-old female cyclist, who was walking her cycle across the road on the school crossing (Figure 7.15). The striking car had changed from the left lane to the right to pass another car shortly before the collision. The cyclist sustained head injuries and was unable to remember the accident, and the driver did not see her until just before the impact, so we have no information on whether or not she may have looked to her right or whether she may have misjudged the speed of the overtaking car.
